AVIATION INVESTIGATION REPORT

A04C0064

IN-FLIGHT BREAKUP / COLLISION WITH TERRAIN

BABY BELLE (HELICOPTER-AMATEUR BUILT) C-FZQN

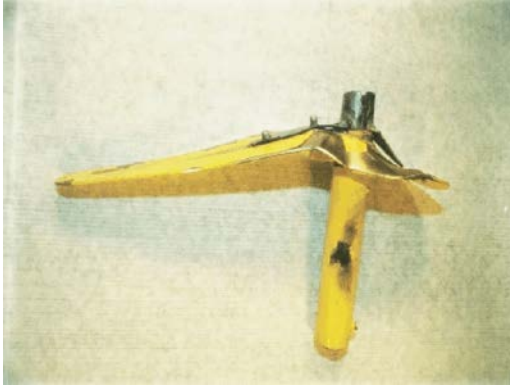
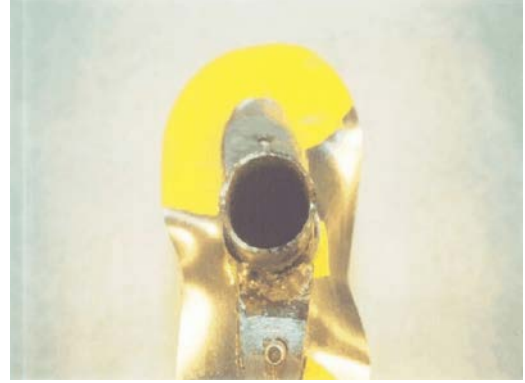
The horizontal stabilizer attachment structure found at the site was equipped with an aluminum end cap that was mounted against the airfoil at the root end (see Photos 1 and 2). A review of the construction drawings and a discussion with the kit manufacturer, revealed that the stabilizer is equipped with an end cap on the outboard end of the airfoil and is not designed with an end cap at the root end.

1. Installation of the end cap at the root end of the stabilizer spar hid the fatigue crack.

The manufacturer of the Baby Belle kit has issued a technical bulletin informing operators of the occurrence and of the recommended inspection criteria. The bulletin also advises operators to comply with the design by removing the end cap, if installed, at the root end.

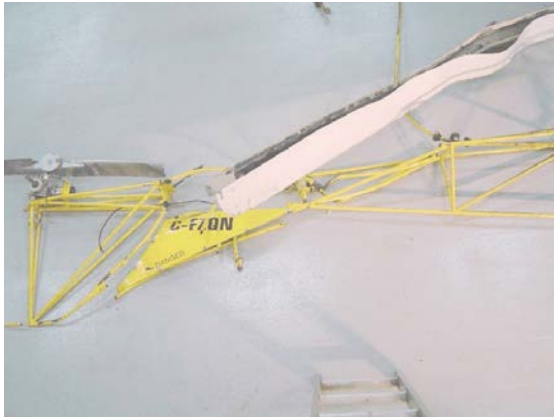
The separation of the horizontal stabilizer during the accident flight is probably related to the previous separation of the tail-rotor blade and its subsequent repair. The separation of the tail-rotor blade induced an excessive amount of vibration in the stabilizer that, when combined with the 22-inch arm of the airfoil, bent the stabilizer spar at the root end. The repair, in which the stabilizer spar was bent back and cold straightened, in combination with the excessive vibration, would concentrate forces at the first rivet hole of the root end. The subsequent two tail-rotor strikes then would have aggravated the localized stress concentrations. The vibrations induced by the tail-rotor blade separation and tail-rotor strikes initiated fatigue cracking. Continued operation of the helicopter resulted in continued fatigue cracking and in the eventual overload failure of the stabilizer spar. Installation of the aluminum end cap at the root of the horizontal stabilizer airfoil did not allow inspection of the area, effectively hiding the fatigue crack.

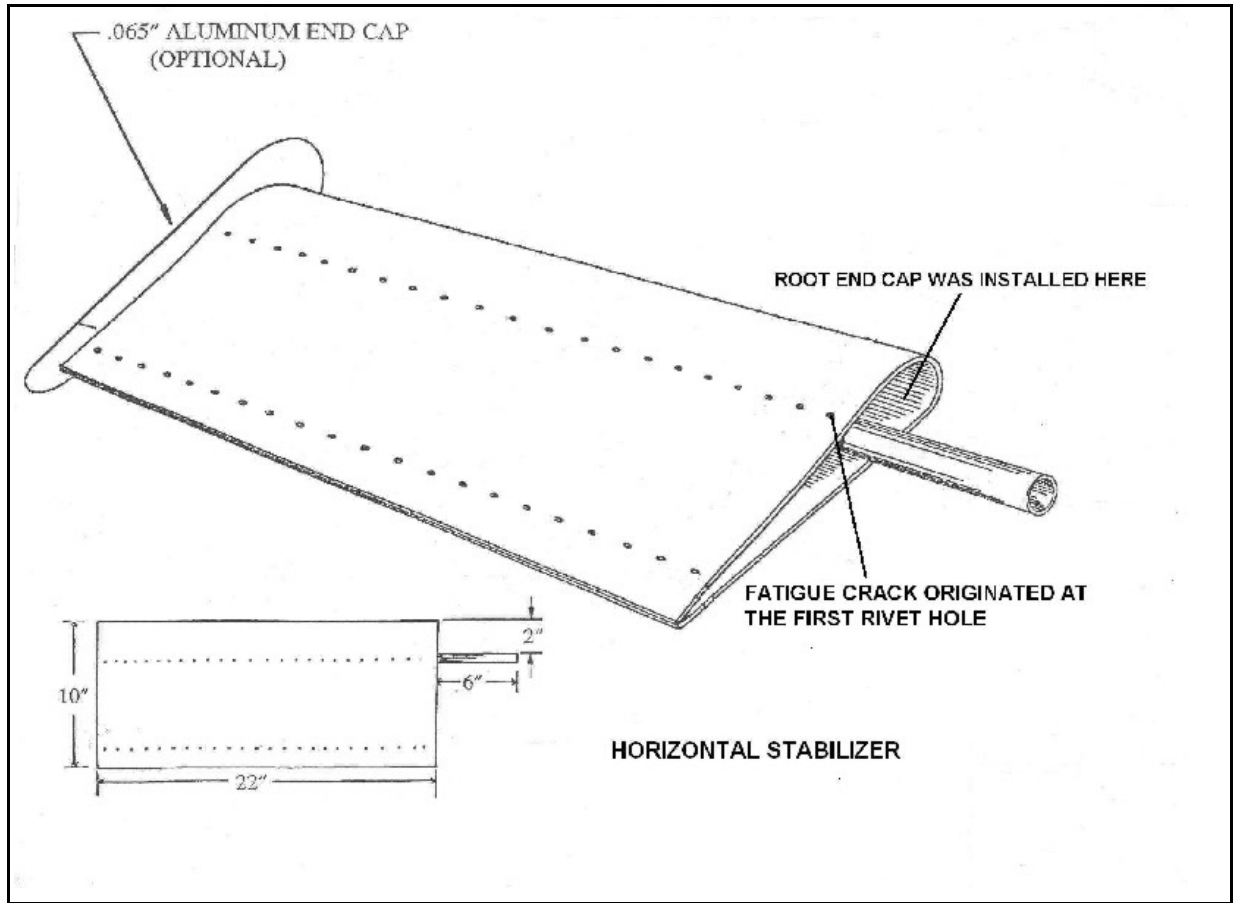
Appendix A - Diagram of Horizontal Stabilizer

The horizontal stabilizer is a 22-inch long symmetrical airfoil mounted with a 2-degree positive angle of incidence, opposite the tail rotor at station 241(see Appendix A). The horizontal stabilizer is constructed of 4130-steel spar tubing and has holes drilled through it for attaching the airfoil with rivets. In forward cruise flight, the stabilizer aids in controlling the helicopter. At speeds below 70 mph, the stabilizer lifts the tail. At speeds above 70 mph, it forces the tail downward. At speeds above 70 mph, the slipstream acts upon the bubble canopy, pitching the nose down and the tail up. As the tail pitches up, the top surface of the horizontal airfoil engages with the slipstream, resulting in a downward force to achieve an equilibrium. The stabilizer also dampens vibrations caused by the tail rotor.
