## **AVIATION INVESTIGATION REPORT**

**A04O0103**

### **AIRCRAFT STALL DURING INSTRUMENT APPROACH**

**RAYTHEON B300 (SUPER KING AIR) C-GEJE**

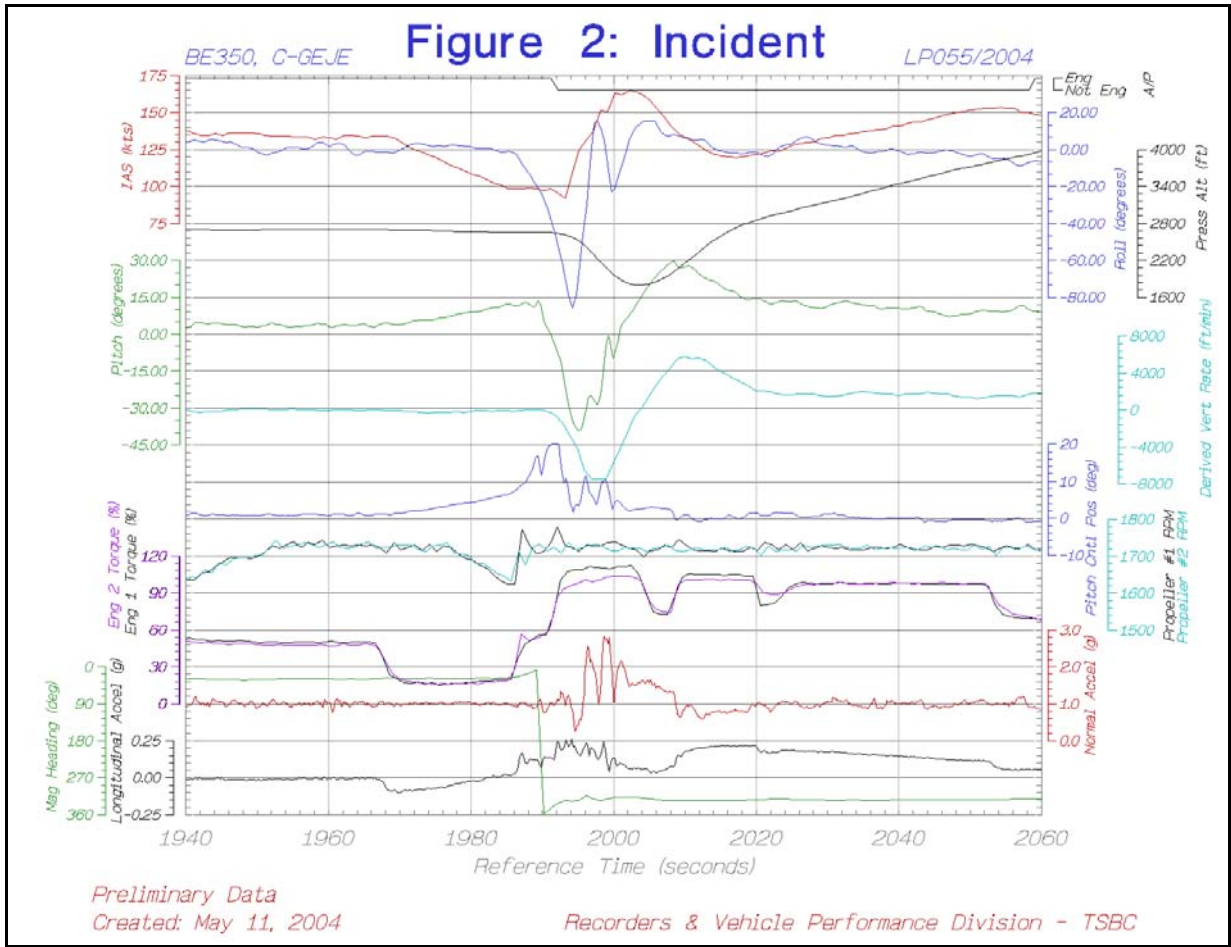
# Appendix B – Flight Data Recorder Plot

Appendix B is a plot of the data at the time of the stall. The data show that the aircraft was level at 2700 feet asl for approximately two minutes prior to the stall. After level off, the airspeed slowly decreased to about 135 KIAS and then remained relatively constant for the next 30 seconds. The power was then reduced from 48 per cent torque to 20 per cent torque, resulting in a fairly rapid airspeed decrease to 98 KIAS over the next 14 seconds. Power was then increased to about 54 per cent torque and the aircraft began to roll left at a rate of about 5° per second. The airspeed held at 98 KIAS for several seconds, while the roll rate increased to 15° per second and the pitch control position<sup>5</sup> increased to +20° before the aircraft stalled. The autopilot remained engaged until the aircraft stalled.

During the stall, the aircraft rolled left to 85° of bank and pitched to 39° nose down during a 0.25 g pushover. Maximum power was applied and, as the airspeed increased rapidly above 125 KIAS, a 2.4 g pull-up was initiated. The back pressure was momentarily released while the aircraft was in a 30° nose-down attitude, allowing the aircraft to accelerate to 150 KIAS before pulling to 2.7 g. When the aircraft reached level flight, the back pressure was momentarily released before a 1.5 g to 2 g pull-up was initiated, with the aircraft reaching 30° nose up. The maximum allowable g load with flaps extended is 2.0 g. The 30° nose-up attitude was held momentarily before it was adjusted to a normal climb attitude of 10° to 15°.
