## AVIATION INVESTIGATION REPORT

A04Q0199

### RUNWAY EXCURSION

**BE-A100 KING AIR C-GAIK**

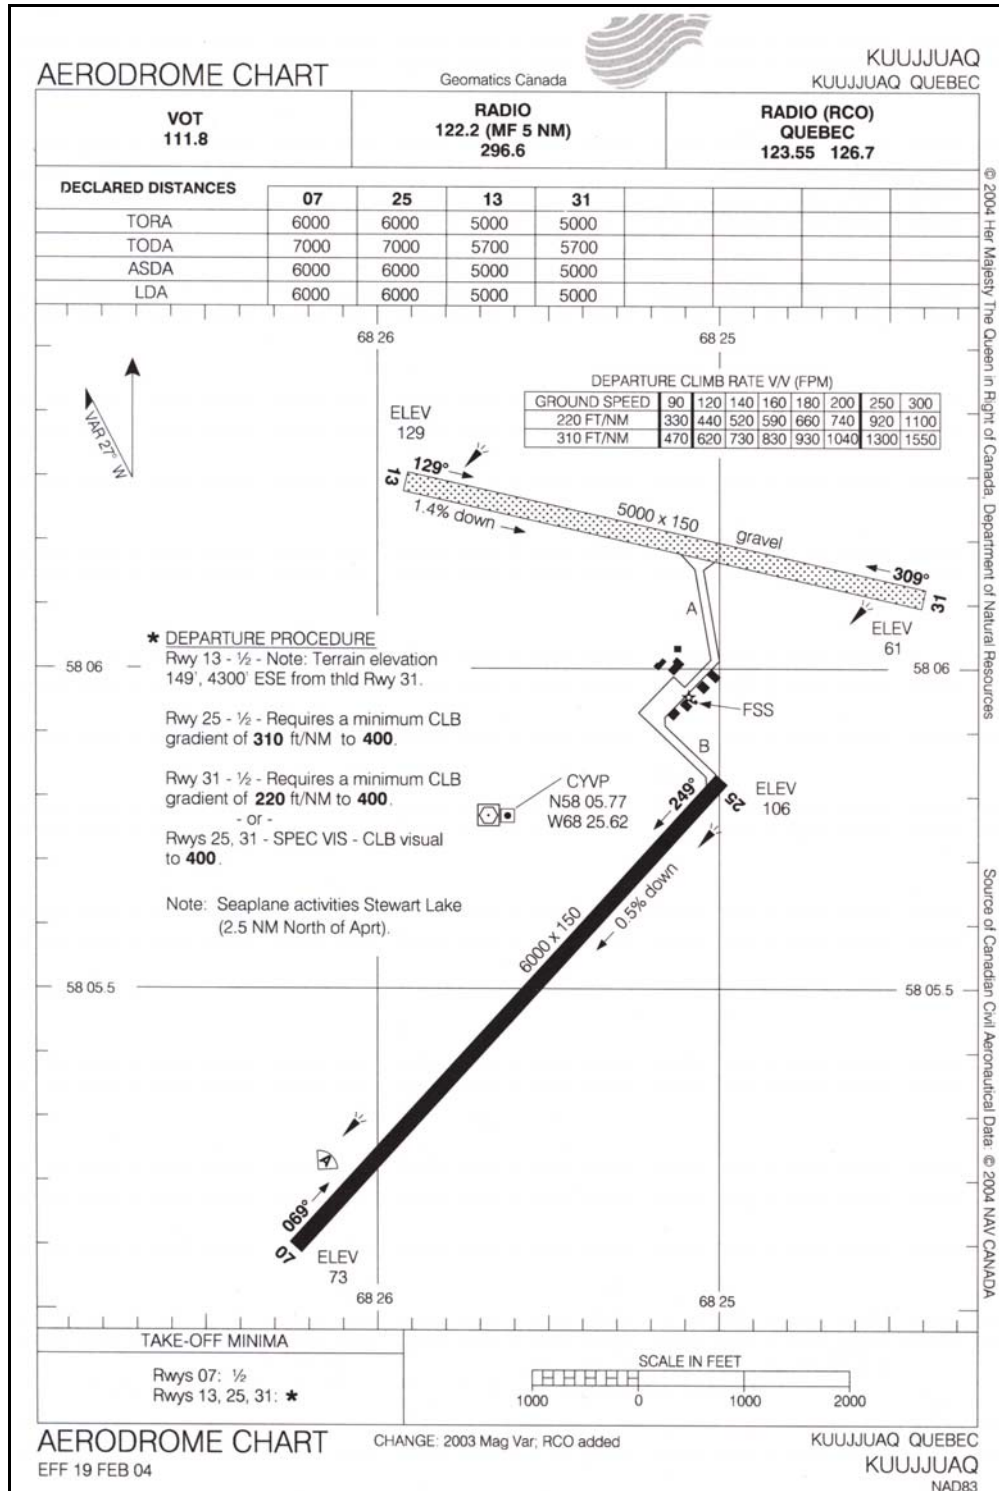
# Appendix A – CYVP Kuujjuaq Aerodrome Chart

was 40 nm from the airport, the FSS specialist reported being able to see the first four or five runway lights of the threshold for Runway 25 from his vantage point in the tower (see Appendix A). This corresponded to a visibility of approximately  $\frac{1}{4}$  mile.

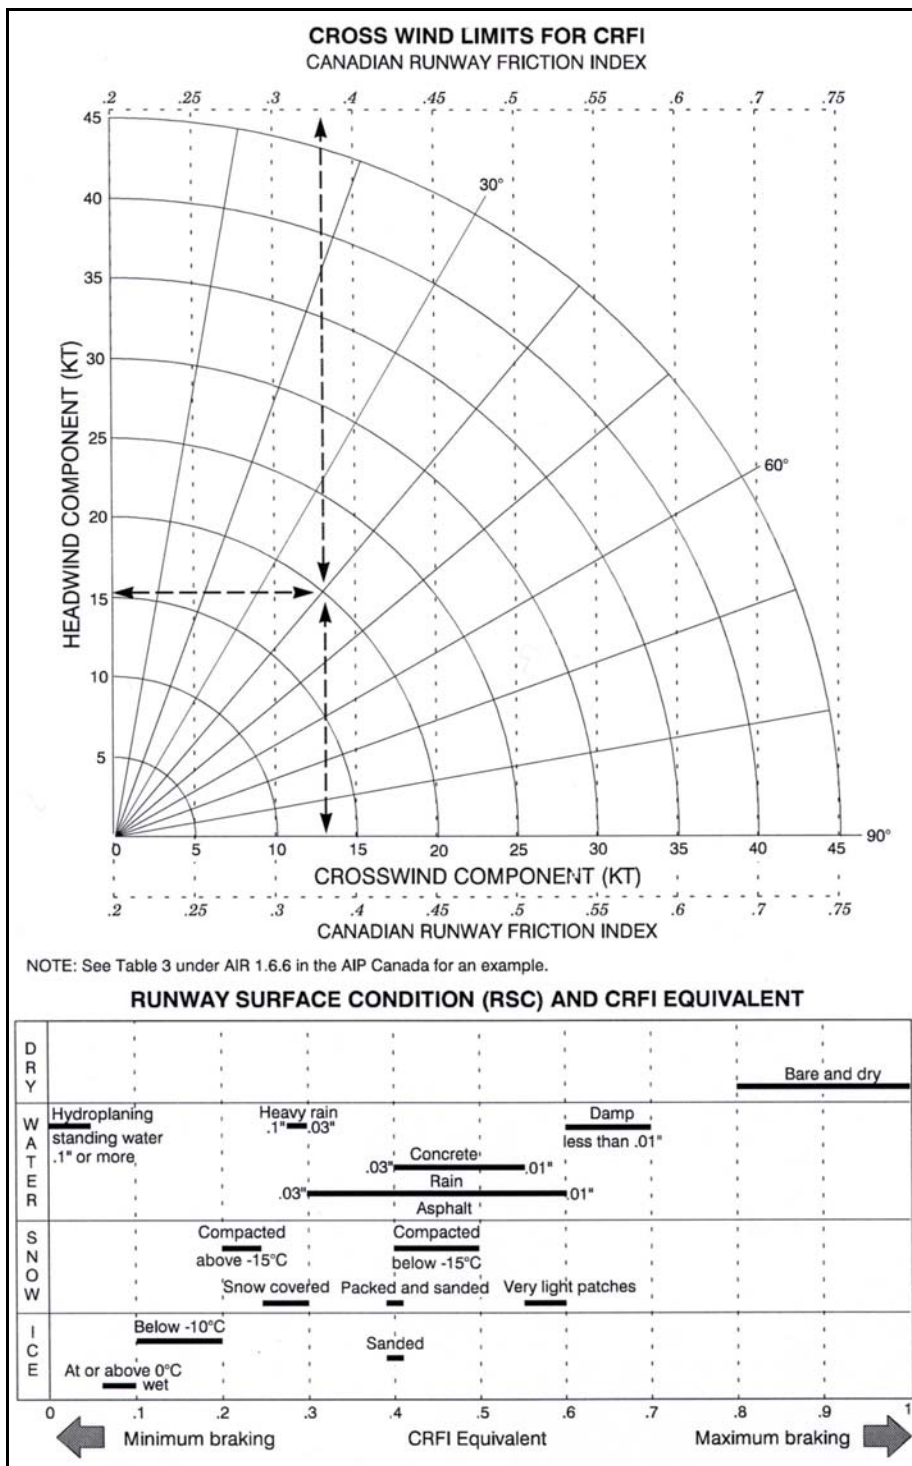
# Appendix C – Canadian Flight Supplement Crosswind Limits for Canadian Runway Friction Index

Both *Aeronautical Information Publication* (A.I.P. Canada), Section AIR 1.6.6, and the *Canada Flight Supplement* (page A64) include a reference chart that provides recommended maximum crosswind components for reported CRFI values (see Appendix C). At the maximum gust speed

reported during the flight, 45 knots, the crosswind component would be about 40 knots, with a recommended minimum runway friction coefficient of about 0.7. This approaches the coefficient of friction expected for a runway that is bare and dry.
