## AVIATION INVESTIGATION REPORT

A05C0187

### LOSS OF CONTROL AND COLLISION WITH TERRAIN

CESSNA 208B CARAVAN C-FEXS

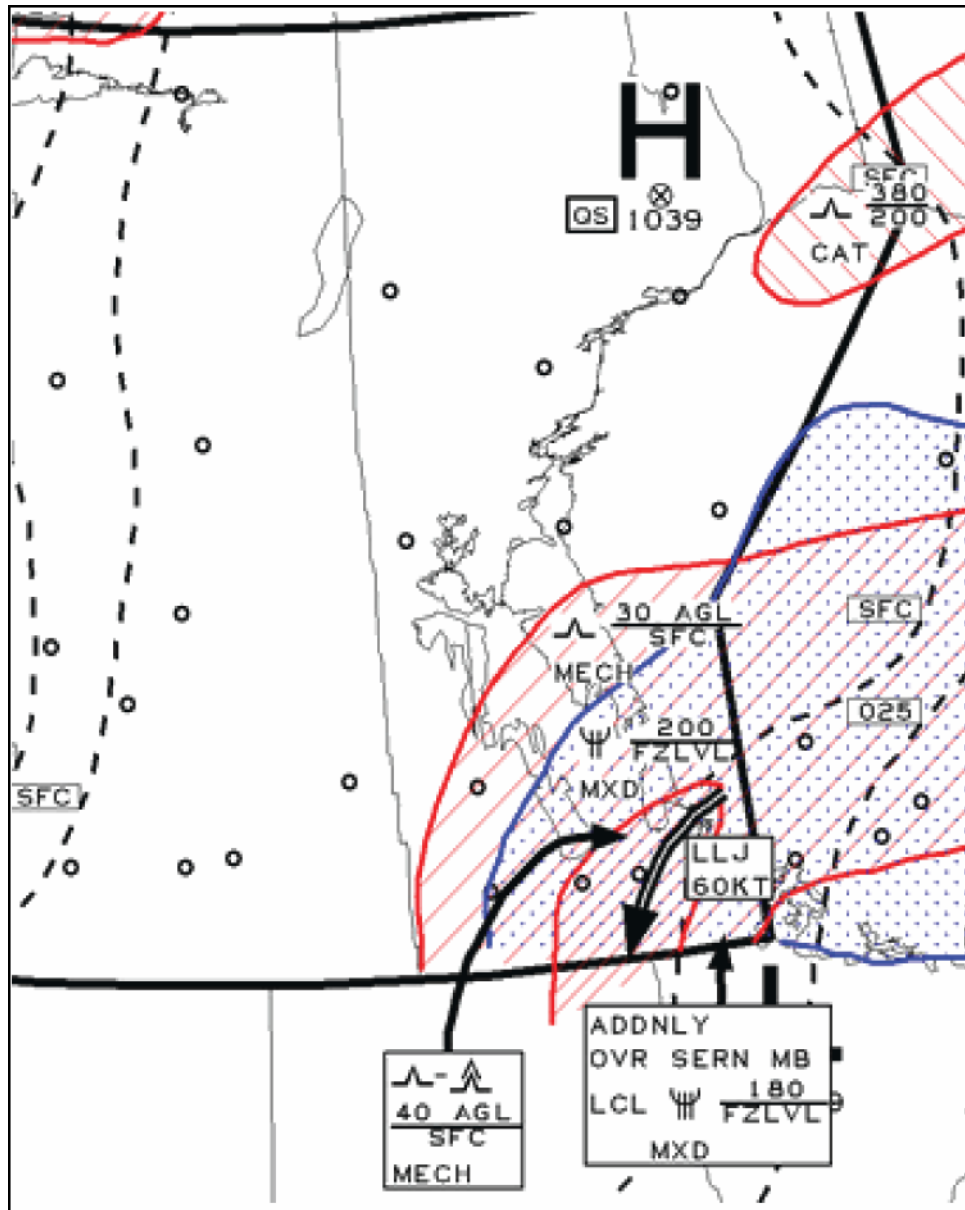
Icing and Turbulence, Winnipeg area (valid October 6 at 0600 UTC)

The icing conditions over Winnipeg were still forecast as moderate at the time of the accident, 0543. Aircraft that operated in the Winnipeg area were encountering in-flight icing conditions at the time of the accident and as late as 0615, although the forecast called for icing conditions to have moved to the east of Winnipeg before the end of the forecast period, 0700. Lower-than-forecast cloud ceilings persisted as late as 0700, indicating that the weather system over the Winnipeg area was moving somewhat more slowly than forecast. As a result of the slower weather system movement, icing conditions prevailed in the Winnipeg area longer than anticipated.

The pilot did not receive the GFAs with the faxed weather and, therefore, did not view the pictorial display of the icing forecast. The weather system over Winnipeg and the flight route to Thunder Bay was moving eastward more slowly than forecast and, therefore, the icing conditions lingered in the Winnipeg area and eastward longer than forecast. Because the telephone briefing dealt mostly with conditions in the Winnipeg area, and the pilot was unable to view the GFA charts, it is possible that the pilot’s understanding of the icing situation was less than complete, especially regarding the eastern portion of the flight route. However, the telephone briefing described the forecast moderate icing conditions over Winnipeg and eastern Manitoba, and those conditions prevailed throughout the flight route. Therefore, it was unlikely that the lack of the GFAs contributed to the pilot’s decision to dispatch the flight or the subsequent encounter with icing conditions in the Winnipeg area.

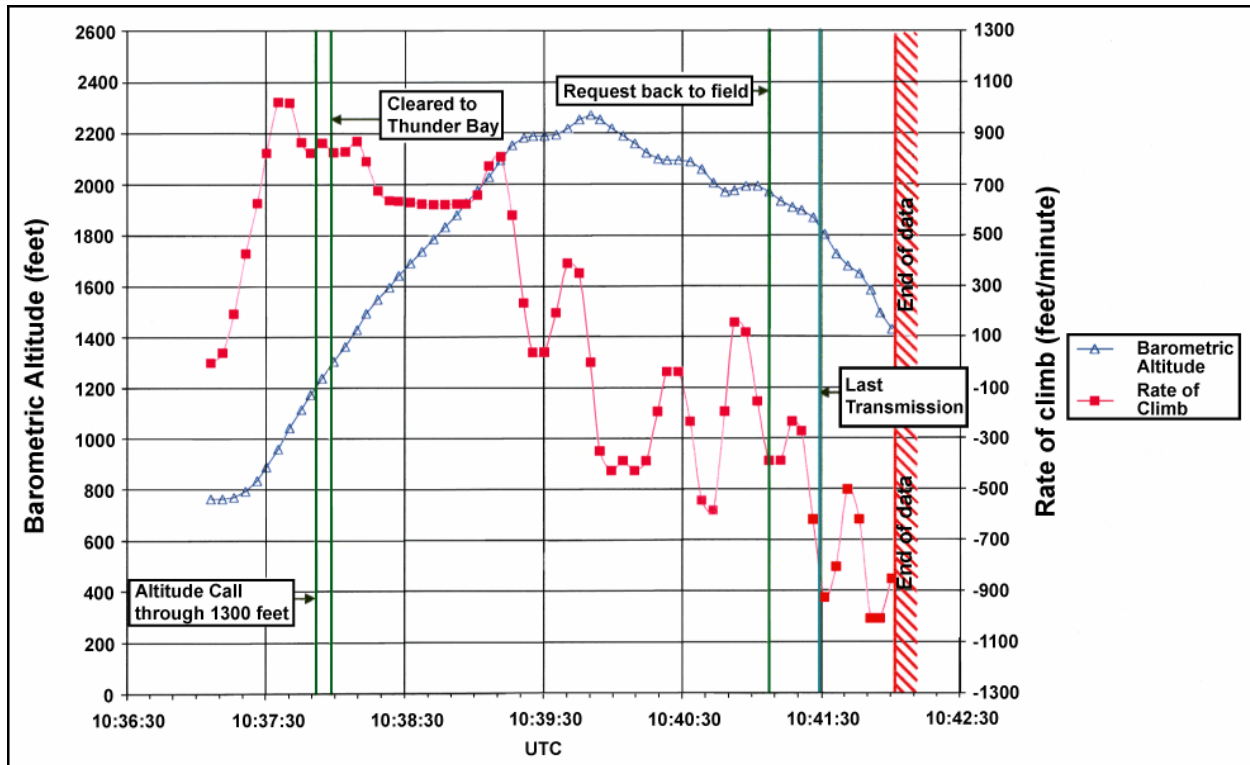
## Appendix D – Altitude versus Rate of Climb/Descent

The aircraft departed the Winnipeg International Airport about three per cent over its maximum gross weight. Its rate of climb on departure was somewhat less than the rate indicated in the AFM for an aircraft at maximum gross weight. However, turbulence and gusty wind conditions prevailed at Winnipeg at the time of take-off, and these conditions, along with the aircraft's overweight condition, would have degraded performance. It was therefore concluded that the aircraft was mechanically serviceable at take-off, and departed without significant critical surface contamination.

Aircraft performance deteriorated progressively after the aircraft climbed through 1000 feet agl. Cloud ceilings were observed at Winnipeg at 700 feet agl, and were forecast at 1000 feet agl. The reduction in aircraft performance began soon after the aircraft entered cloud and was likely the result of the icing conditions, which were forecast to prevail over Winnipeg at that time and were experienced by other crews.

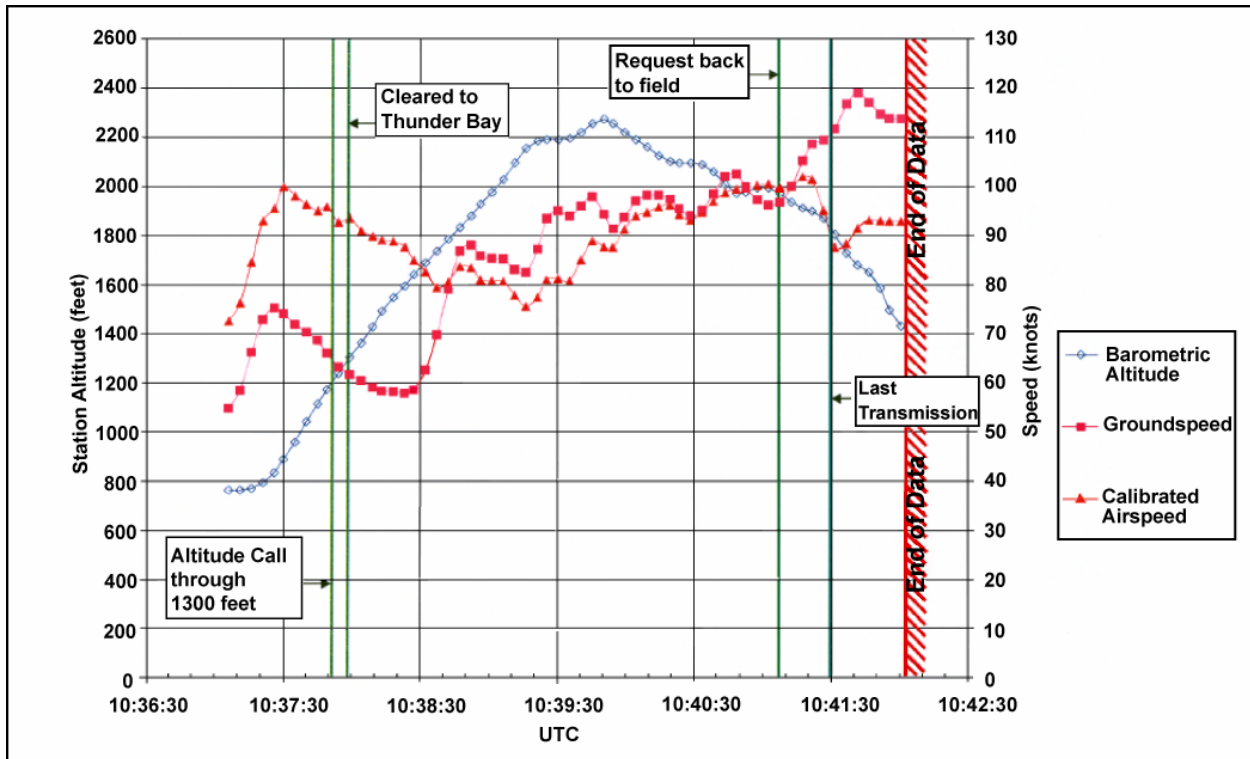
# Appendix E – Altitude versus Groundspeed/Airspeed

The aircraft's calculated airspeed fluctuated during the flight, as might be expected in the gusty wind conditions and turbulence. Most of the flight was conducted at airspeeds below the 0° flap  $V_y$  (best rate of climb airspeed) and below the 0° flap minimum airspeed in icing conditions. It would, however, have been at or above the 20° flap  $V_y$ . Although the flaps were retracted at impact, the flap settings used throughout the flight could not be determined. Without information as to the flap settings, the suitability of the airspeeds during the flight cannot be determined. If the aircraft entered icing conditions in cloud with 0° flap, the airspeeds would have been below the minimum airspeed for those conditions. However, if flaps had been extended during the climb, the 105-knot minimum airspeed would not have applied.
