## **AVIATION INVESTIGATION REPORT**

**A05O0142**

### **DIFFICULTY TO CONTROL**

**BELL 204B C-GRGY**

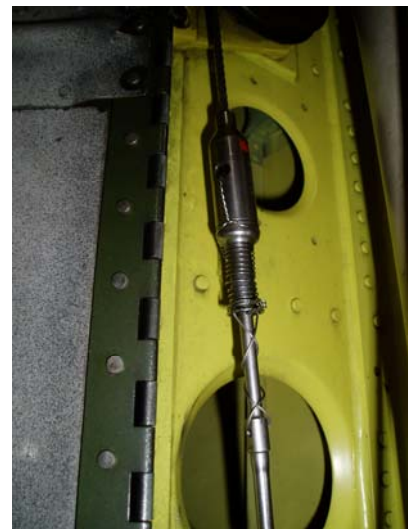
**Photo 2.** Properly lock-wired speed rig
