**AVIATION INVESTIGATION REPORT
A05O0257**

RUNWAY OVERRUN

**JETPORT INC.
GULFSTREAM 100 C-FHRL
HAMILTON AIRPORT, ONTARIO
15 NOVEMBER 2005**

Report Number A05O0257

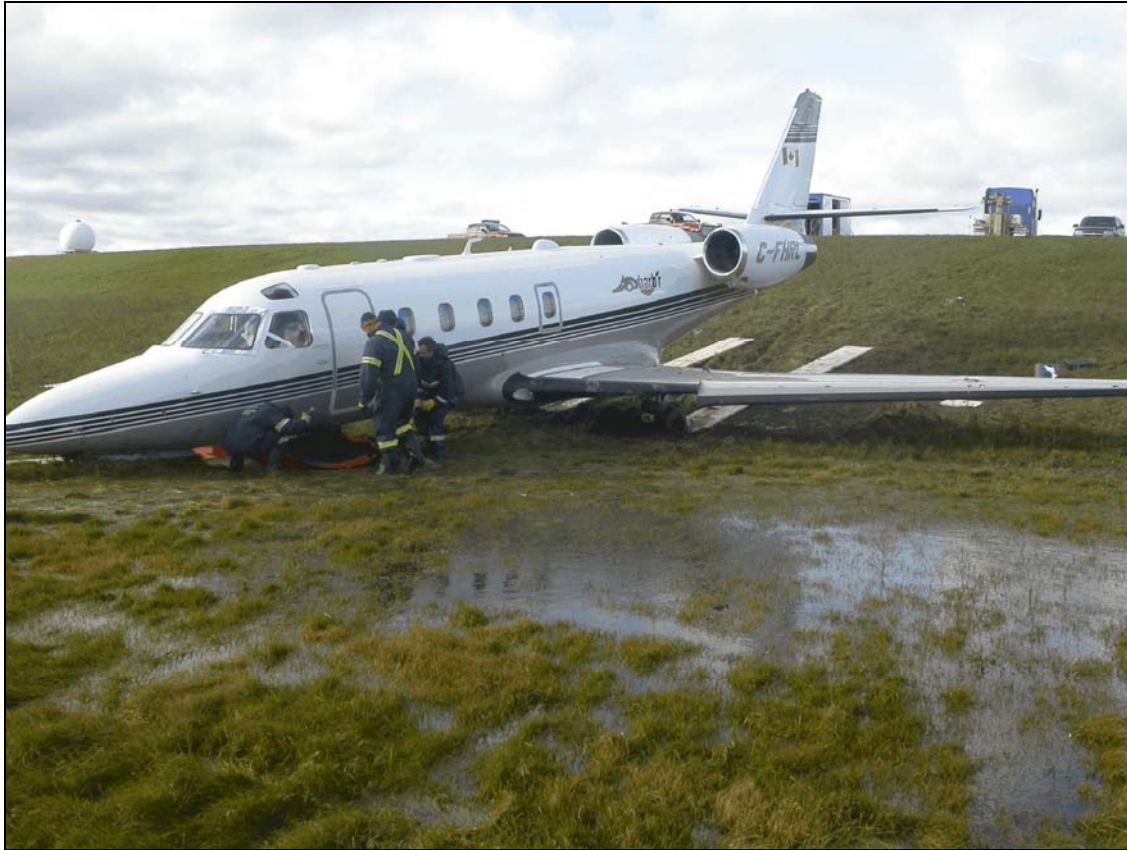
The flight crew were unable to indicate the aircraft touchdown point on the runway. The aircraft was observed to touch down between Charlie taxiway and the intersection of runways 12/30 and 06/24, with approximately 3000 feet of runway remaining. A review of the recorded radar data indicated that the aircraft's speed did not decrease below 130 knots until the aircraft was entering the intersection of the runways. After touchdown, the PNF prompted the PF to deploy the thrust reversers. All braking systems (aircraft brakes, spoilers, thrust reversers) were used to slow the aircraft. However, it rolled 122 feet past the end of the runway and down sloping grass terrain. The aircraft incurred substantial damage when the nose landing gear sheared off, the right main landing gear struck two steel survey stakes, and the right wing struck an aerodrome lighting standard and terrain.

Generally speaking, the speed at which a tire will hydroplane can be calculated by multiplying the square root of the tire pressure by nine. In this occurrence, with a nominal tire pressure of 135 psi, this would equate to hydroplaning speeds of 105 knots for the main landing gear and 85 knots for the nose landing gear. Above 105 knots, it is possible for both the main landing gear tires to hydroplane. This would affect the ability of the aircraft's brake system to deliver effective braking, even with an anti-skid system. Indications of hydroplaning were noted when investigators observed reverted rubber on both the left main gear tires, although none could be found on the other tires.

Photo 1. C-FHRL being prepared to be towed back onto the runway.
