AVIATION INVESTIGATION REPORT
A06C0181

DEPARTURE FROM RUNWAY SURFACE

PERIMETER AVIATION LTD.
SWEARINGEN AIRCRAFT CORPORATION
SA226-TC C-FTNV
NORWAY HOUSE, MANITOBA
08 NOVEMBER 2006

Report Number A06C0181

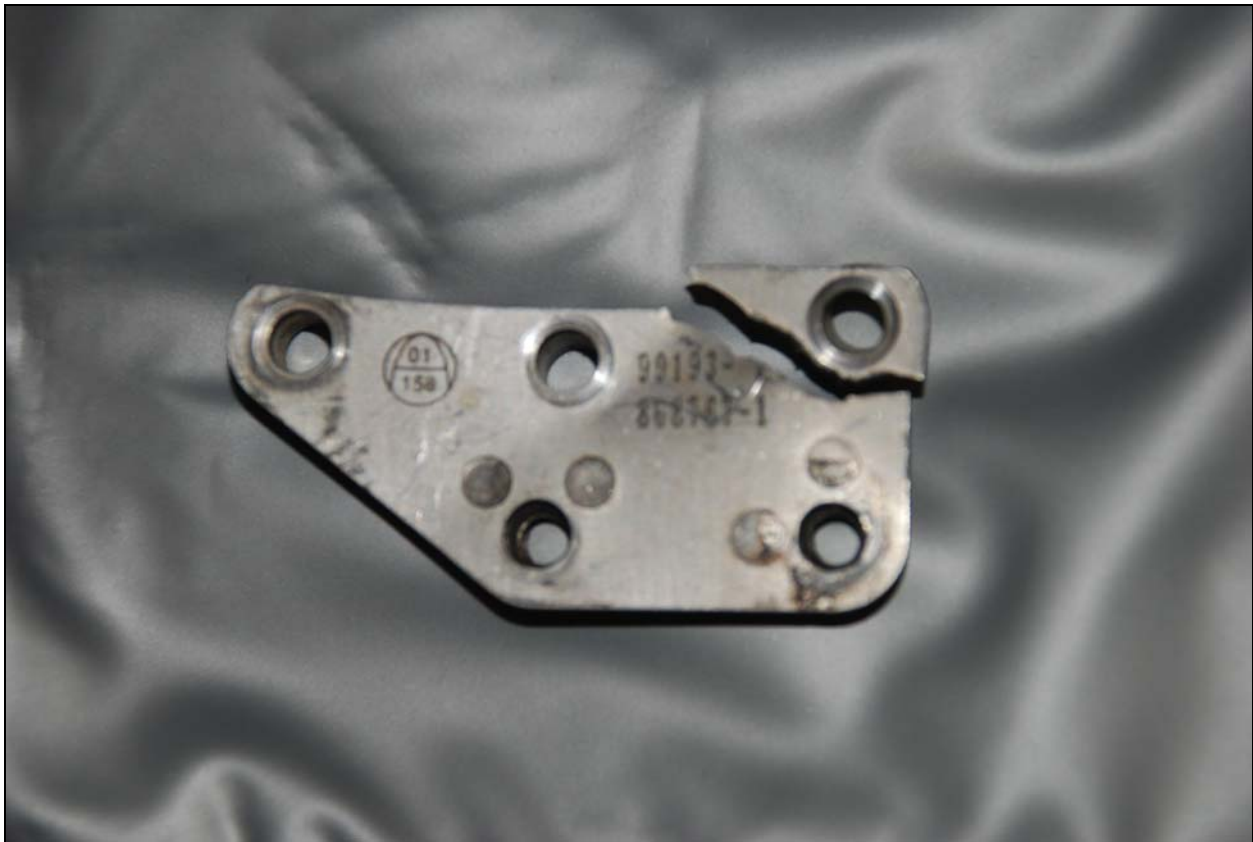
Photo 1. Left engine fuel control upper support assembly

When the left fuel control assembly was removed, the inboard corner and the corresponding attachment bolt of the part number 868767-1 support assembly were attached to the engine case, but separate from the remainder of the assembly. The centre bolt and the outboard bolt were in place on the remainder of the support assembly. A space was evident between the two separated pieces indicating that the outboard portion of the support had rotated slightly and

moved downwards. Engineering examination confirmed that the support assembly failed as a result of progressive fatigue cracking that had initiated in the vicinity of a spacer braze and progressed in two directions to both ends of the fracture face. Additionally, the braze material at the centre bolt spacer showed that similar cracking was commencing at several locations adjacent to that fastener.

After the support assembly failed, any loads applied to the fuel control were transferred to the remaining two bolts. The change in support resulted in a shifting of the support assembly and a subsequent change in the position of the fuel control. With the fuel control removed, the failed support components remained separated by 0.125 inches. It is suspected that, under the effects of loading, that separation could have been as much as 0.25 inches. A change in the position of the fuel control would result in a repositioning of the concentric control shaft and a corresponding change in dimensions at the propeller controls. The corresponding support bracket for the right engine remained intact.

1. The left engine fuel control support assembly failed in fatigue and released one of three attachment bolts, which resulted in a slight displacement of the fuel control and changed the propeller control dimension. As a result, Beta pressure was achieved and propeller reverse was available for the left engine before it was available for the right engine.
2. The pilot selected thrust reverse without confirmation that the Beta lights were on for both engines, and the aircraft veered from the runway, most likely as a result of temporary asymmetric thrust.
