**AVIATION INVESTIGATION REPORT
A06O0141**

LOSS OF CONTROL AND COLLISION WITH TERRAIN

**BEDE BD5-J C-GBDV
OTTAWA / CARP AIRPORT, ONTARIO
16 JUNE 2006**

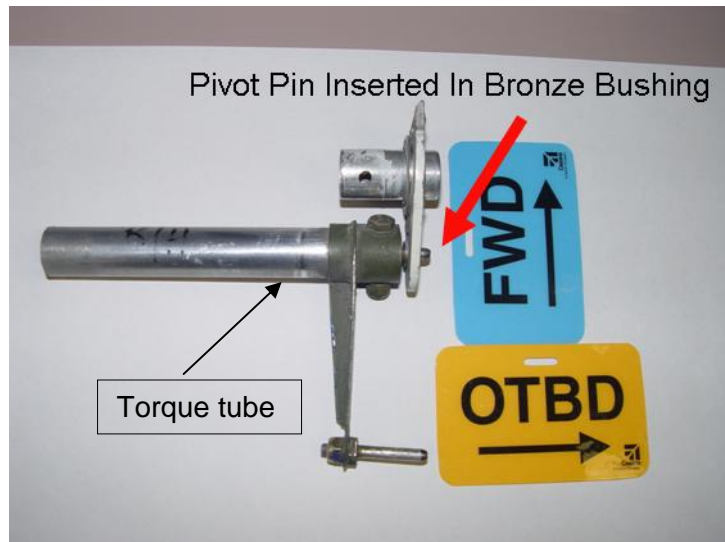
When the wings are installed, the pivot pin on the outboard end of the flap-drive torque tube must be guided into the bronze bushing on the flap arm (see Photo 1). The pin must be visually checked from underneath the aircraft to ascertain that the correct assembly has been accomplished. As a further check of the assembly, the flaps should be extended and retracted using cockpit controls.

Photo 1. Properly assembled right flap mechanism

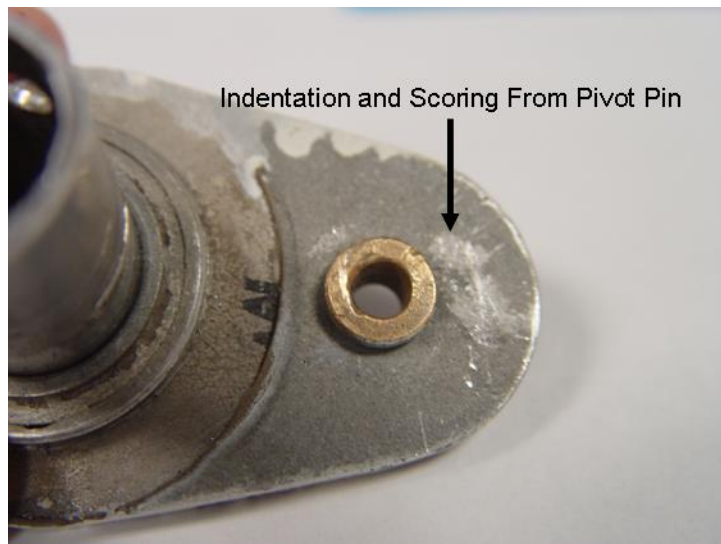
A detailed examination of the right flap hinge arm assembly revealed indentations and a crack in the bronze bushing. There were circular score marks and indications of smearing on the material adjacent to the bushing. These marks had the appearance of being made recently and were consistent with damage that would occur during movement of the flaps. The indentations corresponded in size and radius to the guide pin installed in the end of the flap drive torque tube. The radius of the circular score marks and rubbing corresponded with the radius of the flap drive torque tube.

The smearing indicated that the torque tube had moved upward and aft around the bronze bushing (see Photo 2).

Photo 2. Right flap hinge arm

Reportedly, the pilot checked the flaps for correct installation and function before the accident flight. However, an examination of the aircraft indicated that the right flap was incorrectly installed, in that the torque tube pin was not secured in the flap arm bushing, which would allow the flap to retract in flight.

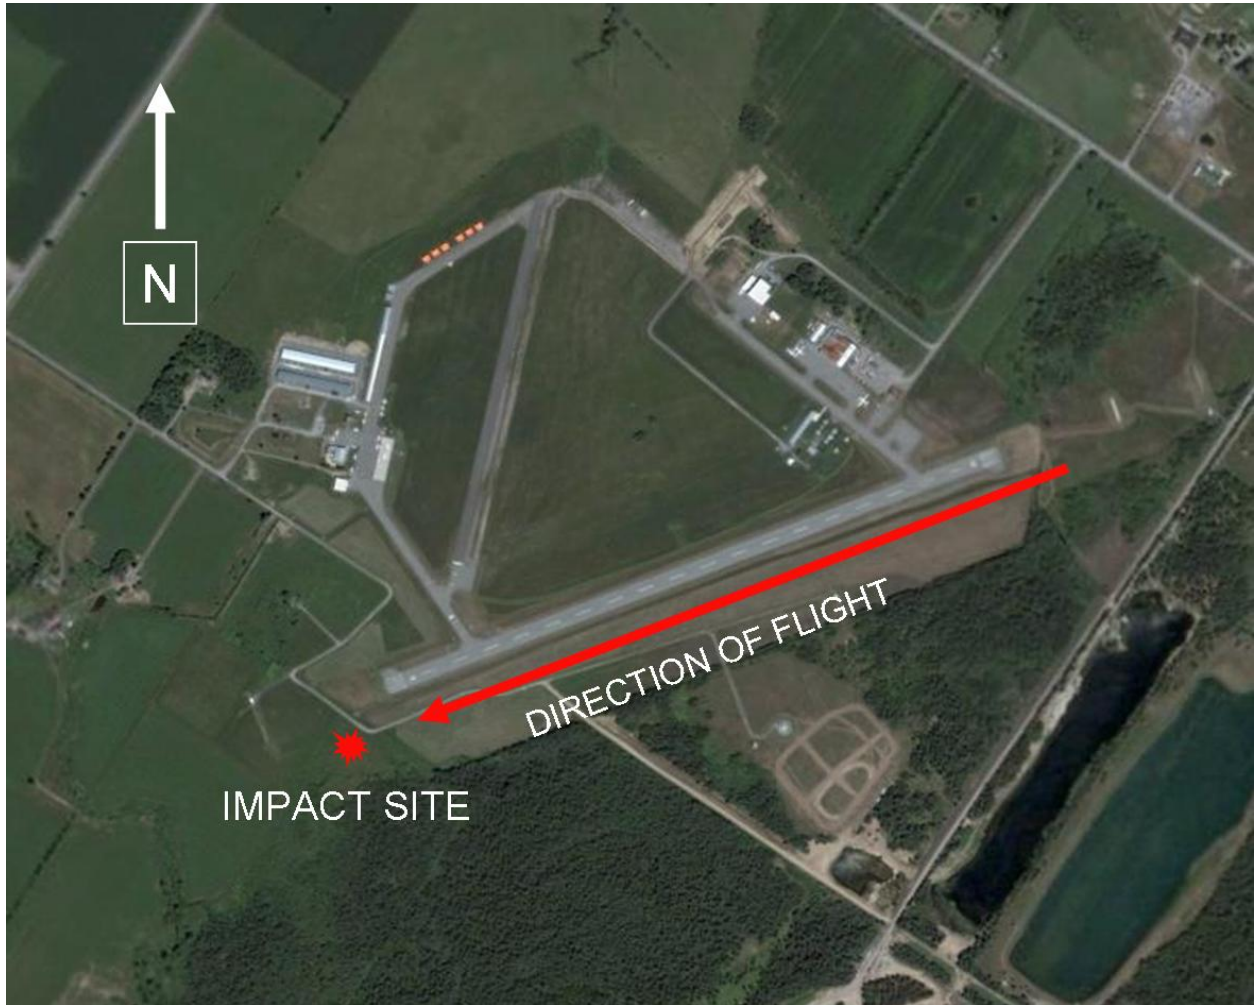
Appendix A – Site Diagram

The initial impact was 460 feet southwest of the button of Runway 10. The aircraft slid 23 feet and came to rest on a heading of approximately 200° magnetic (see Appendix A). The aircraft hit the ground in a slightly nose-low, left-wing-down attitude. The ground scars showed that the landing gear was down and that both wings separated from the aircraft at impact. When the aircraft was examined at the site, no discrepancies were found in the aileron, rudder, or elevator control systems.
