**AVIATION INVESTIGATION REPORT**  
**A07A0025**

**LOSS OF SEPARATION**

**SERCO FACILITIES MANAGEMENT INC.  
GOOSE BAY, NEWFOUNDLAND AND LABRADOR  
13 MARCH 2007**

Report Number A07A0025

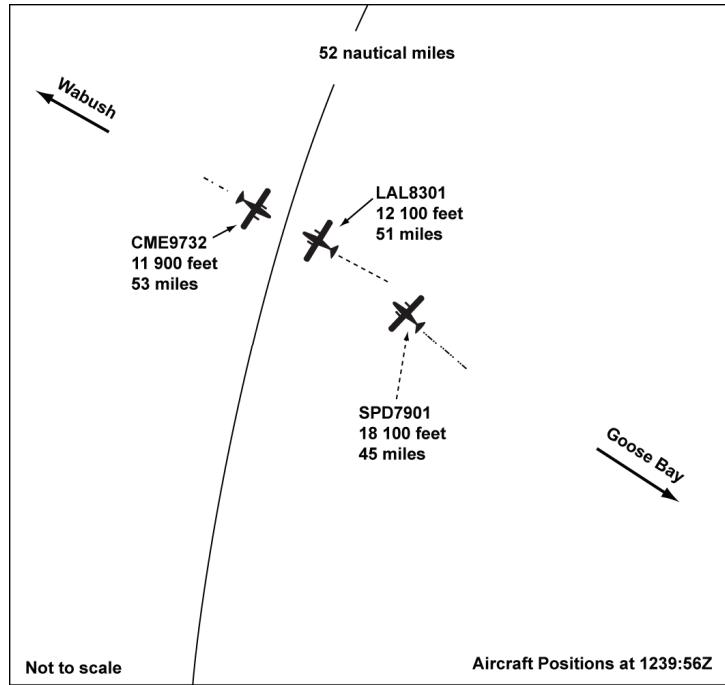
Figure 1. Aircraft positions at 1239:56

At 1239:40, after deviating in response to a traffic alert and collision-avoidance system (TCAS) resolution advisory (RA), the crew members of LAL8301 contacted Goose Bay terminal asking if there was other traffic in the area, adding that they were showing traffic on the TCAS.

The controller immediately issued a left turn of approximately 30° to LAL8301, followed by an instruction to CME9732 to fly a heading of 080°. The crew of CME9732 reported LAL8301 in sight passing on the right, and the crew of LAL8301 reported CME9732 in sight. At the point of closest approach, the two aircraft had about 300 feet vertical and 1.8 nm horizontal spacing.
