**AVIATION INVESTIGATION REPORT
A07A0118**

IN-FLIGHT COLLISION BETWEEN TWO HELICOPTERS

**NEWFOUNDLAND HELICOPTERS LTD.
BELL 206L LONG RANGER, C-GCHA
AND
UNIVERSAL HELICOPTERS NEWFOUNDLAND LTD.
EUROCOPTER AS 350 BA ASTAR, C-FHHH
POSTVILLE, NEWFOUNDLAND AND LABRADOR
03 OCTOBER 2007**

Report Number A07A0118

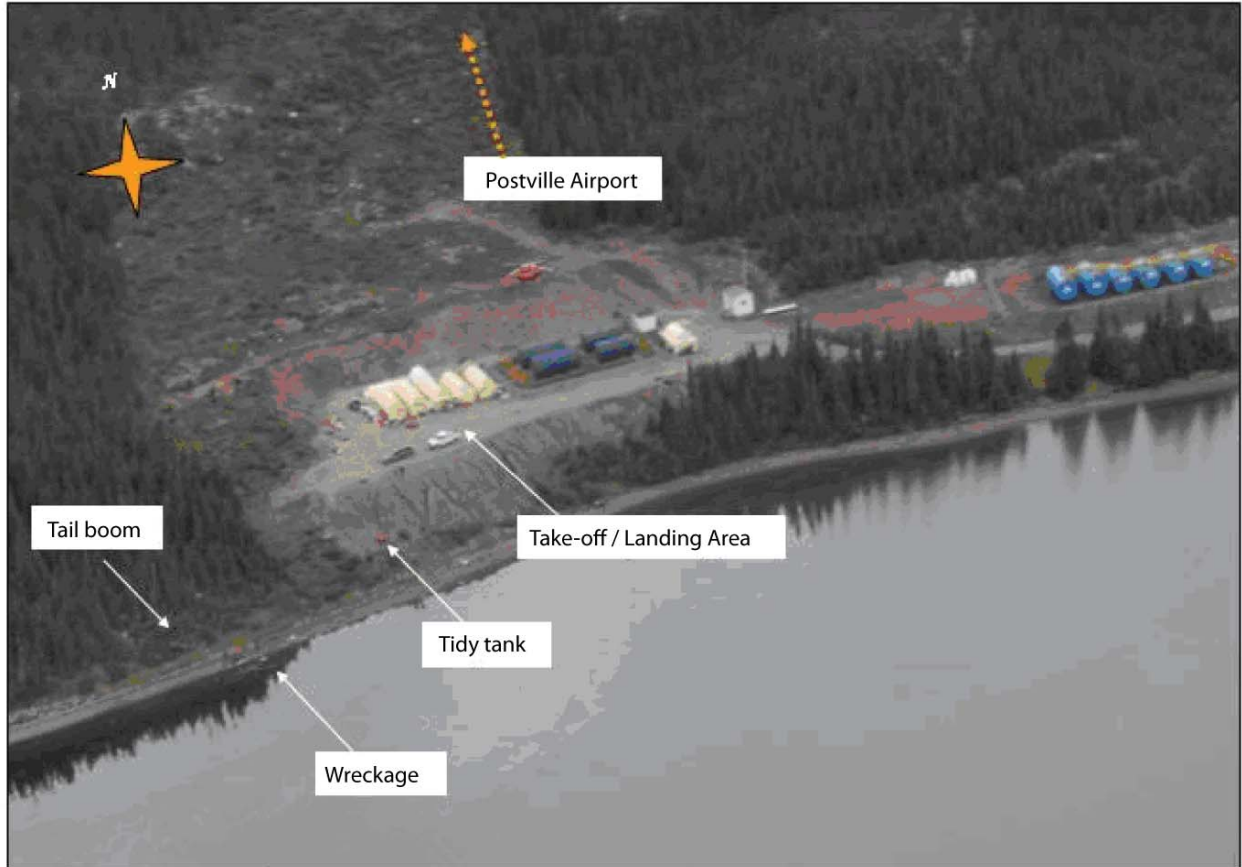
Appendix A – Photograph of Accident Area

The fuel-staging area is a flat, gravel-surfaced area bordered by trees to the west, the town's supply of diesel fuel tanks and an access road to the east, low-lying brush to the north and the waters of Kaipokok Bay to the south (see Appendix A - Photograph of Accident Area). The helicopter landing area is approximately 100 feet by 55 feet and is about 40 feet above the shoreline. Helicopters using the fuel-staging area land south of the fuel tanks facing towards the north, with the tail booms overhanging the embankment between the landing area and the shore. There is room to land and manoeuvre three to four helicopters at one time. All tanks are on the north side of the fuel-staging area. Aircraft normally approach and depart upwind; winds are generally westerly and most departures out of the fuel-staging area are to the west.
