AVIATION INVESTIGATION REPORT

A07O0305

RUNWAY INCURSION

LEARJET 35A, N70AX

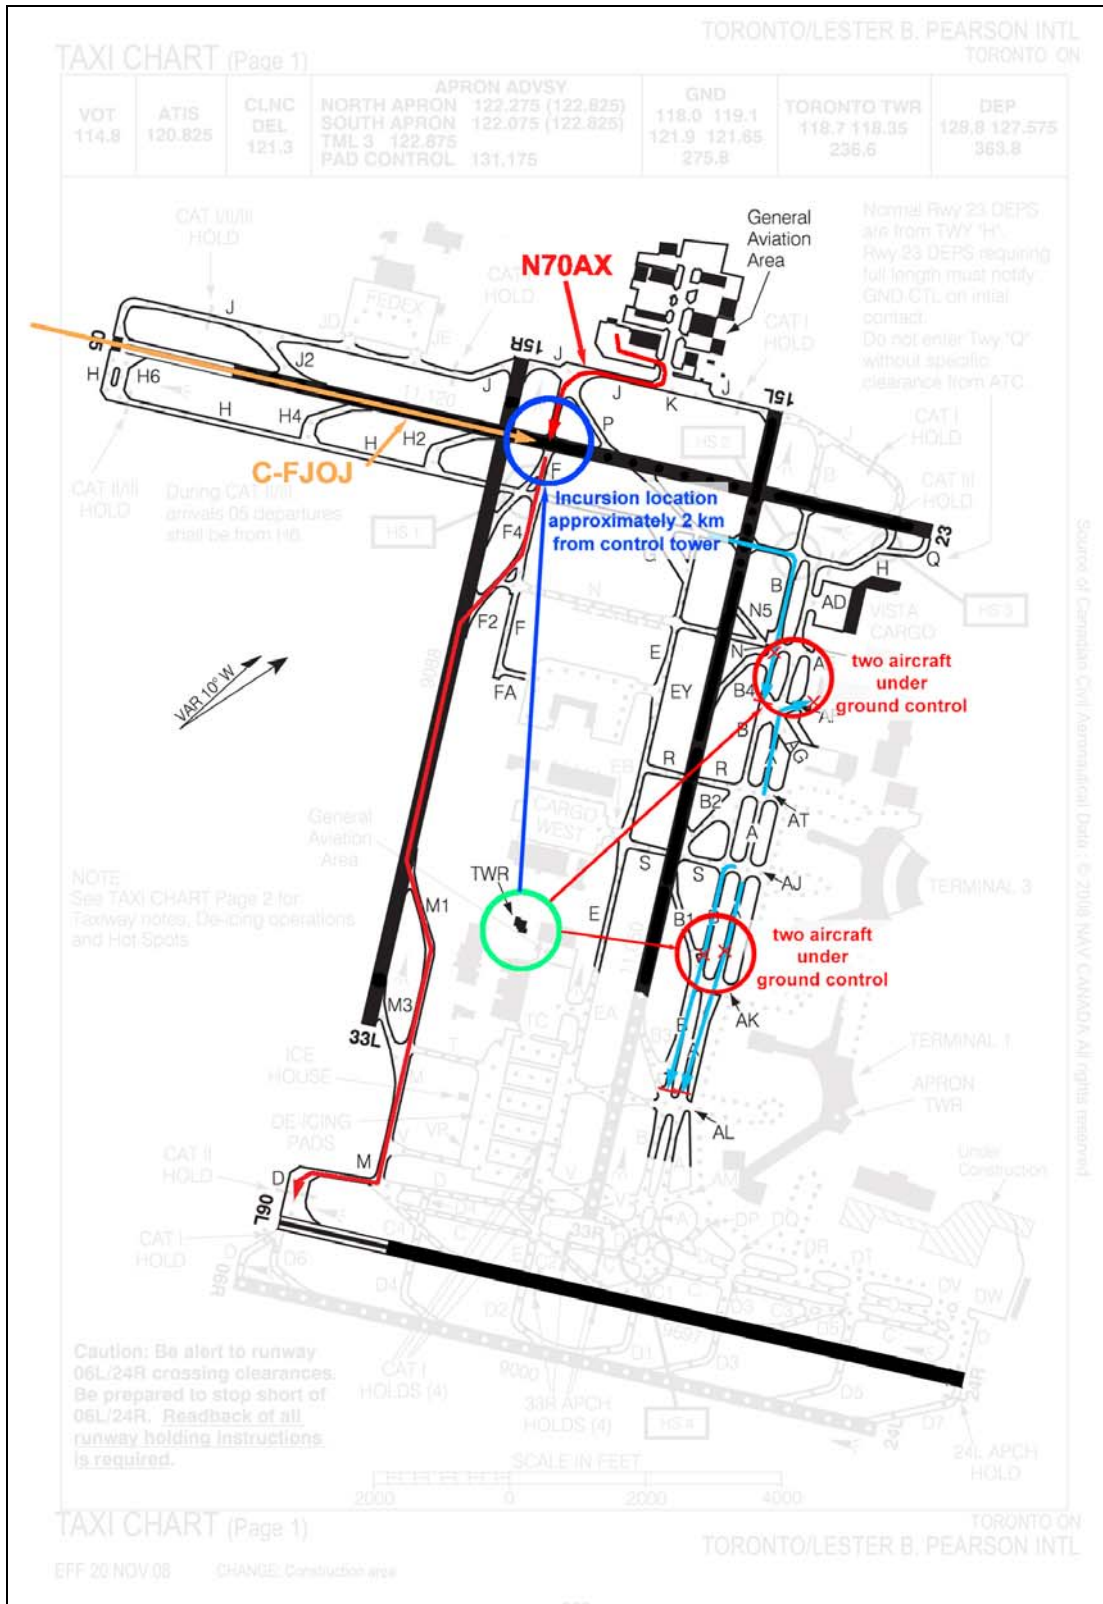
Appendix A – Aircraft Positions

In addition to N70AX, the North Ground controller was controlling four other aircraft, three taxiing and one under tow, which were on the east side of Runway 15L-33R, a different direction from N70AX as shown in Appendix A - Aircraft Positions. The North Ground controller communicated with three of these aircraft in the 60 seconds prior to the incursion and was monitoring the fourth as it was reaching its clearance limit. Within 10 seconds of the incursion, with C-FJOJ on the landing roll, the north ground controller scanned back to N70AX, which was travelling directly towards the control tower approximately one mile away.

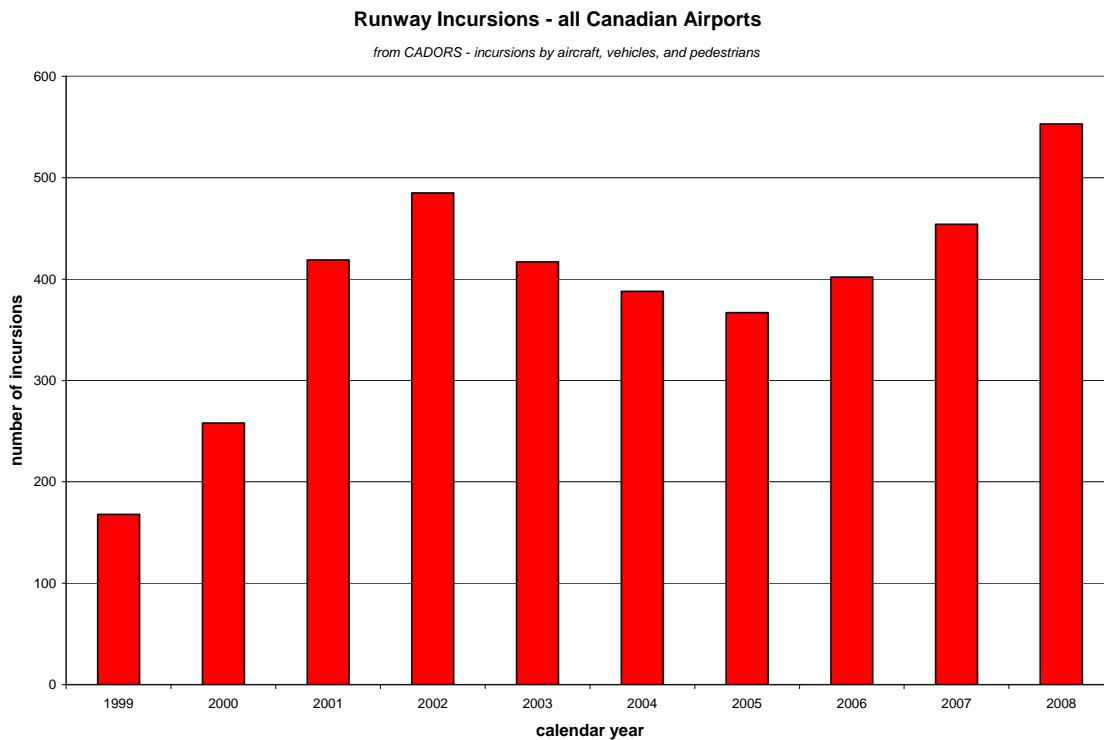
Figure B-1.
Runway Incursions – All Canadian Airports

Because the majority of runway incursions are not reportable to the TSB, TC records were reviewed for runway incursions in Canada. There were 3831 incursions nationwide in a 10-year period from 1999 to 2008, 183 of which occurred at Toronto / LBPIA. Trends are presented in Appendix B - Runway Incursion History in Canada. Both nationwide and at Toronto / LBPIA, runway incursion reports decreased in the period from 2002 to 2005; they have since increased. These trends are closely related to the number of air traffic movements. Approximately one-third of the Toronto / LBPIA incursions occurred at night.
