AVIATION INVESTIGATION REPORT

A07P0295

HOT AIR BALLOON ACCIDENT

**SRP ADVENTURE TOURS
AEROSTAR S77A (HOT AIR BALLOON), C-GTRU
SURREY, BRITISH COLUMBIA
24 AUGUST 2007**

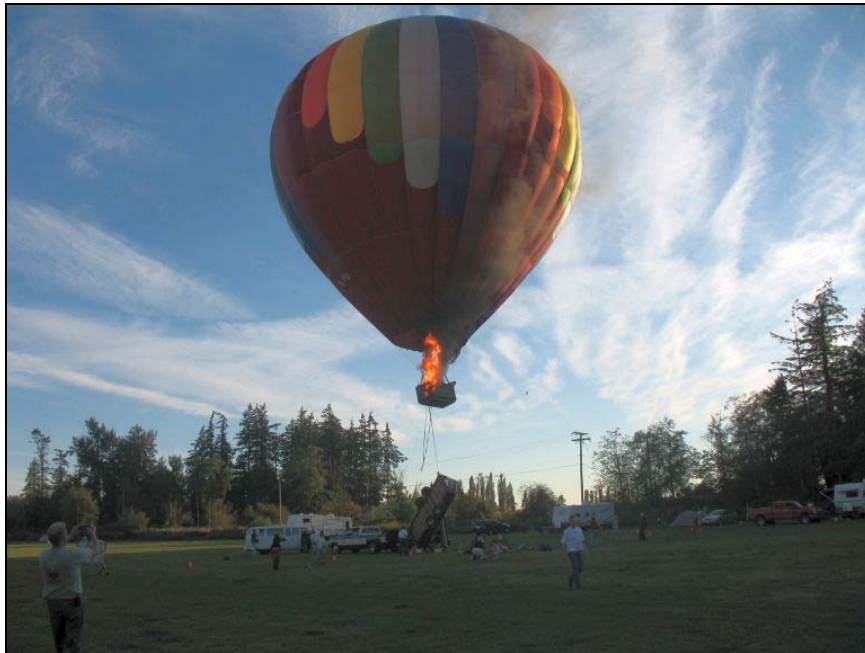
As passengers began to evacuate, the basket began to rise, forcing people to jump from a considerable height. The basket rose to a height of approximately 30 feet, forcing the trailer off the ground. As people continued to jump, some struck the trailer sustaining more serious injuries. The strap was made of a synthetic material that was susceptible to heat damage and it failed, releasing the balloon with two passengers still on board. The balloon climbed and drifted to the north. As the fire progressed, the number 2 cylinder fell from the basket. The balloon envelope collapsed and the burning wreckage descended into a residential trailer park. The two passengers remaining in the basket were fatally injured. Three mobile homes and some vehicles were destroyed.

Photo 1. Balloon lifting trailer

6. The strap securing the balloon to the trailer was made of a synthetic material which was susceptible to heat damage and failed in tensile overstress, releasing the balloon with two passengers still onboard.

7. During the initial envelope inflation, the balloon was fastened to its trailer, which was in turn attached to a pick-up truck. When the fire started and people began to evacuate the basket, the balloon began to rise because the emergency deflation system had not been activated. As people continued to evacuate the basket, they had to jump from a considerable height. Some suffered more serious injuries as a result of striking the trailer.

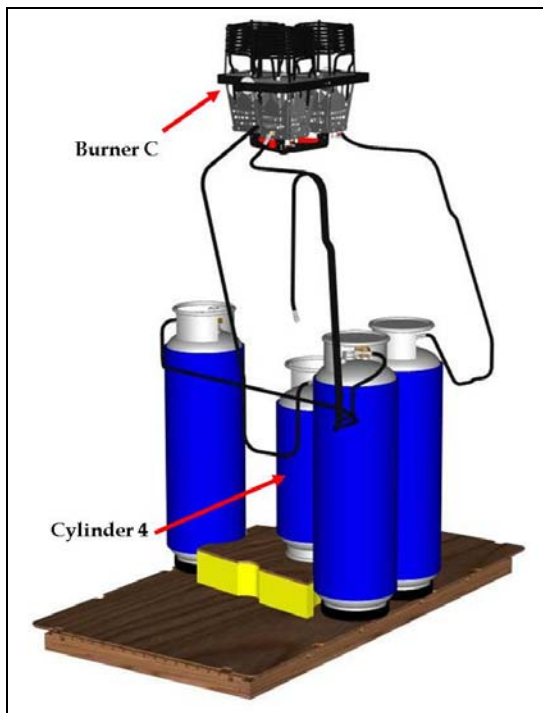
The balloon was originally manufactured with two burners and three 23-gallon capacity propane cylinders installed in the basket. The pilot/owner had replaced the two burners with a three-burner installation which was approved by the manufacturer as part of the type design of the aircraft. He had also installed a fourth cylinder, of 15-gallon capacity, in the basket. This modification was not approved by the manufacturer as part of the type design, nor was it approved by TC. No documentation was produced by the operator to show that this installation was performed or signed-off by an aircraft maintenance engineer (AME). The pilot had instituted the practice of using an auxiliary 10-gallon portable cylinder for initial filling of the envelope with hot air. It was not installed, but placed in the basket for the hot inflation, and removed when its propane was exhausted. The manufacturer was not aware of this practice.

Figure 1. S77A modified configuration

The pilot's practice was to coil the number 4 cylinder fuel line around the cylinder when not in use. That practice, in addition to the practice of connecting and disconnecting the line during every flight, probably led to more stress on the tank valve/fuel line connection. This extra wear and tear likely led to the hose pulling out of its end fitting.

3. Modification of the balloon from the manufacturer's configuration by the addition of cylinder number 4 and the use of an additional auxiliary cylinder (number 5) for initial envelope hot inflation contributed to the likelihood of hose/valve discontinuity because of extra wear and handling.
