## AVIATION INVESTIGATION REPORT

A07Q0063

### LOSS OF CONTROL AND COLLISION WITH TERRAIN

PIPER PA31-350 C-FTIW

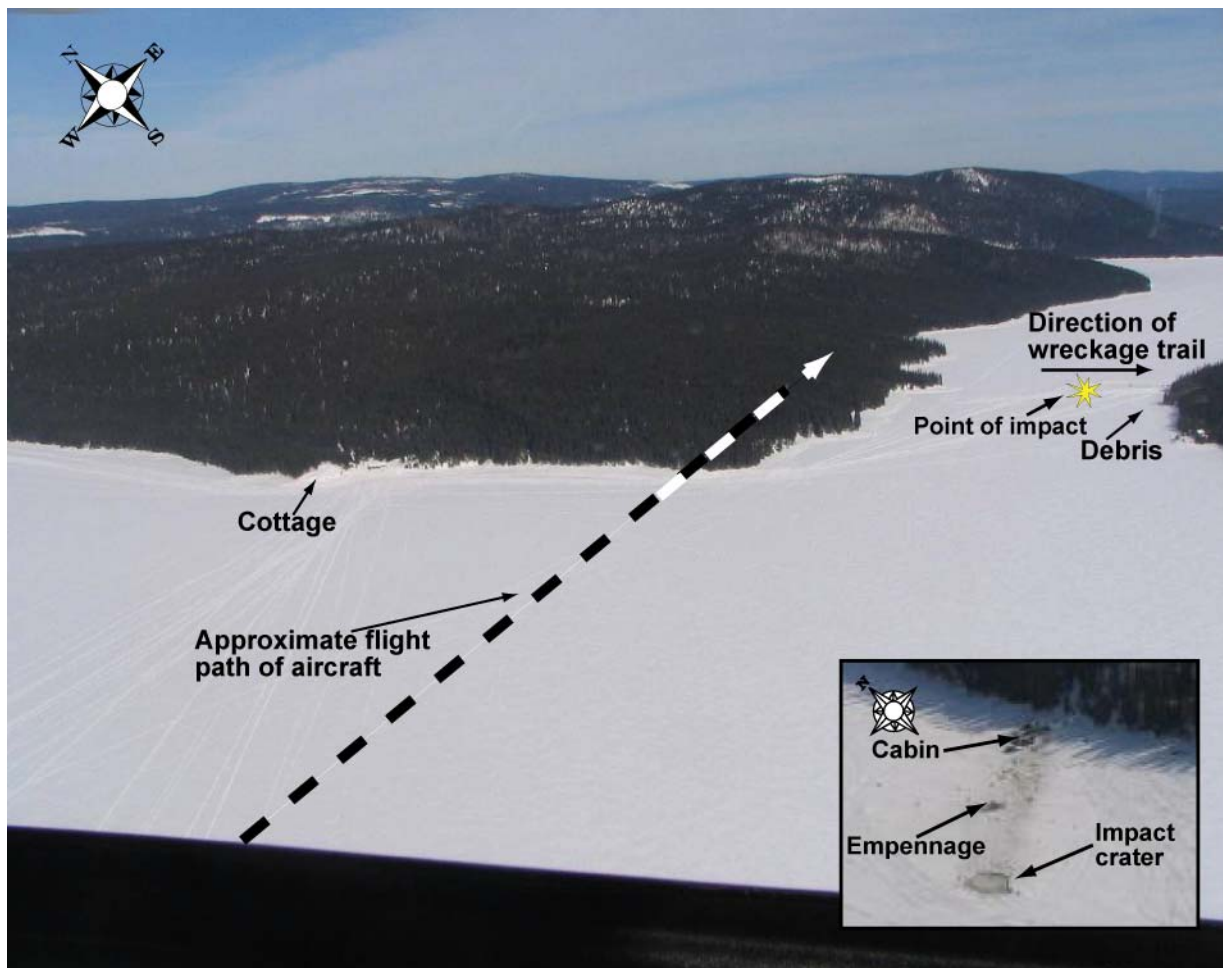
**Figure 1.** Aerial view of accident site

The accident occurred on the frozen surface of the southeast bay of Grand lac Germain, at an elevation of 1780 feet ASL. The aircraft struck the frozen surface of the lake 525 feet east of the shoreline it was flying over and 275 feet west of an island in the middle of the bay. The aircraft crashed approximately 2300 feet northeast of the cottage and 1600 feet after disappearing behind the trees. The aircraft broke through the top layer of ice, which was about two inches thick, then bounced off the second layer of ice. The impact produced a crater 30 feet in circumference.

The aircraft heading was 117°M at the time of impact, which is 14° off the breakup trajectory. Photogrammetric analysis of the crater established that the aircraft struck the ice surface in a low right bank attitude with the nose slightly up. The slope of the flight path was approximately 18° downward.

The wreckage was examined to the extent possible. The aircraft broke into several pieces. The breakup trajectory was on a heading of 103°M. The wreckage trail was approximately 250 feet long and an average 40 feet wide. The wing tips were found 50 feet from the point of impact. The cabin roof was completely torn off. The cockpit and cabin were so damaged by impact forces that the occupant space was almost completely reduced. The accident was not survivable.

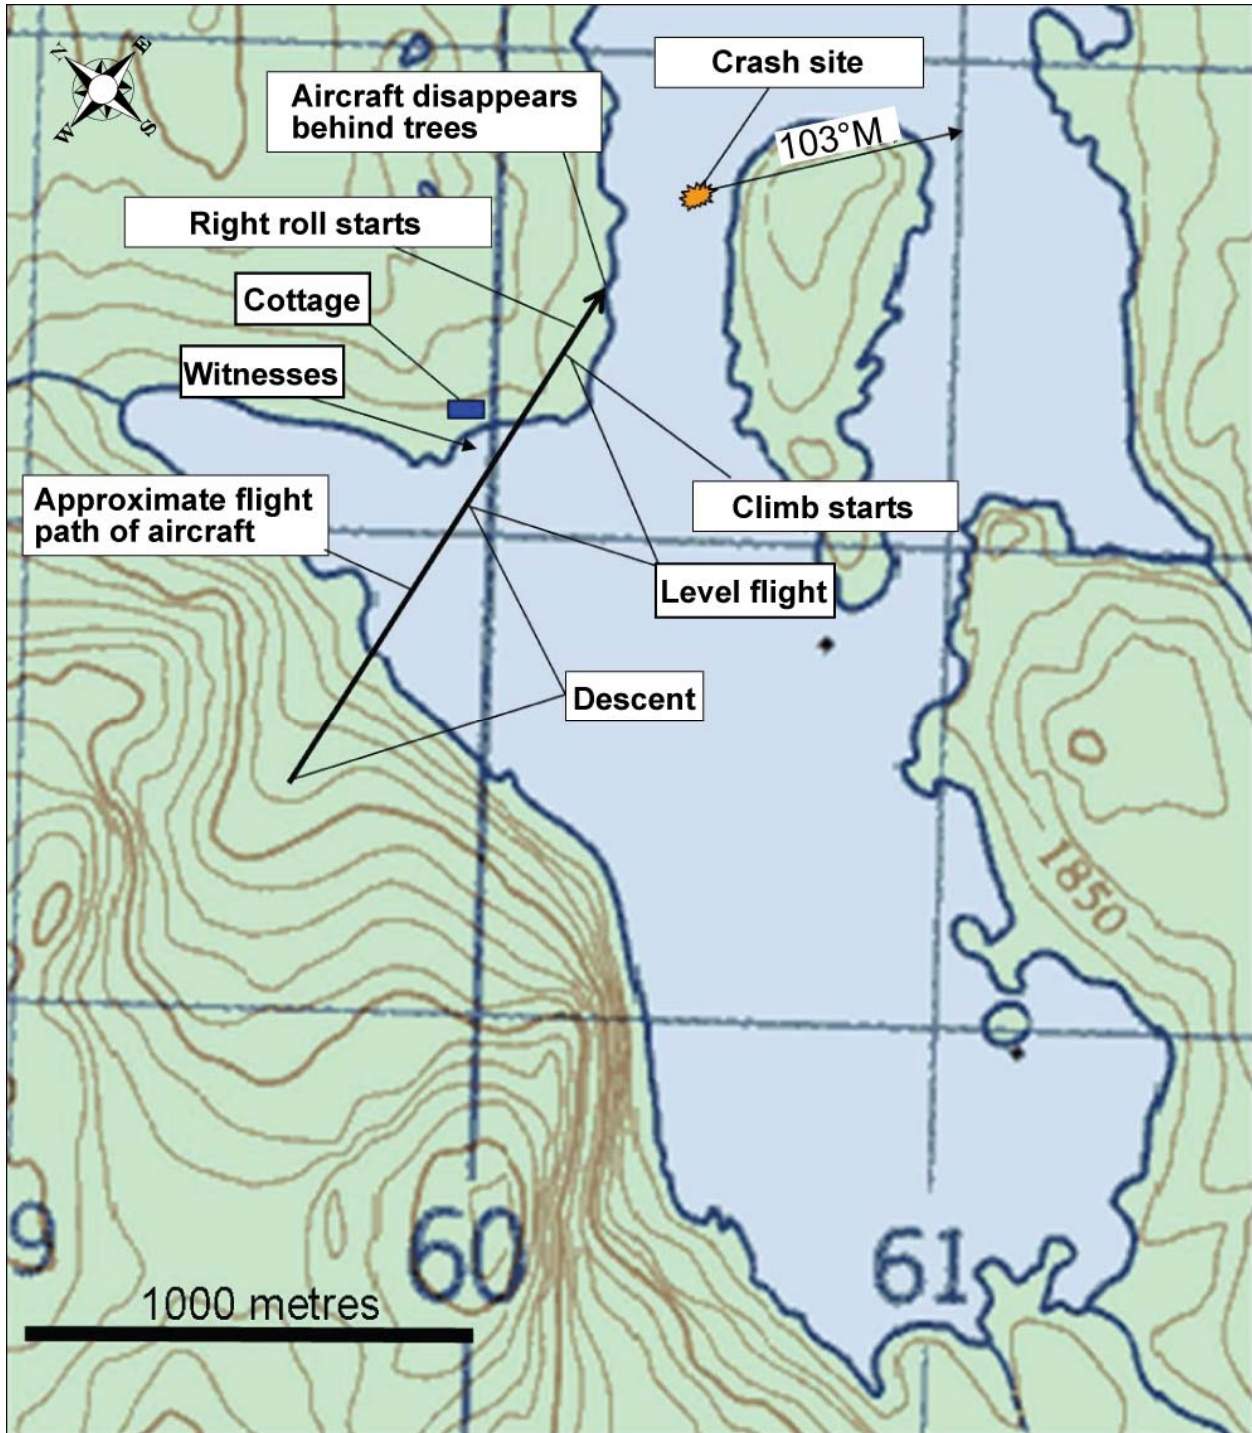
*Appendix A – Approximate Flight Path of Aircraft*

The aircraft flew over the area twice. The aircraft was not observed the first time it overflew the area. The second time it overflew the area, it flew a northeast heading and followed the downward slope of the terrain on the south side of the bay, passing about 500 feet to the east of the cottage. When it was over the lake, the aircraft arrested its descent at a height of approximately 100 to 300 feet. The aircraft's speed could not be determined. The landing gear was up and no anomalies were observed. The engine noise seemed constant and normal.

Over the north shore of the bay, the aircraft initiated a gentle climb followed by a steep bank, then disappeared behind the trees. The aircraft roughly followed the west shore of the lake as it moved farther away from the cottage. The noise of an impact was heard a few seconds later. A few minutes after that, the aircraft was found broken up on the frozen surface of the lake.

The flight path of C-FTIW could not be accurately determined. However, the information available reveals that the aircraft was heading northeast at an altitude between 100 and 300 feet before initiating a climb and a right turn. A few seconds later, the aircraft stalled and crashed after travelling approximately another 600 feet, in a slight nose-up attitude and banked slightly right.
