AVIATION INVESTIGATION REPORT

A08A0147

MID-AIR COLLISION

04 NOVEMBER 2008

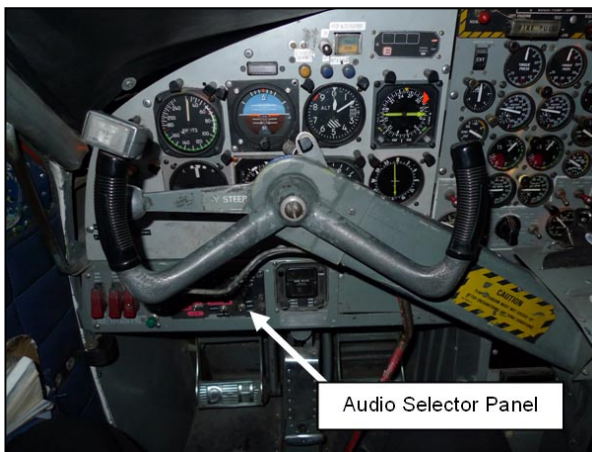
Each aircraft was fitted with two very high frequency (VHF) radios installed in the right side of the centre instrument panel. The radio to be used for broadcasting is selected via the audio selector panel, which is partially obscured by the control yoke (see Photos 1 and 2). The practice of both companies was to have the PNF make the appropriate radio advisories.

Photo 1. PAL Aircraft – left seat

The location of the audio selector panel on both aircraft made it difficult for flight crews to visually confirm proper radio selection. In this occurrence, the PNF of SPR961 would have lacked obvious cues to indicate whether or not the correct radio and/or frequency had been selected.

5. The audio selector panels on both aircraft were partially obscured from the pilots' direct line of sight. This increased the risk of missed or inadvertent transmissions due to incorrect radio selection.

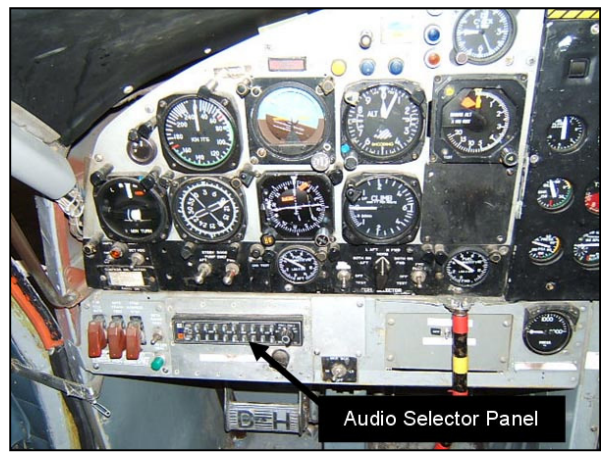
Photo 2. LAL Aircraft – left seat (yoke displaced)

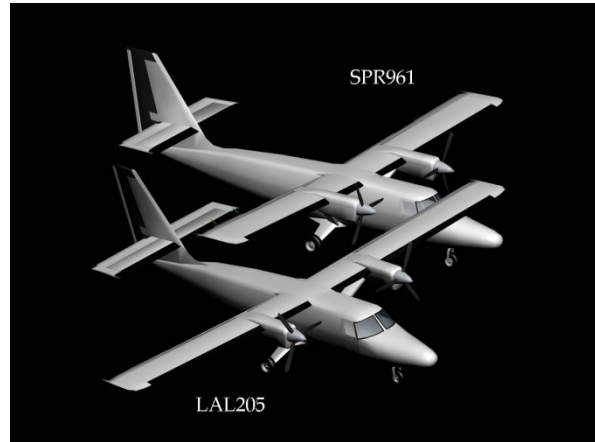
Figure 2. Aircraft Orientation at Impact

Being focused on straight-in landings, both flight crews were looking forward just prior to impact. While they converged, the orientation of the two aircraft would have made it difficult for the PF to see the other aircraft. Initially, LAL205 was above, to the right, and behind SPR961. LAL205's approach was steeper and faster than SPR961, which created a blind spot under the belly of LAL205. LAL205 first saw SPR961 following the landing at Natuashish, after being called on the radio by the other captain. SPR961 observed LAL205 just prior to the collision (see Figure 2). The first officer initiated a climb, after which the captain assumed control and initiated an evasive left turn away from LAL205.

LAL205's left horizontal stabilizer impacted SPR961's right aileron. SPR961's aileron was partially crushed in a downward and forward direction. LAL205's horizontal stabilizer's rubber de-ice boot was torn, the boot had scuff marks consistent with SPR961's aileron rivet pattern, and the outer tip of the horizontal stabilizer had localized crushing.
