**AVIATION INVESTIGATION REPORT
A08P0011**

LIMITED POWER – HARD LANDING

**PRISM HELICOPTERS LIMITED
EUROCOPTER AS 350-B3 (HELICOPTER) N530NA
PITT MEADOWS, BRITISH COLUMBIA, 2 nm W
10 JANUARY 2008**

Report Number A08P0011

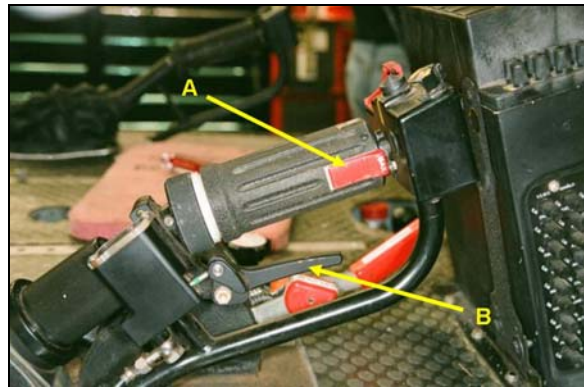
The controls installed to accommodate a second pilot in the left front seat were different from the right seat position. The normal pilot position (right) controls have a collective lever that incorporates a throttle lock referred to as flight notch in the RFM (see Photo 1). In case of emergency, releasing the lock allows manual fuel control operations at all power settings. The left seat throttle control does not have the lock (see Photo 2). Newer versions of the AS 350-B3 incorporate an electrical release that functions automatically when MANUAL MODE is selected, or when the red GOV light is triggered.

Photo 1. Right seat collective showing throttle lock (A) and cargo release (B).

The left seat controls did not have a release mechanism for the throttle lock. Therefore, the PIC was unable to initiate manual control of the throttle. There was insufficient fuel flow to provide the power necessary to arrest the rate of descent and a hard landing ensued.

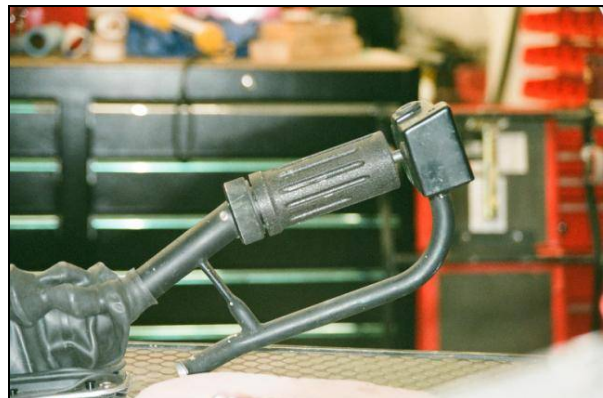
Photo 2. Left seat collective.

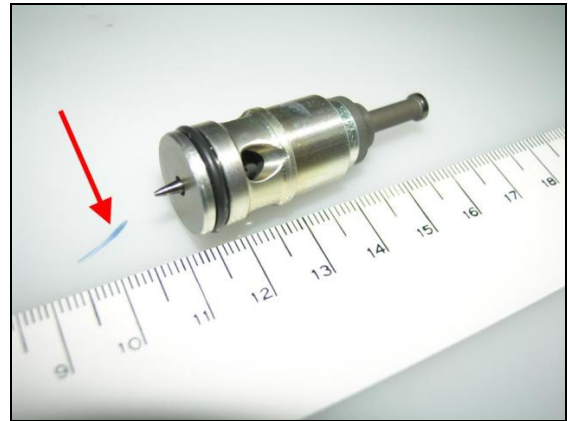
A detailed disassembly and examination of the HMU by Turbomeca, Thales, the BEA, and TSB Laboratory personnel revealed the presence of a contaminant within the HMU fuel channels. This contaminant was determined to be a small sliver of O-Ring seal material resting in the delta P diaphragm chamber (see Photo 3 and Photo 4). There was no metal generated within this component. The stepper motor and DECU were extensively tested individually with no results that could explain the condition experienced. A detailed diagram of the metering unit assembly is provided at Appendix A.

The TSB Laboratory investigation determined that the portion of blue O-ring was not part of the O-rings installed on the system and therefore had likely been introduced into the system during previous maintenance work or during the initial manufacture of the system.

Photo 4. O-ring material and metering valve

A sliver of O-Ring material found in the HMU fuel channels could have obstructed the fuel metering valve. It was not large enough to completely obstruct the orifice; however, it could impede the movement of the valve if it were to try and close as the sliver was wedged between the needle and the orifice. This could result in a differential between the resolver and stepper motor positions and cause a fixed fuel flow condition. The governor could not deliver the increased fuel flow required to maintain the high hover and the helicopter descended.
