AVIATION INVESTIGATION REPORT

A08Q0209

RISK OF COLLISION

BOEING 737 C-FNVT / DE HAVILLAND DHC-8 C-GYWX

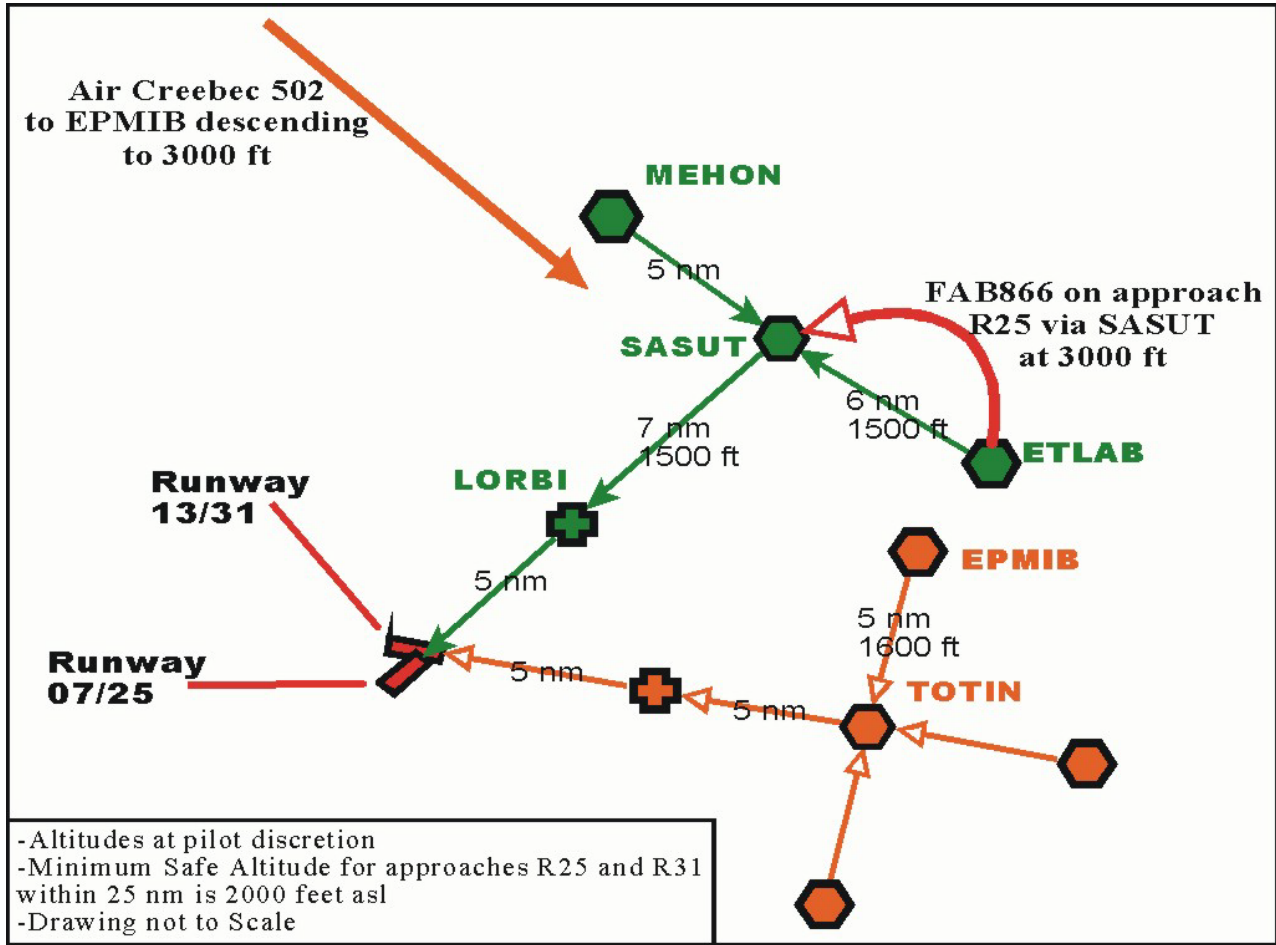
Appendix A – Proximity RNAV Approach Fixes Runways 25 and 31 at Kuujjuaq Airport (CYVP)

In order for CRQ502 to fly the RNAV 31 approach starting at the EPMIB entry point, the aircraft had to fly across the approach area for the RNAV 25 approach. Although minimum altitudes are published on the approach charts, pilots may use their discretion on what altitude to maintain. Without standard arrival routes or specific requirements to fly at published altitudes, there is a risk of collision if aircrew do not take into consideration the approaches to other runways when they are transitioning to their chosen approaches. Because individual approaches are published on separate pages, it is difficult for pilots to visualize how other approach paths may affect their own approach. The proximity of entry fixes for RNAV 25 (ETLAB)²³ and RNAV 31 (EPMIB) could also lead to a risk of collision when aircraft are manoeuvring at these fixes simultaneously.

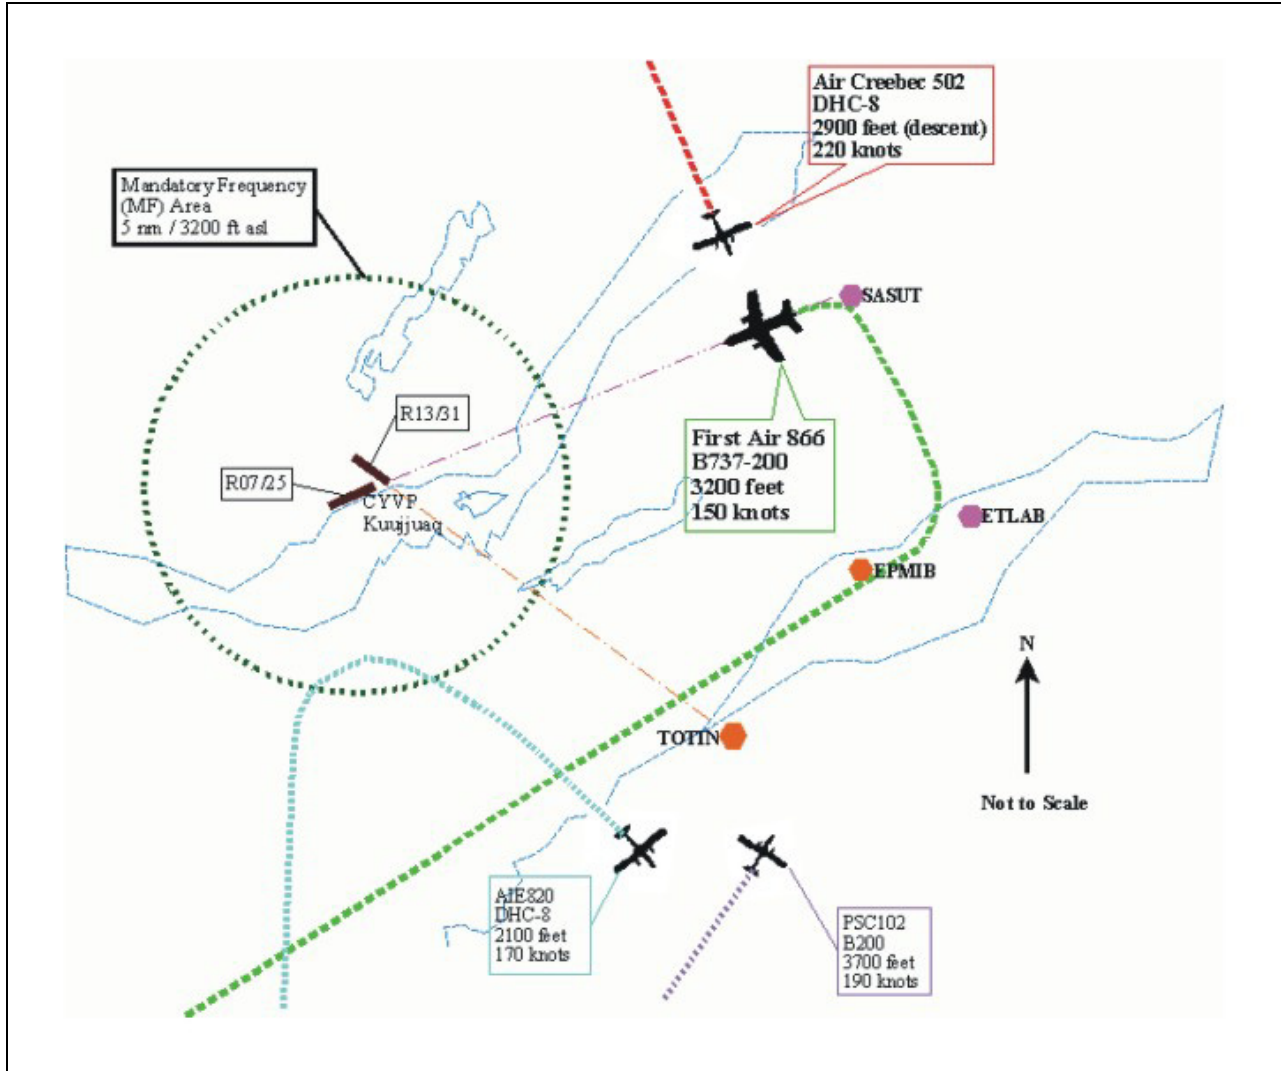
Appendix B – Aircraft Flight Paths – Vicinity of Kuujuaq Airport (CYVP)

1. Neither the crew of Air Creebec 502 (CRQ502) nor First Air 866 (FAB866) were aware of the point at which their flight paths would conflict. A risk of collision resulted when CRQ502 and FAB866 flew toward each other at the same altitude in instrument meteorological conditions (IMC), without visual contact.

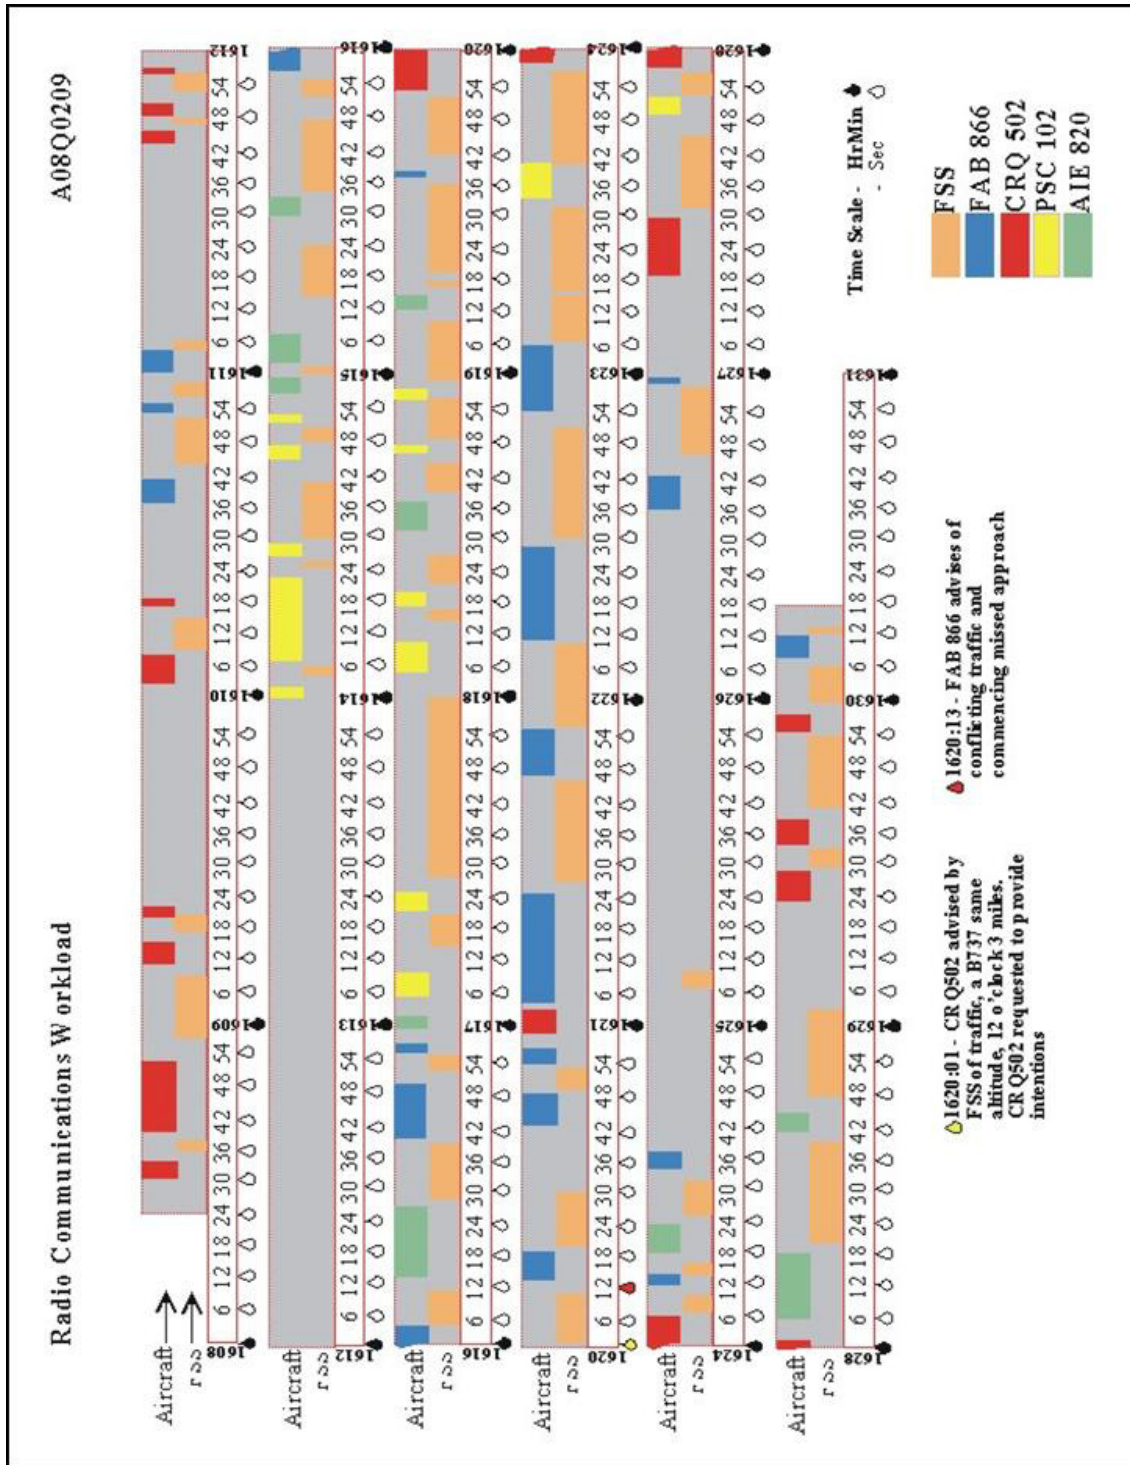
Appendix C – Communications Workload

For the 11 minutes before the conflict between FAB866 and CRQ502 had been resolved, 91 per cent of available air time was taken up with verbal communications between the VP FSS and the four IFR aircraft inbound to CYVP. There was little opportunity remaining for the crews to resolve conflicts and come to an agreement on an orderly arrival sequence. On several occasions, it was also apparent that crews did not hear or did not understand the traffic information provided by other aircraft even though they were listening on the common frequency. This required the VP FSS to repeat the traffic information – often in the other official language. Because the weather was IMC, it was unlikely crews would see other aircraft visually while inbound to the airport and on approach to the runway, and, in fact, neither crew acquired the other aircraft visually.

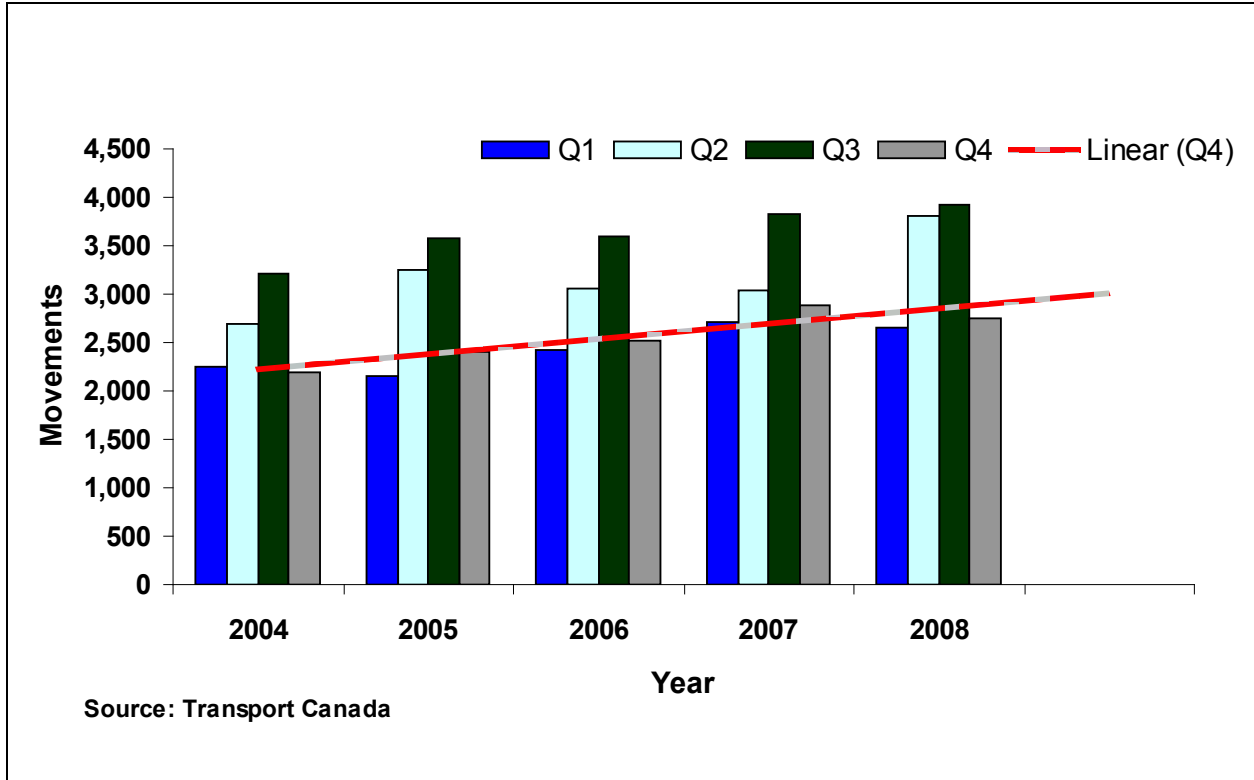
Appendix D – Kuujjuaq Airport (CYVP) Movements and Trend by Quarter

CYVP is a hub airport in Quebec's northern area. Commercial carriers provide local flights to smaller communities as well as scheduled flights to and from southern Quebec. There were 13 129 local and itinerant aircraft movements in 2008. In the past five years, traffic increased an average of six per cent per year (see Appendix D – Kuujuaq Airport Movements and Trend by Quarter). Many of the commercial aircraft flying into CYVP are medium to large passenger aircraft capable of carrying 50 or more passengers.
