AVIATION INVESTIGATION REPORT
A09P0249

LOSS OF CONTROL – COLLISION WITH WATER

ELBOW RIVER HELICOPTERS LIMITED
BELL 212 (HELICOPTER), C-GTKE
LILLOOET, BRITISH COLUMBIA, 20 nm S
14 AUGUST 2009

Report Number A09P0249

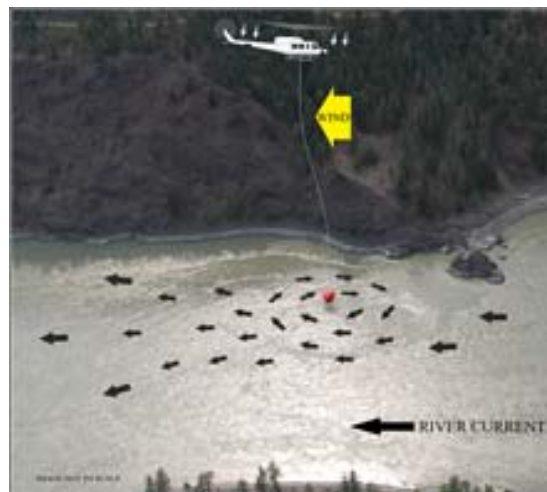
At the time of the occurrence, four helicopters were engaged in forest fire water bucketing operations approximately 20 nm south of Lillooet. They were using the Fraser River to fill their water buckets. At the accident location, the Fraser River is in a canyon and was flowing south at about 9 knots. The pilots had chosen a spot in the river where there was a whirlpool. The backside of the whirlpool is characterized by back-flowing current in the opposite direction to the river current. The pilots were dipping their buckets in this back-flowing water, which prevented the current from dragging them downstream (see Figure 1).

Figure 1. Water pickup before accident

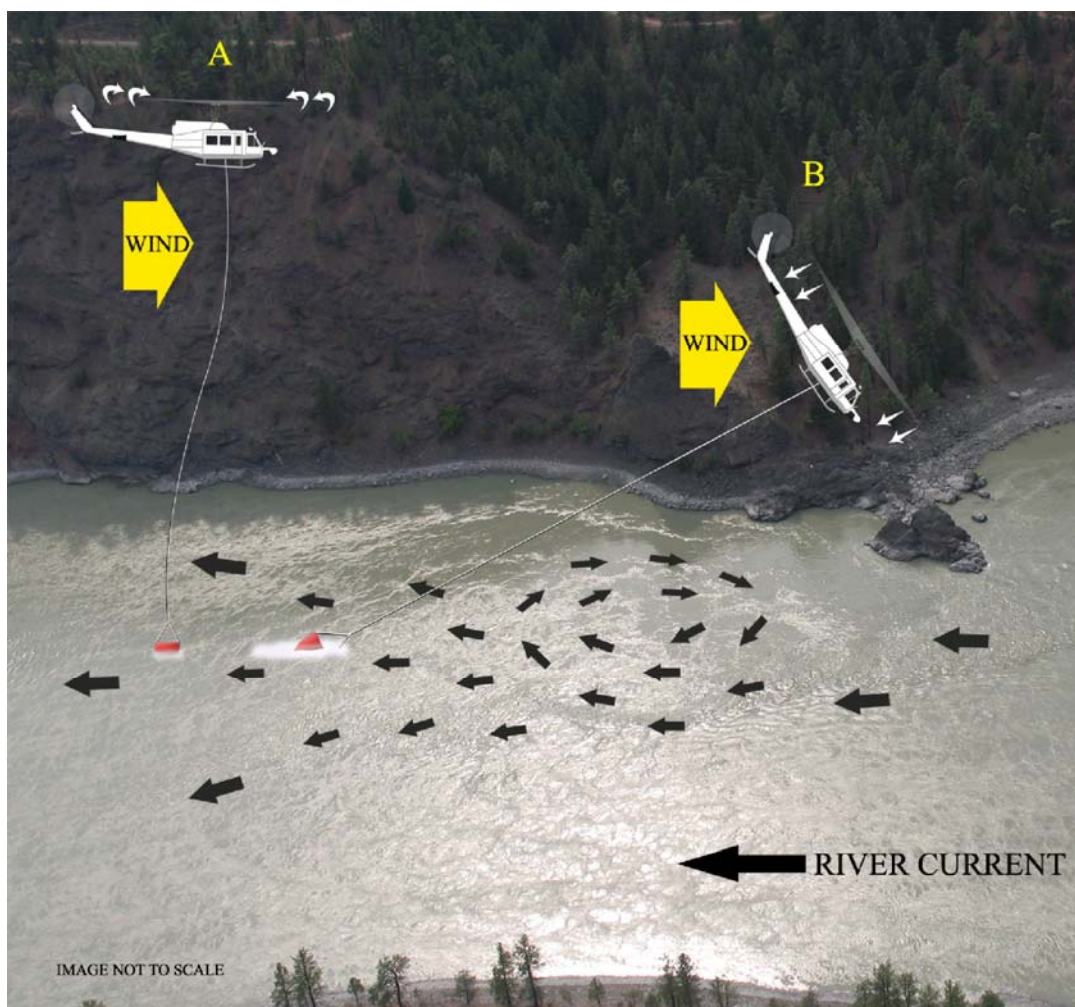
The tight circuit just before final approach—likely for spacing—put the helicopter in a position that would have necessitated a steep approach, requiring careful power management. It is likely that the accident pilot's approach was unknowingly conducted with a tailwind, due to the sudden change in wind direction. This would have caused the helicopter to lose translational lift early on the approach, likely producing a sudden increase in the rate of descent. To counter this descent, the pilot would have to add power. The combination of a steep approach, unknowingly conducted downwind at slow speed with power applied, likely caused the helicopter to descend into its own downwash. This would have caused the helicopter to enter VRS and produced a rapid descent. The VRS condition and/or the attempt to recover by gaining airspeed or lowering the collective caused the water bucket to drop into the river before reaching the back eddy (See Figure 2, position A).

Figure 2. Accident sequence (VRS followed by bucket anchoring)

In an attempt to recover from VRS, the pilot would have pushed the cyclic forward to gain airspeed. However, the water bucket would have been full and drifting downstream, opposite to the direction of flight. This would have produced an anchor-like effect on the helicopter, causing it to pitch nose-down (see Figure 2, position B). The pilot would have quickly run out of aft cyclic travel while trying to raise the nose, causing a loss of control and the helicopter to fly in a descending arc until it collided with the water.

If the pilot had released the longline before he ran out of aft cyclic travel, he would likely have been able to fly away without losing control.

1. The combination of a steep approach, unknowingly conducted downwind at slow speed with power applied, likely caused the helicopter to enter a vortex ring state (VRS).
2. During the pilot's attempt to recover, the water bucket dropped into the flowing river and acted as an anchor, causing the helicopter to pitch nose-down and collide with the water.
3. The helicopter was likely being operated with the belly hook electrically disarmed, limiting the pilot's ability to jettison the water bucket before losing control.
4. Although the pilot was able to escape the helicopter wreckage in the water without injury, he was not wearing a personal flotation device (PFD) and drowned.

Immediately following the accident, the helicopter operator instituted policies requiring pilots to fly with the belly hook armed and to wear personal flotation devices (PFDs) when water bucketing.
