**AVIATION INVESTIGATION REPORT
A09P0351**

**FLIGHTDECK WINDSHIELD - ELECTRICAL ARCING AND
FIRE**

**JAZZ AIR LP (D.B.A. AIR CANADA JAZZ)
DEHAVILLAND DHC-8-311, C-FRUZ
VANCOUVER, BRITISH COLUMBIA, 40 NM NE
20 OCTOBER 2009**

Report Number A09P0351

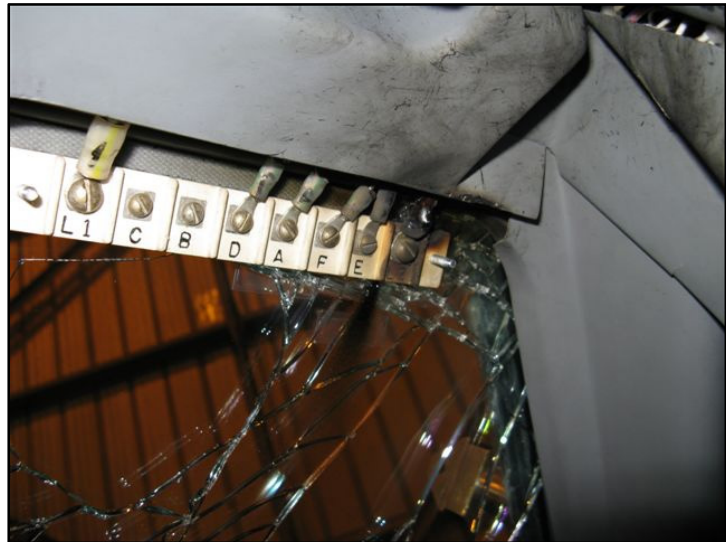
The windshield is a 3-ply laminate. The inner ply was cracked (see Photo 1), but not the outer and centre plies. The windshield heat controller was tested and performed as designed.

Photo 1. Damaged left hand windshield and terminal block

Most of the terminal block was undamaged, but the terminal block material near the L2 connection exhibited heat damage, some melting and some burn damage. Most of the direct melting and heat damage was located on the side of the terminal block and not at the L2 connector itself.

The L2 connection on the bottom of the terminal block was severely burnt and the wire braid was severed from the terminal due to arcing damage. The solder connections of the braids to the remaining pads on the terminal block, including the other power connection (L1), appeared to be in good condition and solidly connected.

As evidenced by the localized re-melting of glass, the cracking of the windshield appears to have originated from under the L2 connection on the terminal block. The re-melted glass had penetrated beyond the case depth of the glass ply, which is the strengthened portion of the glass. Softening of this type of glass occurs at about 593°C (1100 degrees F), melting occurs at about 815°C to 1093°C (1500 to 2000 degrees F). Pressure builds up in the glass at about 50 psi for every degree F difference (between one area and the next).

As the glass melted in a small localized area where the arcing occurred, a high temperature differential was experienced and, as the melting had penetrated beyond the strengthened portion of the glass, the glass ply cracked. This indicates that the cracking was caused by the arcing.

1. Electrical arcing in the braid lead to the L2 connector on the windshield terminal block occurred as a result of damage within the wire braiding. It was not possible to determine the initial cause of the damage within the wire braid.
2. Due to its proximity to the arcing, the inner ply of the windshield cracked.

Instigated an immediate Dash-8 fleet wide check of all heated transparency terminal block connections for proper torque, hardware and installation.

The DHC-8 Maintenance Schedule was amended to include a torque check of the windshield terminal block connections at each C Check (5500 hours).
