## AVIATION INVESTIGATION REPORT

A09Q0065

### COLLISION WITH CABLE - SINKING IN WATER

AIR RICHELIEU 1990  
CESSNA 150L C-GJAE  
SAINT-LOUIS, QUEBEC  
04 MAY 2009

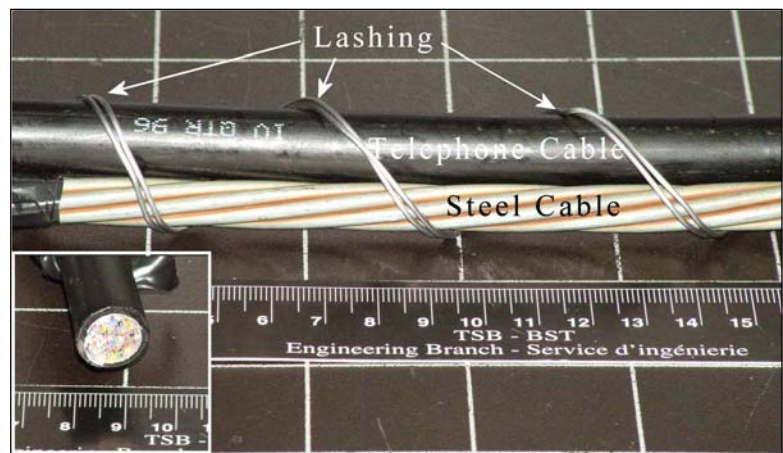
The cable consists of a telephone cable covered with black protective sheathing lashed to a steel cable (see Photo 1). The cable did not break on impact.

**Photo 1.** Cable specimen from occurrence site

Although not required by regulation, but in light of recently reported low flying over the river since the occurrence, Télébec (Bell Alliant) has installed red and white markers on the telephone cable that spans the Yamaska River, Quebec.

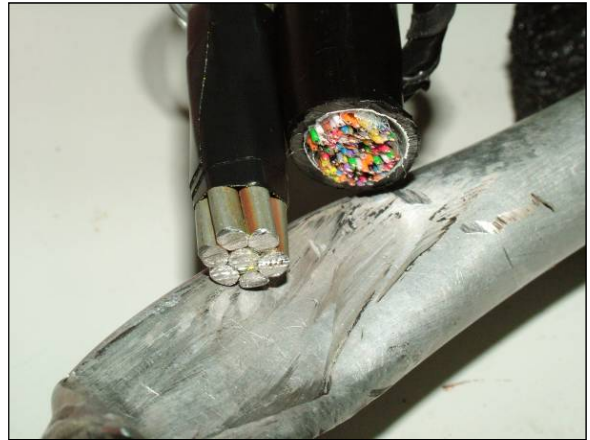
Impact marks and material transfer from the telephone cable were noted on the engine crankcase vent line. The impact marks on the vent line had the same spacing and width as the wires of the steel cable that support the telephone cable (see Photo 2). Neither the propeller nor the main nose wheel tire exhibited indications of damage from possible contact with the cable. However, the right steering arm rod end failed in overload, probably as a result of the impact with the cable, but any material transfer from the cable was probably masked by the engine cowling.

**Photo 2.** Cable markings on crankcase vent tube

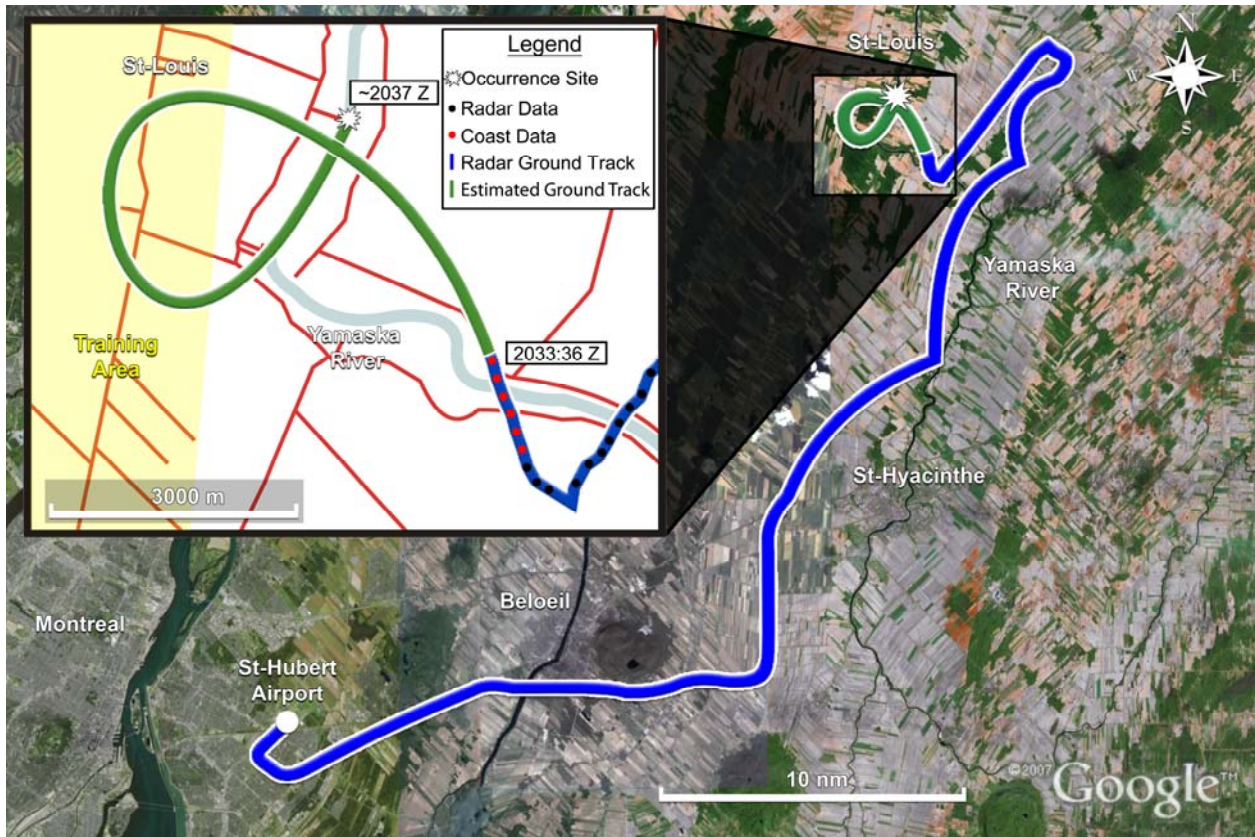
# Appendix A – Aircraft Trajectory

There were several aircraft in the assigned training areas that day. Radar data showed that C-GJAE first travelled east past Beloeil towards the training area closest to Montréal/Saint-Hubert Airport (CYHU), then north of Saint-Hyacinthe towards another training area located 27 nautical miles (nm) to the northeast of CYHU (see Appendix A – Aircraft Trajectory). This is likely because the closest training area was crowded. While C-GJAE made its way north, the radar data shows the aircraft in level flight, climbs, and descents.

After 1634, while flying below the radar floor, the aircraft flew at low altitude at approximately 200 feet above ground level (agl) towards the village of Saint-Louis, heading in a north-westerly direction. The aircraft then headed northeast at low altitude, descending below 100 feet agl over the Yamaska River. Hundreds of geese on the river bank took flight as the aircraft passed by at low altitude. While heading northeast in level flight, at tree top height, and over the river, the aircraft travelled a total distance of approximately 2.4 km before colliding with the unmarked

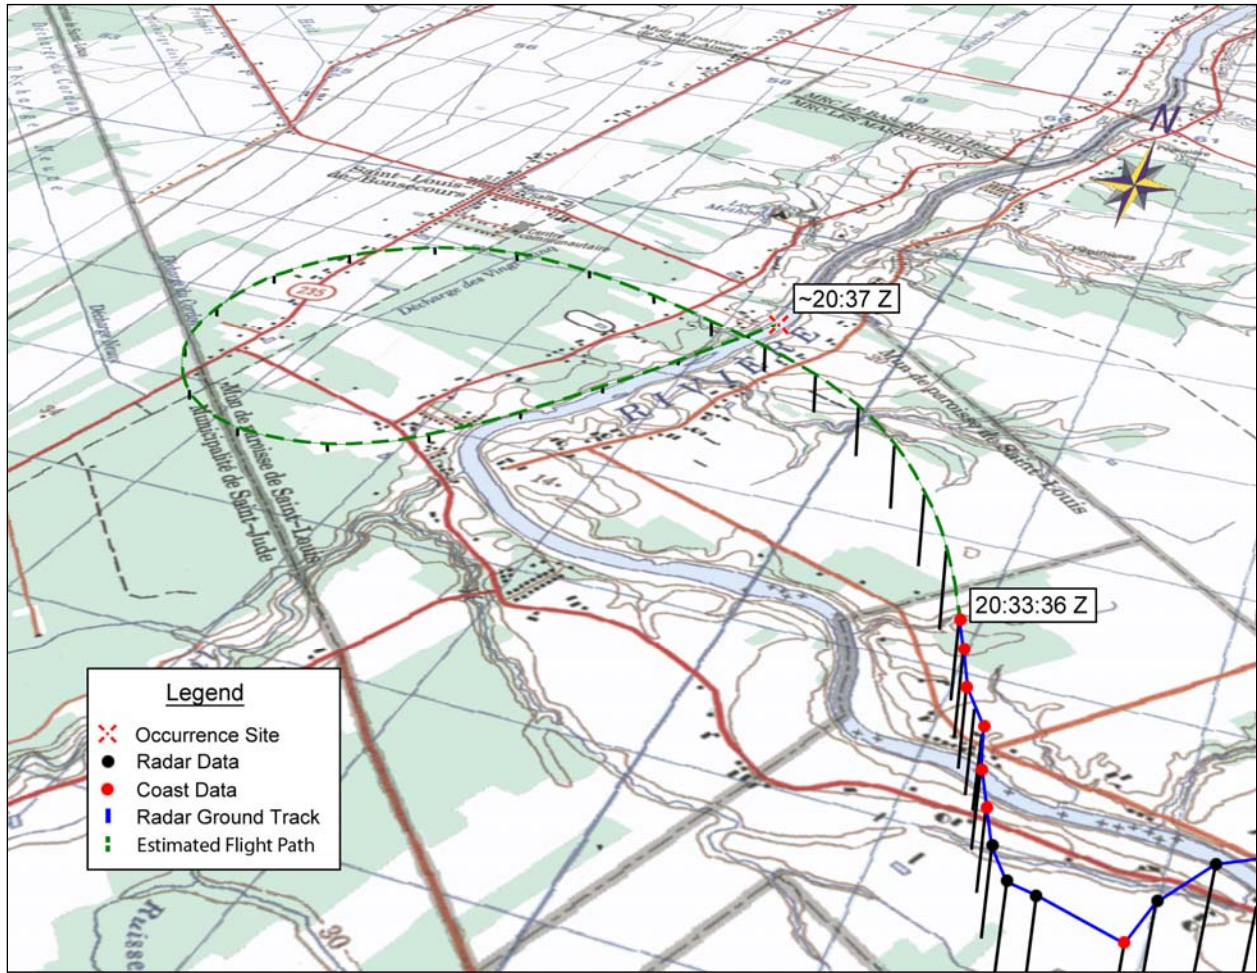
# Appendix B – Oblique View of Aircraft Trajectory

telephone cable that spans the river from west to east, which at this point is located at approximately 60 feet (18 m) asl <sup>6</sup> (see Appendix B – Oblique View of Aircraft Trajectory). The engine sound seemed normal prior to impact with the cable. The aircraft struck the cable with a 30-degree bank angle, struck the surface of the water in a nose-down attitude and sank quickly. The flight instructor, seated in the right seat, was fatally injured. The student pilot, seated in the left seat, successfully evacuated the aircraft after impact with the surface of the water, but drowned. This seating arrangement is typical of an instructor providing flight instruction. The occurrence took place at approximately 1637, after one hour of flight instruction.
