AVIATION INVESTIGATION REPORT A10C0123

ENGINE POWER LOSS - FORCED LANDING

**AERO COMMANDER 500S N5800H
RANKIN INLET, NUNAVUT
18 JULY 2010**

Report Number A10C0123

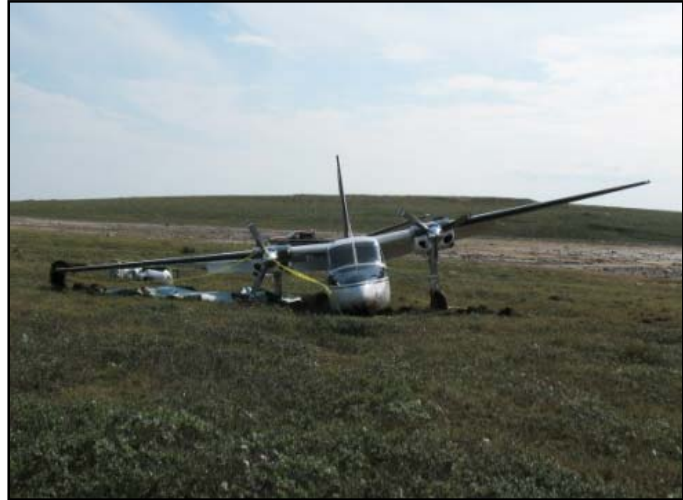
As the aircraft came to a rest, following the forced landing, the right landing gear oleo piston failed in overload and the right wing dropped. The aircraft came to a rest in an upright position facing north, with the right wing low (see Photo 1). The entire wreckage trail was approximately 270 feet long. First responders put down some spill blankets under the right wing to absorb fuel leaking from the fuel vents.

Photo 1. Occurrence site.

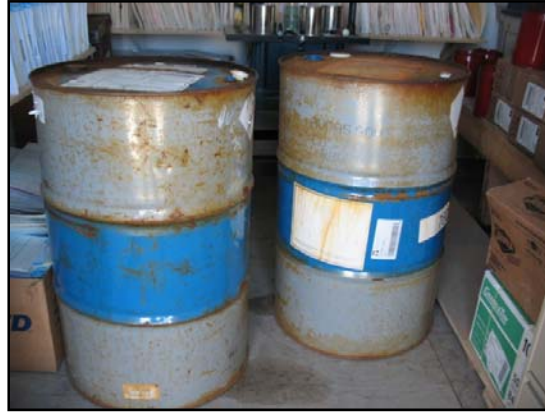
Photo 2. First and second 45-gallon drums.

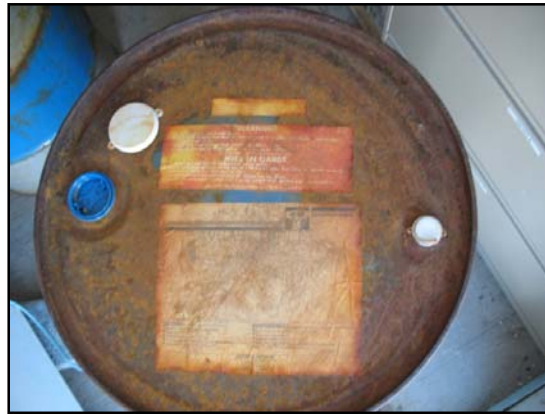
Photo 3. First drum with both bung plugs

Following the accident, the local fire department and the Royal Canadian Mounted Police secured both 45-gallon drums that were used to refuel the accident aircraft. An inspection of the first drum revealed no anomalies with the fuel. The fuel was blue in colour and its odour was indicative of 100LL AVGAS. An inspection of the second 45-gallon drum revealed that the texture, odour and colour of the fuel were not characteristic of 100LL AVGAS. The bottom of the drum also contained a considerable amount of debris.

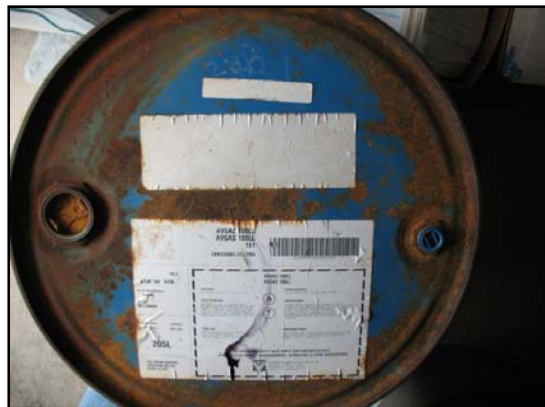
Five days prior to their arrival in Rankin Inlet, the crew had placed an order for two 45-gallon drums of 100LL AVGAS². After landing at the airport, the fuel handler was notified and asked to deliver the drums of 100LL AVGAS. Each 45-gallon drum was delivered separately by the same fuel handler. The drums were similar in appearance (see Photo 2). The first drum was labelled as 100LL AVGAS and both bung plugs had plastic seals on them (see Photo 3). The second drum was picked up by the fuel handler adjacent and in close proximity to the sealed and palletted 45-gallon drum stock of 100LL AVGAS. Photos taken during the refuelling indicate that the large bung plug of the second 45-gallon drum of fuel was weathered and did not have a white plastic seal over it (see Photo 4).

Photo 4. Second drum with weathered large bung plugs and no plastic seal. On delivery of barrel, the small bung plug did have a plastic seal.

3. The fuel handler did not notice that the large bung plug was not sealed on the second 45-gallon drum and, as a result, delivered the drum of slops to the aircraft.

4. The pilots did not notice that the large bung plug was not sealed on the second 45-gallon drum and, as a result, fuelled the aircraft with contaminated fuel.

The supplier has isolated the sealed 45-gallon drums of 100LL AVGAS from the slops drums by moving the slops drums to the opposite end of the fuel storage compound.

Renovations of the storage facility have been completed with designated storage areas: slops barrel storage is separated from AVGAS barrel storage. The majority of the 45-gallon barrels of slops have since been discarded and the remaining and future slops will be stored in a 100 000 L holding tank.
