**AVIATION INVESTIGATION REPORT
A10C0159**

ENGINE SHUT-DOWN AND FORCED LANDING

**NORTHERN WATERWORKS SALES AND CONSULTING INC.
PIPER PA 31-310 NAVAJO, C-FWQX
PICKLE LAKE, ONTARIO, 30 NM E
10 SEPTEMBER 2010**

Report Number A10C0159

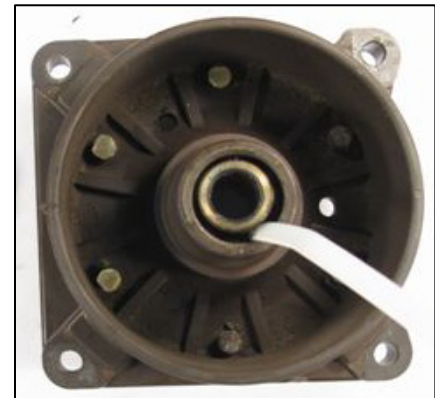
Disassembly of the magneto revealed that the bronze bushing molded into the centre of the distributor block (P/N 10-391586) was loose (see Photo 1). The distributor rotor gear is supported in a cantilever fashion by the distributor rotor gear shaft, which rotates in the distributor

Photo 1. Loose distributor block bushing held askew by Tyrap

The initiating event of the occurrence was a magneto failure in the left engine. This failure was the result of the loss of retention of the bushing in the distributor block of the left magneto. The subsequent misalignment of the distributor rotor caused the rotor to become out of synchronization with the engine. This caused the left engine to run rough, backfire and lose power. The clean, shot-blasted appearance of the piston crowns indicates that the rough running and back firing likely released combustion products that contaminated sparkplugs of both magneto systems. It could not be determined whether the engine would have been capable of producing significant power running on the right magneto alone.

Checking the distributor block bushing for looseness is a specific task described in the 500-hour inspection of the *Service Support Manual* and any looseness requires distributor block replacement. As the engine manufacturer, Textron Lycoming issues bulletins that are essentially a reprint of all original equipment manufacturer SBs with the intent of bringing them to the attention of aircraft owners. Textron Lycoming issued Mandatory SB 515 in 1994 to introduce TCIS SB 643. The cover page of SB 515 reminds the reader to “[e]nsure that this reprint of Teledyne Continental Motors Service Bulletin No. 643 is still current at time of compliance”.

The aircraft magnetos had been inspected every 100 hours, as required by Piper Navajo service manual checklists. These inspections are sufficient to satisfy the routine maintenance that is required as the magneto accumulates hours in service. However, the inspections were not sufficient to detect an incipient failure that had developed over many hours of operation. If the SB 643B 500-hour inspection recommendations had been completed by following the procedures contained in the *Service Support Manual*, there would have been several opportunities to detect and correct any distributor block bushing looseness before the magneto failed.

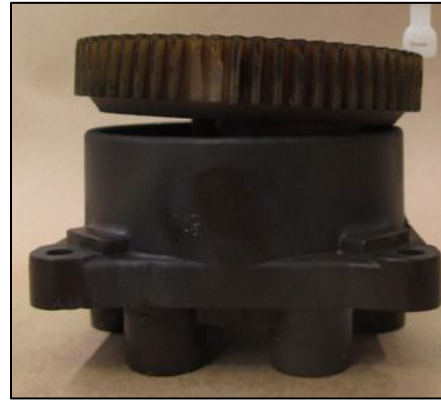
The loose distributor block bushing allowed the distributor rotor gear to be displaced radially (see Photo 2). The resulting misalignment caused reduced gear tooth mesh and fracture of 2 distributor rotor gear teeth.

The intermittent engagement of the distributor rotor gear with the drive pinion gear of the input shaft resulted in the distributor rotor becoming out of synchronization with the engine. The out-of-time, intermittently-turning rotor would have caused the rough running, backfiring, power decrease and drop of exhaust gas temperature. This was further illustrated by data recovered from the engine temperature indicator that showed that the engine was running poorly on 3 cylinders when it was shutdown.

Photo 2. Displaced distributor rotor
