**AVIATION INVESTIGATION REPORT
A10O0145**

COLLISION WITH TOWER

**ESSENTIAL HELICOPTERS
BELL 206B (HELICOPTER) C-GCHB
ELK LAKE, ONTARIO, 7NM SW
23 JULY 2010**

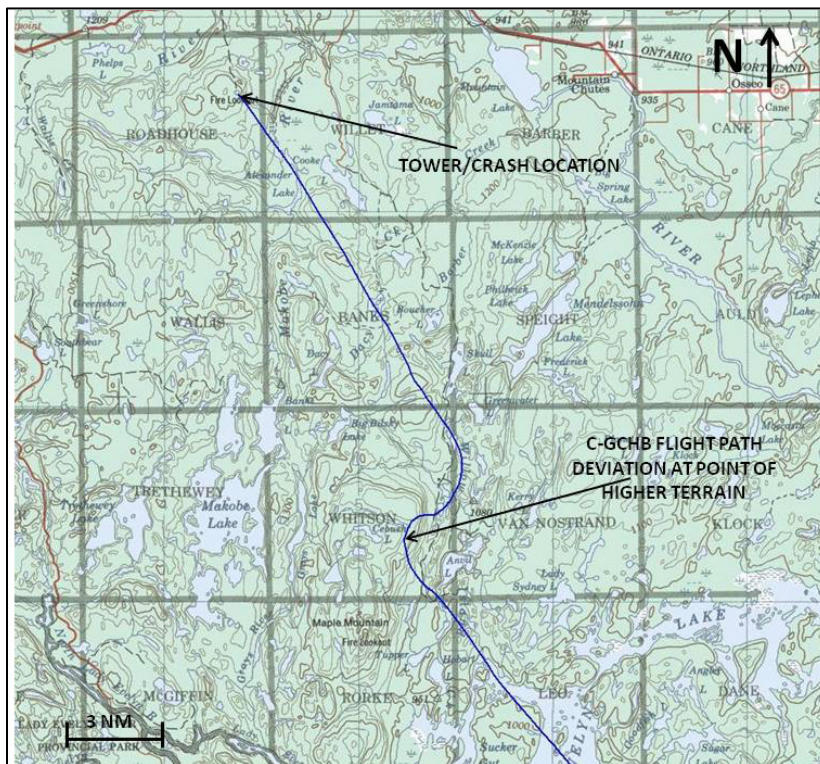
Figure 1. Topographical Map - Aircraft flight path deviation

Two hand-held global positioning system (GPS) devices were on board and data from one was recovered. According to the GPS data, the helicopter reached a maximum altitude of approximately 2300 feet above sea level (asl), 20 nautical miles (nm) from North Bay. Shortly afterwards the helicopter began to descend, and for the remainder of the flight the altitude ranged between approximately 1550 feet asl and 1950 feet asl.

About 17 nm prior to the occurrence location, the pilot had deviated from the intended flight path, and reduced the helicopter's speed, likely due to higher terrain and weather conditions. However, shortly afterwards, cruise speed was re-attained, which decreased the time the pilot had to react prior to tower impact.

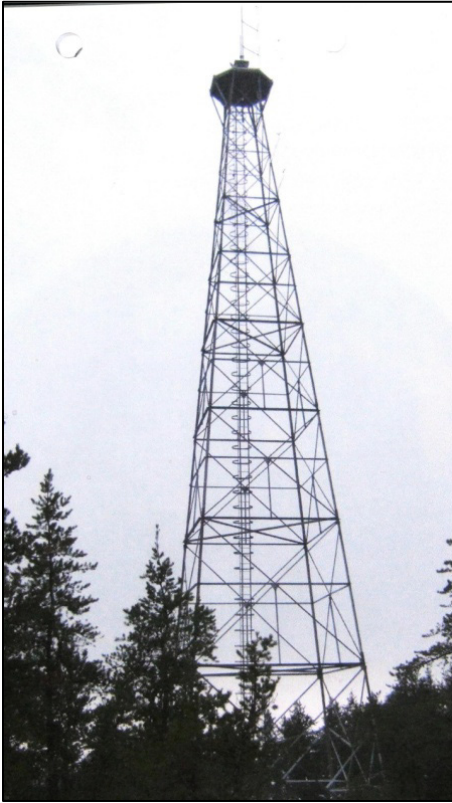
Photo 1. The tower prior to impact

The tower was owned by the Ontario Ministry of Natural Resources (OMNR). It was constructed from steel and was built several decades ago for forest fire detection (see Photos 1 and 2). At the time of the occurrence, the tower was used as a radio communications tower, and was leased to a logging company. It was grey in colour and not lighted or painted with visible markings. The tower was approximately 79 feet in height, and was located on top of a hill, with a ground elevation of about 1670 feet asl.

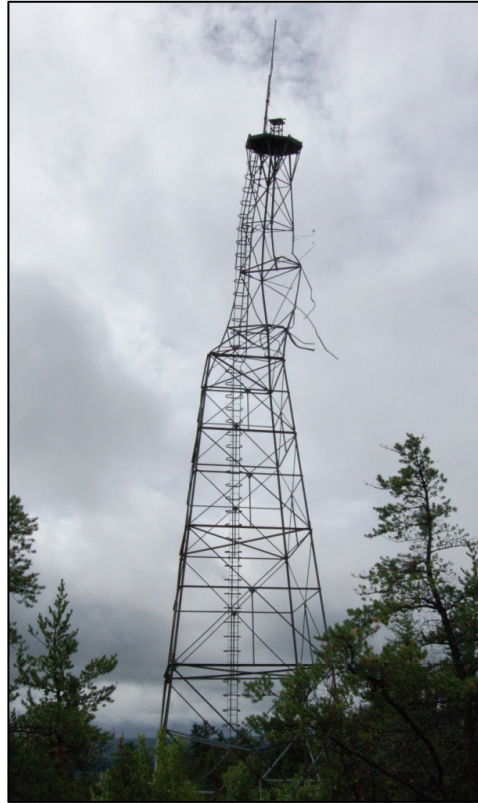
Photo 2. The tower post- impact

The damage sustained by both the helicopter and tower were consistent with a frontal impact with significant velocity. The helicopter sustained substantial structural damage during impact and began shedding major structural components prior to ground impact, including parts from the forward section of the fuselage, rotor blades and main rotor transmission. Consequently, there was a large debris field. The wreckage trail began at the base of the tower and continued 138 feet past the main fuselage. The entire debris field was approximately 568 feet in length.

The helicopter was travelling at a normal cruise speed (104 knots) about 1000 feet from the tower, and the damage sustained by both the helicopter and tower were indicative of a frontal impact with significant velocity. The GPS data did not indicate any sudden manoeuvring. The velocity and course appeared constant, implying the pilot did not see the tower with enough time to react prior to impact, likely because the tower was obscured by the weather, or blended into the overcast conditions.

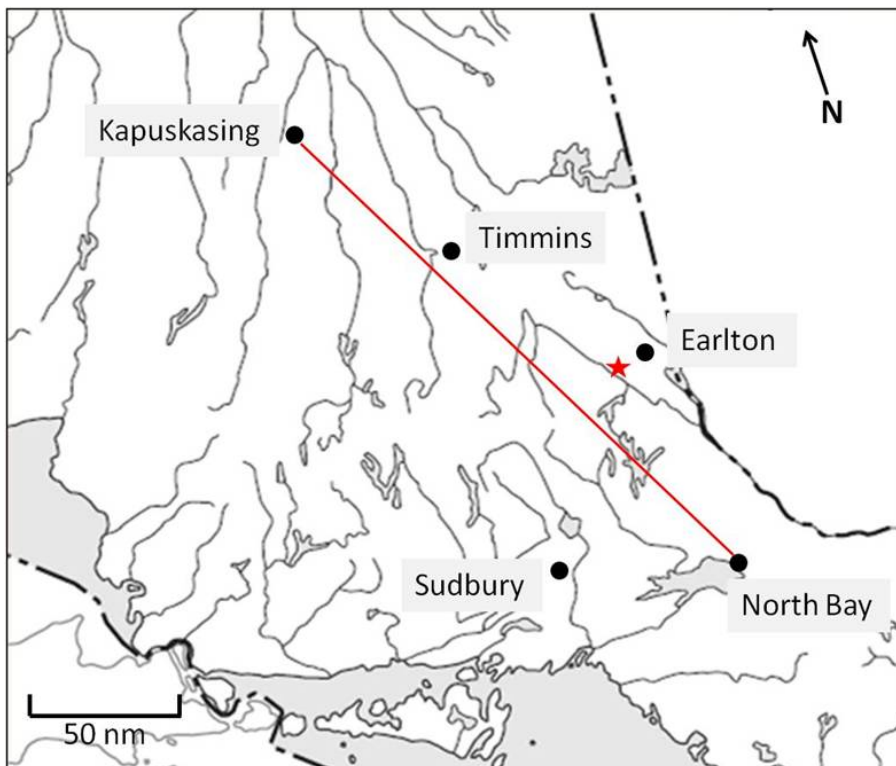
Figure 2. Flight planned route showing accident location (star)

Weather information for other airports located near the route of flight, such as Sudbury (elevation 1140 feet asl, located 42 nm west of the intended track) or Earlton (elevation 800 feet asl, located 21 nm east the intended track) (see Figure 2), and the graphical area forecast (GFA)

In the vicinity of the helicopter's intended flight path (see Figure 2), the GFA issued at 0731, valid from 0800, indicated an overcast ceiling at 3000 feet agl and visibility greater than 6 sm with patchy visibility of 1 sm to 3 sm in drizzle and mist and a ceiling at 600 feet agl. The GFA issued at 1351, valid from 1400, indicated isolated cumulonimbus cloud (CB) topped at 30 000 feet with 1 sm visibility in heavy thunderstorm, rain and mist (see Appendix A).

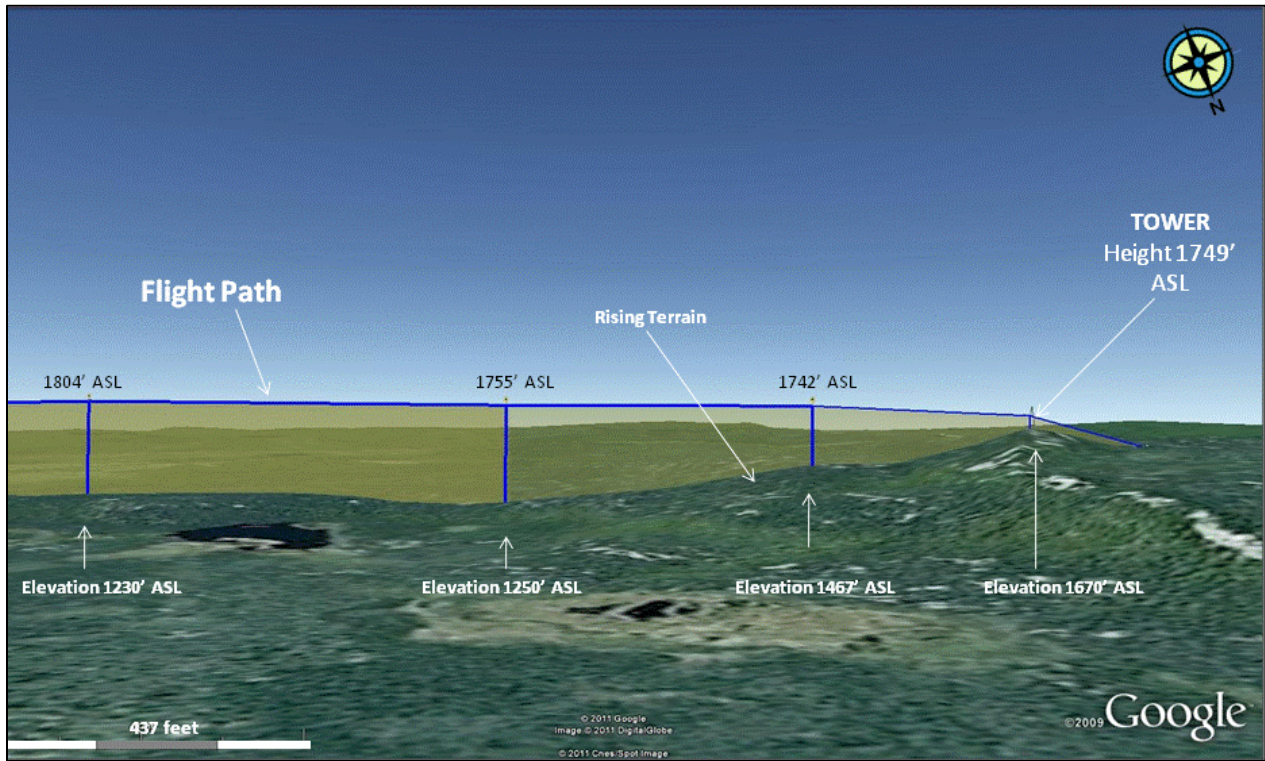
Figure 3. Flight Path and Ground Elevations

For a good portion of the occurrence helicopter's flight, the ground elevation was similar to that of North Bay (1160 feet asl). The ground elevation along the helicopter's flight path for the 3 nm prior to the tower was around 1050 feet asl, gradually increasing to about 1470 feet asl just prior to the tower, and finally 1670 feet asl at the tower location (see Figure 3). The elevation decreased again past the tower.
