**AVIATION INVESTIGATION REPORT
A10Q0098**

ENGINE PROBLEM - COLLISION WITH TERRAIN

**AÉROPRO (2550-4330 QUÉBEC INC.)
BEEHCRAFT A100 KING AIR C-FGIN
QUÉBEC, QUEBEC
23 JUNE 2010**

Report Number A10Q0098

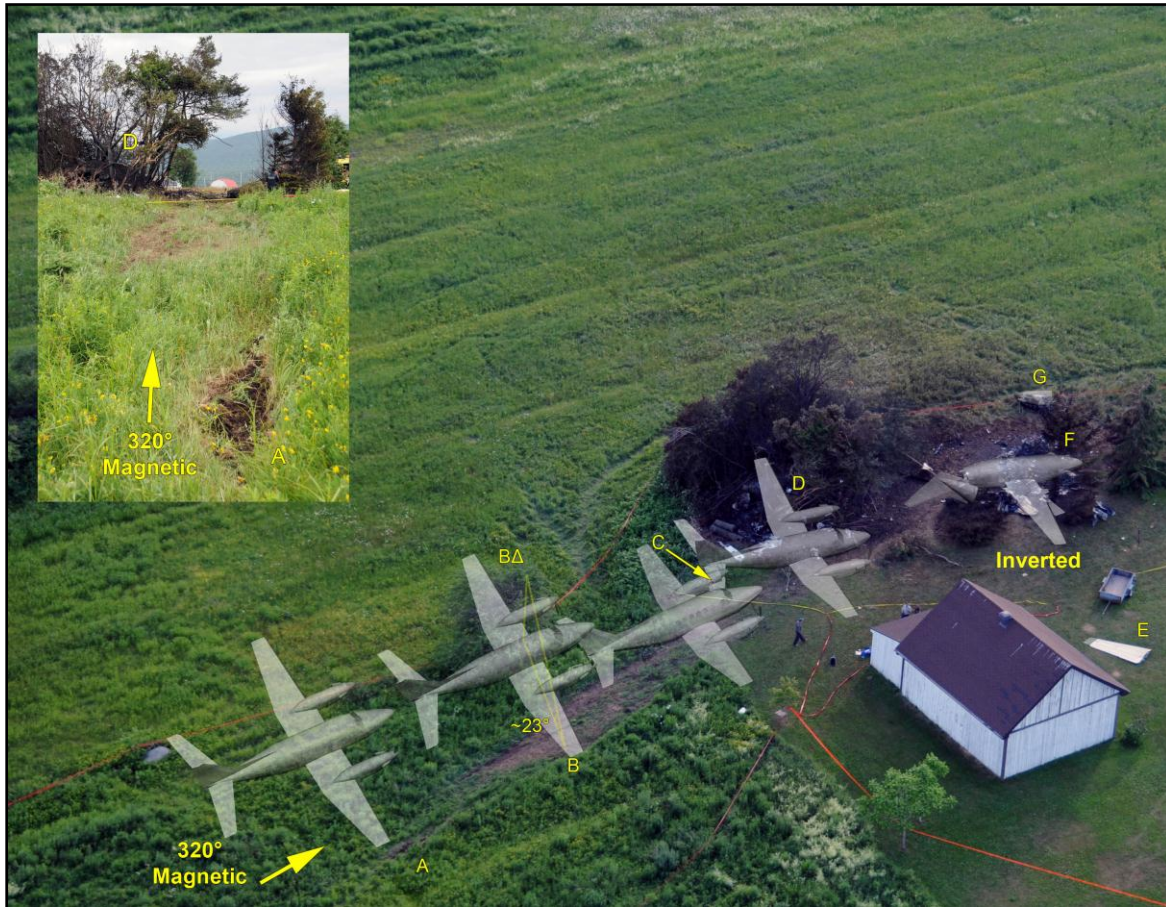
Figure 3. Illustration of impact sequence

The marks made by the left wing in a tree (BΔ) show that the aircraft was banking right at approximately 23°. About 92 feet further, there were marks made by the left propeller (C). The space between the first 3 marks made by the propeller is 0.8 feet. Analysis of these marks revealed that the aircraft was travelling at 69.7 knots, based on the assumption that the engine rpm was 2200 at that specific time. Approximately 23 feet further on, the left wing hit a berm (D), causing the fuselage to roll to the right. The right wing broke on the ground, the right engine (G) separated from the wing and the fuel tank was crushed. After point (C), where the left propeller struck the ground, the aircraft travelled just over 82 feet before coming to rest on its back (F). Much of the aircraft was destroyed by fire. The fire may have been caused by electrical arcing resulting from damaged electrical harnesses, the heat of the engines and possibly friction from the sheet metal coming into contact with the fuel.

The fuselage assembly was on its back. The left elevator (E) was separated from the empennage and lay some 62 feet to the right of the wreckage (F). An examination of the wreckage did not reveal any deficiencies, and the damage was consistent with the impact with the berm and the ground. The right engine and propeller (G) were approximately 26 feet in front of the wreckage along the crash trajectory of the crash.

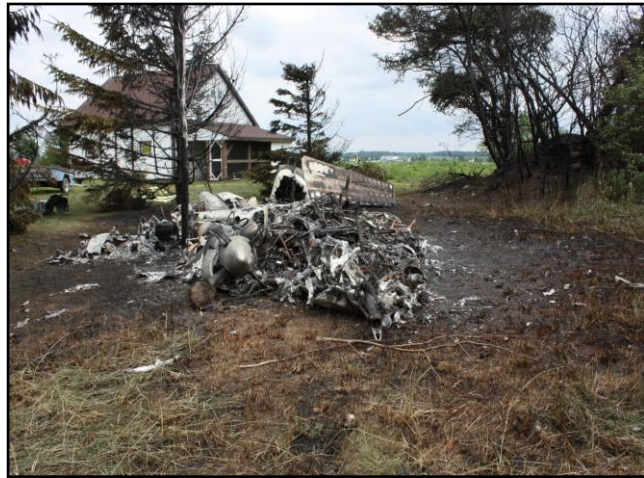
Both propellers were manufactured by Hartzell Propeller Inc., model HC-B4TN-3A.³⁴ The left propeller was still attached to the engine and showed damage consistent with rotation at the time of impact with the ground. Laboratory examination of the propeller did not reveal any

defects. The evidence gathered shows that the propeller was rotating and developing power at low pitch. However, the exact power could not be determined.

Photo 1. Damage to the left propeller

Internal examination of the left engine revealed significant rub marks in the various areas of the engine made by the rotating components coming into contact with the engine housings. The engine air inlet strut was fractured from the impact and torsional overstresses. The evidence indicates that the engine was developing power at the time of impact (Photo 1).

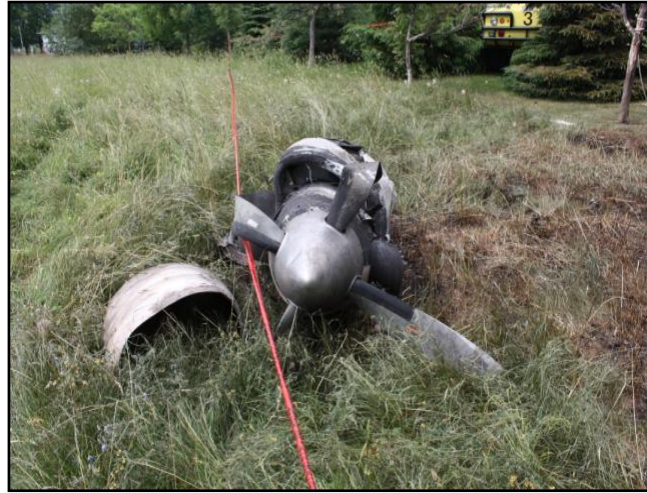
The right propeller was still attached to the engine and showed less rotation damage than the left propeller. Laboratory examination of the propeller did not reveal any malfunctions. The information gathered confirms that the propeller was rotating and indicates that it was developing little power compared to the left engine, and that the blades were in the low pitch range on impact. However, the exact power could not be determined.

Internal examination of the right engine revealed that the turbine and compressor components showed very faint rub marks, indicating that the engine was developing power below engine idle speed or little power at impact (Photo 2).

Photo 2. Damage to the right propeller
