AVIATION INVESTIGATION REPORT

A10W0040

RUNWAY INCURSION

CALGARY INTERNATIONAL AIRPORT, ALBERTA

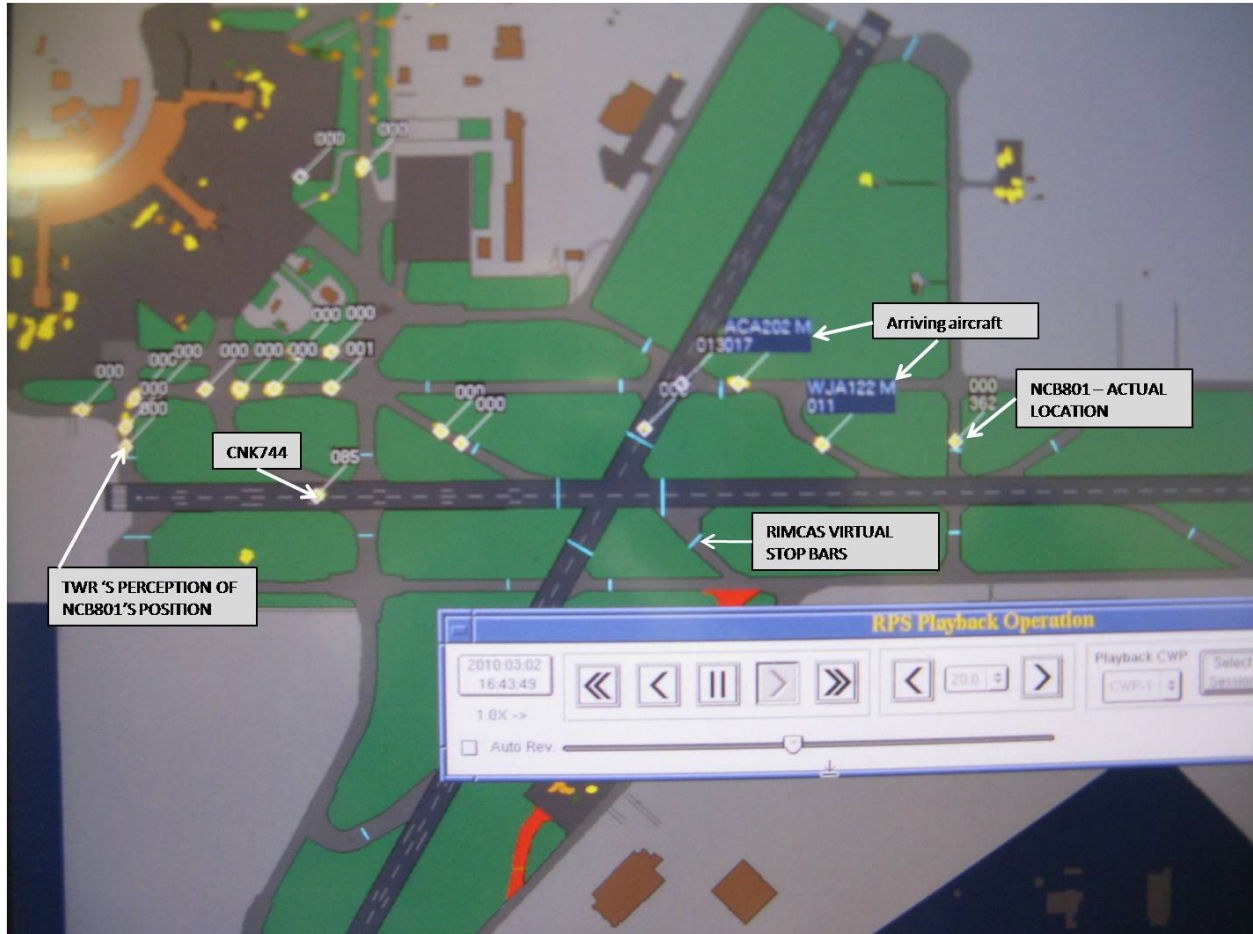
Appendix C – ASDE Display at 0943:49

4. The ASDE display does not show the identification tags of departing aircraft, allowing the controller to continue with the mistaken belief that NCB801 was at the threshold rather than at taxiway U.

Only arriving aircraft have tags that correlate to their flight information, due to the secondary surveillance radar system having correlated the target with the aircraft's mode 'C' or mode 'S' transponder.

The three digit number in the black tag for the ASDE target represents ground speed.

It is unknown what the 362 associated with NCB801 means.
