**AVIATION INVESTIGATION REPORT
A11O0166**

**STALL AND COLLISION WITH WATER
GEORGIAN BAY AIRWAYS
FOUND FBA-2C2 BUSH HAWK-XP, C-GYWK
PARRY SOUND, ONTARIO
08 SEPTEMBER 2011**

Report Number A11O0166

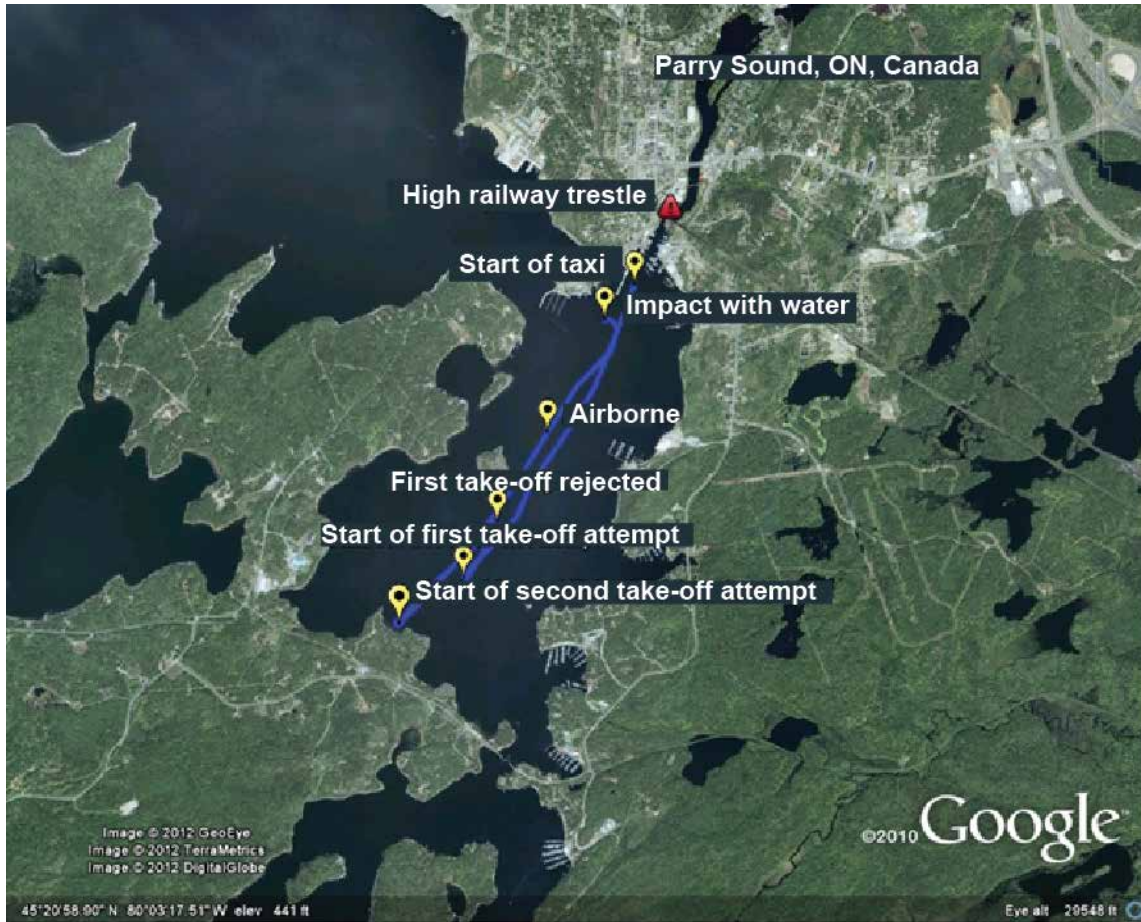
Figure 1. Occurrence aircraft's attempted take-offs

The pilot elected to take off into the wind and, as such, taxied toward the southwest end of the harbour. The engine run-up and pre-take-off checklist were completed while taxiing; no anomalies were noted. Flaps were set correctly at 20° for take-off. Approximately 1400 feet from the shore, the pilot turned the aircraft northeast and began the take-off run. The aircraft had difficulty getting on the step, ² and the pilot rejected the take-off attempt after approximately 1300 feet of take-off run.

The pilot turned the aircraft toward the southwest and taxied back to attempt a second take-off, this time commencing from as close to the shore as possible. Once again, getting the aircraft on the step and off the water was difficult, but it became airborne in approximately 4200 feet. The aircraft began to slowly climb in ground effect as the pilot maintained 60 knots indicated airspeed (KIAS), 6 knots below the best angle-of-climb speed of 66 KIAS. The stall speed, at gross weight with 20° flaps, is listed in the *Pilot's Operating Handbook* (POH) as 49 KIAS, increasing to 53 KIAS in a 30° bank. During this time, the stall warning horn sounded intermittently.

At the northeast end of the sound, approximately 4000 feet from the liftoff point, the terrain rises fairly rapidly, and there are several significant obstacles, including a high railway trestle. The pilot determined that the aircraft could not climb above the approaching terrain and elected to make a left turn to pass over some lower ground and, shortly thereafter, open water. At an altitude of approximately 40 feet, just out of ground effect, the pilot entered a slow left bank. Almost immediately after entering the bank, the stall horn became steady, the left wing and nose dropped rapidly, and the aircraft impacted the water.
