**AVIATION INVESTIGATION REPORT
A12P0070**

CONTROLLED FLIGHT INTO TERRAIN

**DE HAVILLAND DHC-2 MK 1 (BEAVER) C-GCZA
PEACHLAND, BRITISH COLUMBIA, 10 NM W
13 MAY 2012**

Report Number A12P0070

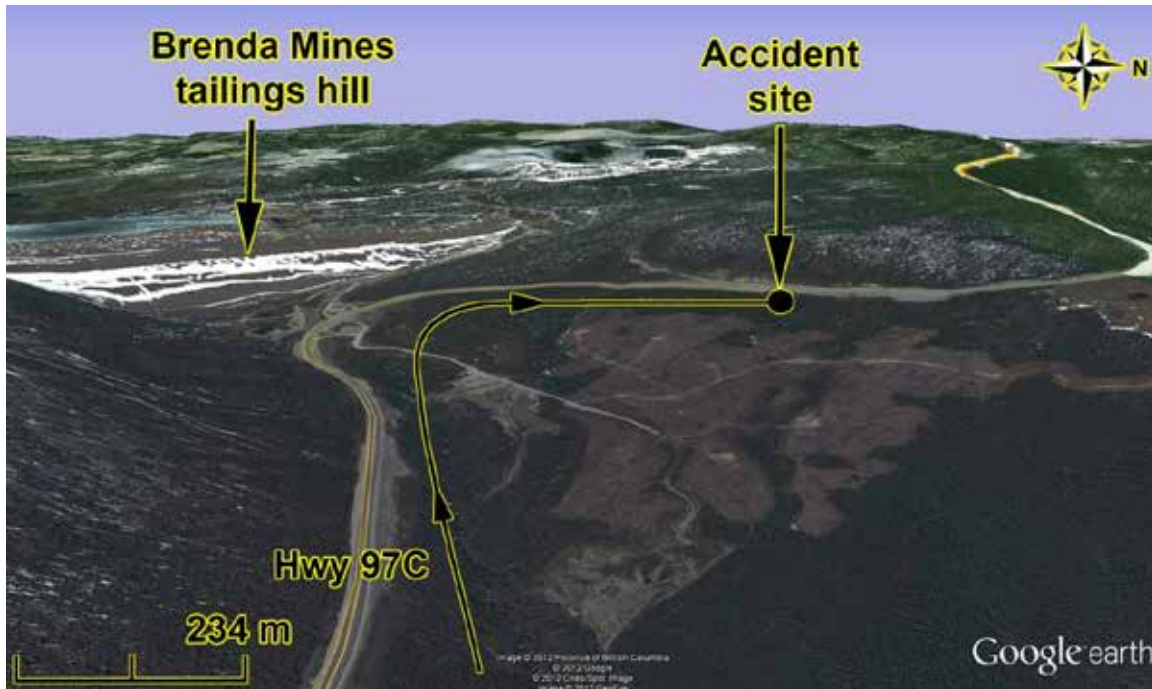
Figure 1. Flight path of the occurrence aircraft

Highway 97C has a steep uphill grade westbound as it climbs out of the Okanagan Valley. The highway then turns right (northbound) at the base of the Brenda Mines tailings hill, and continues to climb steeply (Figure 1).

Reaching the bend in the highway at the bottom of the Brenda Mines tailings hill, the aircraft was flying below the level of the highway and close to it in a climb, when it started a right turn to the north, and continued climbing. The aircraft remained below the highway and just about parallel to it. The aircraft struck trees on a small knoll that rises slightly above the surrounding terrain, which slopes into the valley to the right of the flight path. The impact was not witnessed, as there were trees obscuring the view from the highway. A column of rising smoke was observed, and 911 was notified of the suspected accident.

The period of flight from the turn at the bottom of the Brenda Mines tailings hill to the occurrence site was approximately 24 seconds. To the right of the occurrence aircraft's track along the highway, the terrain sloped down the valley toward lower elevations.

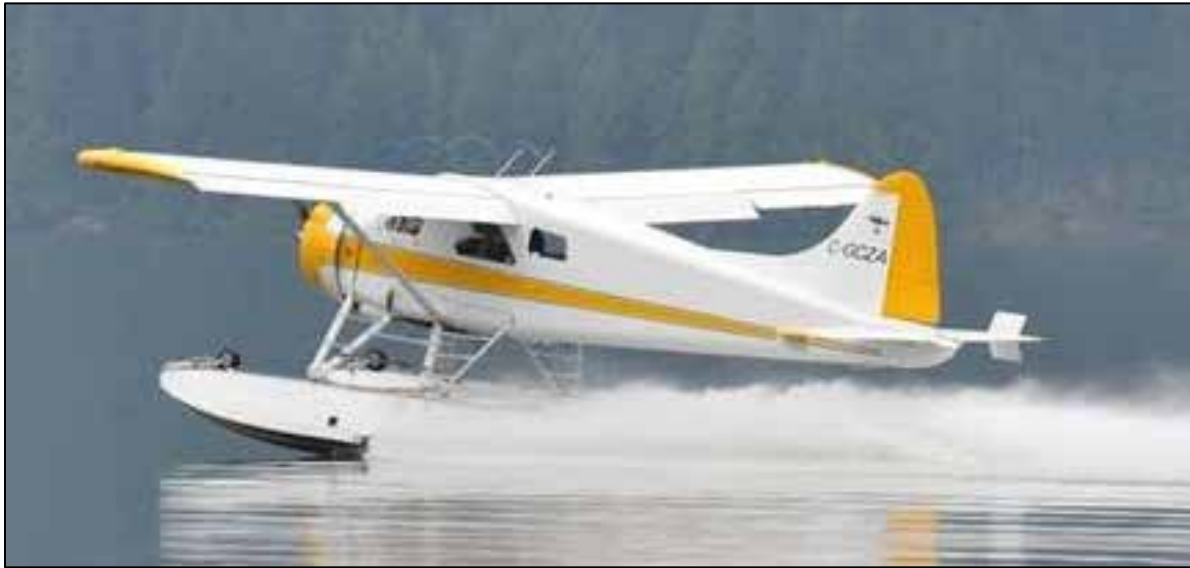
Photo 1. C-GCZA

The de Havilland DHC-2 MK 1 amphibious floatplane, commonly known as a Beaver, was registered to the pilot/owner in June 2011. The Beaver is a single-engine, piston aircraft that is used widely in bush-flying operations. It can be used on wheels, skis, or floats, or in amphibious (wheels/floats) configuration (Photo 1).

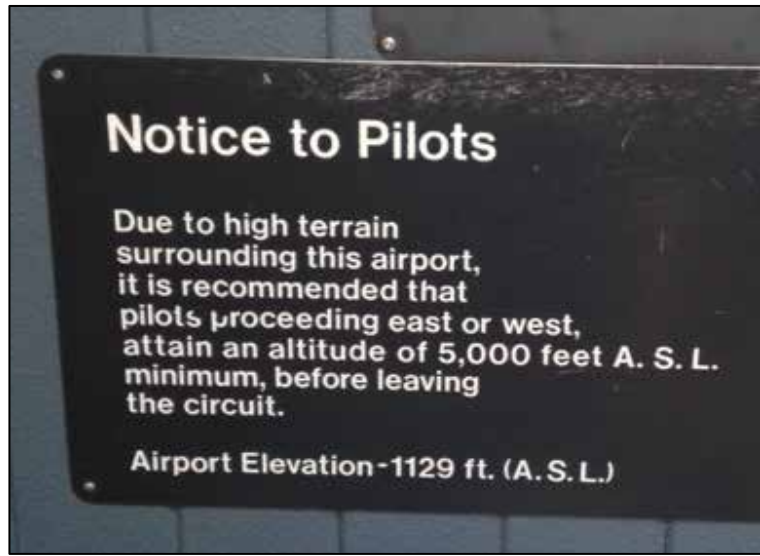
Photo 2. Sign at Penticton Airport

A sign located on the airside wall beside the door to the pilots' information kiosk at Penticton Airport, 30 nm from Kelowna and at the south end of Okanagan Lake, warns pilots about the high terrain in the area and the importance of reaching 5000 feet asl before leaving the circuit (Photo 2).

There is no visual flight rules (VFR) special departure procedure published for airports in the Okanagan Valley. At the time of the occurrence, the only clear warning or indication of such a procedure was a sign at Penticton Airport warning pilots heading east or west not to leave the circuit until reaching a minimum of 5000 feet above sea level (asl). If pilots do not proceed by the door where the sign is located, are on a transit stop to another airport, or are operating from another airport in the Okanagan Valley, they would not see the sign. If no other warnings are available, there is a risk that pilots may leave the circuit at an altitude too low for terrain clearance outside the Okanagan Valley.
