**AVIATION INVESTIGATION REPORT
A12Q0029**

SMOKE IN THE CABIN

**PASCAN AVIATION INC.
BEECHCRAFT B100, C-FLKS
MONTRÉAL/SAINT-HUBERT AIRPORT, QUEBEC
21 FEBRUARY 2012**

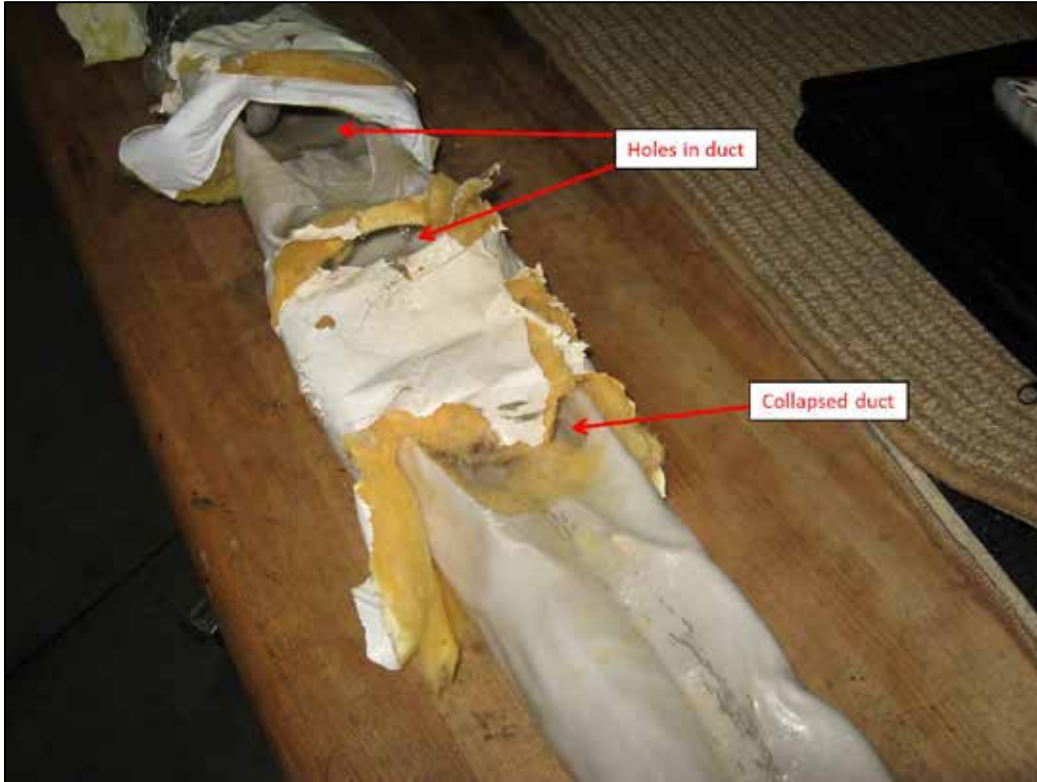
Photo 1. Damaged hot air ducts as found on the occurrence aircraft

Three hot air duct sections carrying bleed air, located under the floor on the right side of the main cabin, were found melted, collapsed, and perforated (Photo 1). A de-icer pressure tube used for carrying air to the de-icing boots had also melted and collapsed. The No. 2 inverter,

located under the right-side cabin floor, adjacent to the hot air ducts, had overheated, and its protection system had disconnected from the circuit during the event; there was no apparent damage.

Based on the thermal damage observed, it is clear that the hot air ducts had been exposed to a range of temperatures from 185 °C to 200 °C, which is above the overheat protection system limits. However, the investigation could not pinpoint which environmental system component had failed, or when the deforming, melting, bubbling, and perforating of the hot air ducts took place. The heat escaping from the perforated hot air ducts likely caused the appearance of light smoke in the cockpit and cabin.

The highest temperature measured on the non-insulated bleed air line during ground tests, with the thermal switch removed, was 148 °C. Bleed air lines run under the right cabin floor and are located very close to the hot air ducts, which start to deflect at 145 °C. Therefore, in some cases, the integrity of the hot air ducts may be affected by hot air, caused by the proximity of the ducts to the non-insulated bleed air line.

1. The heat generated by the non-insulated bleed air line affected the integrity of the air ducts and the de-icer tube due to their proximity.
2. The hot air ducts were exposed to a temperature that caused thermal damage.
3. The material used to manufacture the hot air ducts does not resist the highest temperatures to which they may be exposed under operating conditions; consequently this material may not have been suitable for this purpose.
4. The air escaping from the perforated hot air ducts likely caused the appearance of light smoke in the cockpit and the cabin.

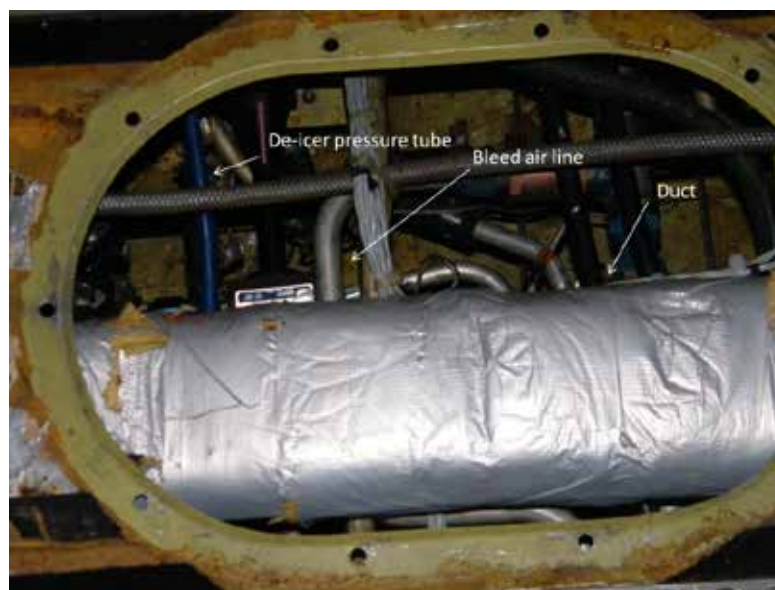
Photo 3. Hot air duct, de-icer pressure tube and bleed air line under the right side of the floor during tests

The bleed air lines are not insulated and are located within 0.5 inches of the hot air duct, a few inches from the de-icer tube.

When the engine was operating at full engine revolutions per minute (rpm), the maximum temperature recorded on the temperature probe, which was attached to a bleed air line in the left engine nacelle, was 116 °C. This temperature indication was affected by the ram air condition from the running propeller and engine.

The thermal switch was removed from the top of the heater plenum, at the juncture of the bleed air line, to replicate the maximum temperature obtained with an unprotected electrical heating system. With the engine operating at full engine rpm, a temperature of 148 °C was recorded by a probe attached to the non-insulated bleed air line in the cabin.

With the thermal switch in place, and the engine operating at full engine rpm, the maximum temperature recorded was 105 °C, suggesting that the thermal switch was functioning as intended. At this recorded temperature, damages caused by heat were almost impossible.
