**AVIATION INVESTIGATION REPORT
A12W0121**

LOSS OF CONTROL AND COLLISION WITH TERRAIN

**ALTA FLIGHTS LIMITED
CESSNA 172M C-GRGW
CLARESHOLM, ALBERTA, 22 NM WNW
26 AUGUST 2012**

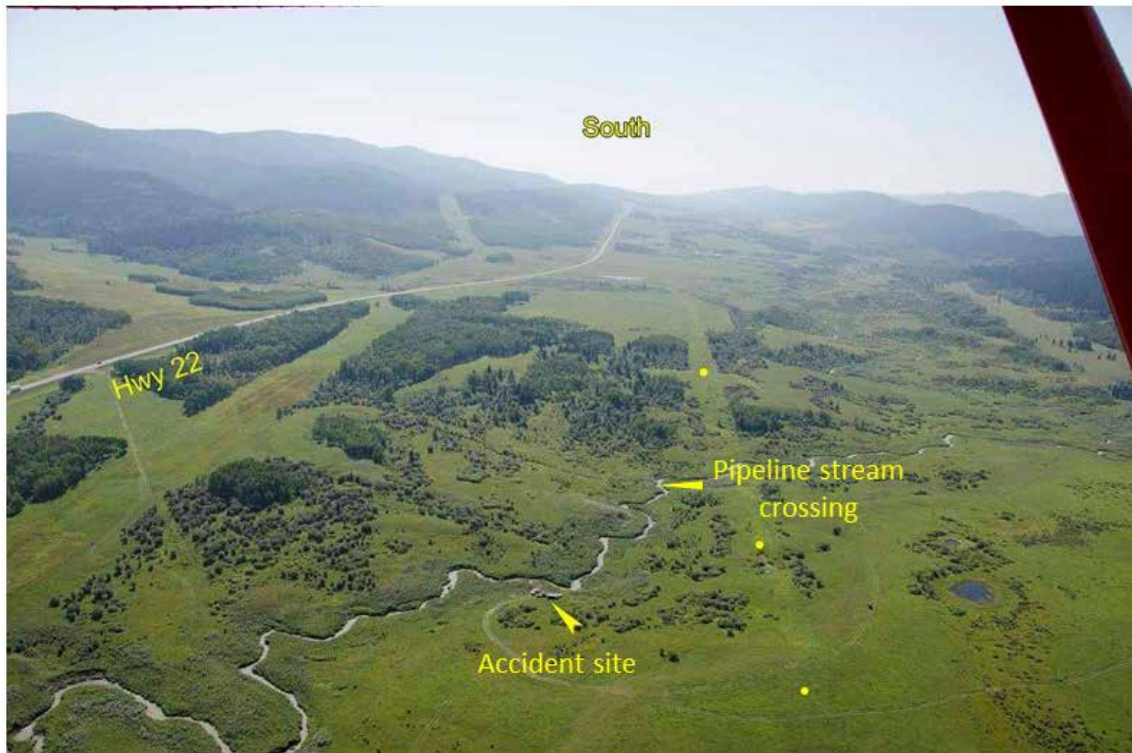
Appendix B – Aerial Photograph of Accident Site

The accident occurred about 1700 feet west of Highway 22, in rolling foothills ranchland. At the site, a small meandering creek (Chaffen Creek) was oriented east-west, with banks about 13 feet apart and 6 feet deep (Appendix B). Elevation was 4300 feet above sea level (asl). The aircraft collided with the ground vertically at the south edge of the creek, in a nose-down, wings-level attitude, on a heading of 260° magnetic. There were no indications of rotation about the yaw axis. After the initial impact, the fuselage bounced and came to lie in the water on the north side of the creek, with the left wing detaching and coming to rest on the north bank. The right wing remained attached and lay on the north bank, along with numerous pieces of the aircraft. All 4 wing fuel tanks had separated, and damage indicated that they contained substantial quantities of fuel. Wing flaps were in the retracted position. The engine mounts were broken, and the engine was connected to the airframe only by the engine control cables. The crankshaft flange had broken aft of the propeller, and fracture surfaces and propeller damage indicated that the engine was developing significant power on impact. The severity of the impact damage precluded detailed examination of flight control rigging and determination of elevator trim setting; however, no discrepancies were found in the flight control systems.
