# AVIATION INVESTIGATION REPORT A14F0065

## **Unstable approach and hard landing**

Airbus A319, C-FZUG

Sangster International Airport

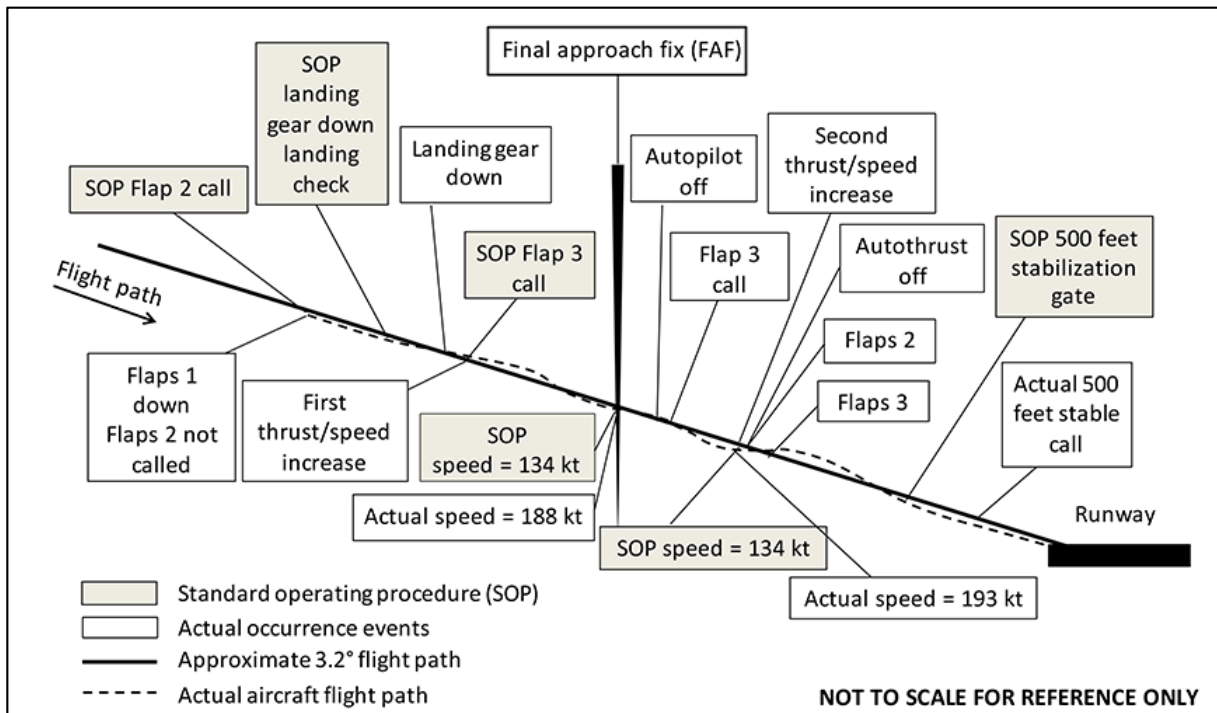
Figure 4. Actual occurrence events compared with Air Canada Rouge standard operating procedures (SOP)

Several other deviations from the SOPs occurred during the approach. The Air Canada Rouge SOPs for flap and gear selection, calls, and landing checks during the final approach segment are compared with the actual occurrence sequence in Figure 4. For a more comprehensive table, see Appendix C. In addition, the flight crew did not announce or cross-check several FMA changes, as required by the SOPs.

Management of the aircraft’s energy condition diverted the flight crew’s attention from monitoring and controlling airspeed during the descent. As a result, the aircraft passed the FAF arrival gate at a high airspeed and with a flaps configuration that was not in accordance with the SOPs.

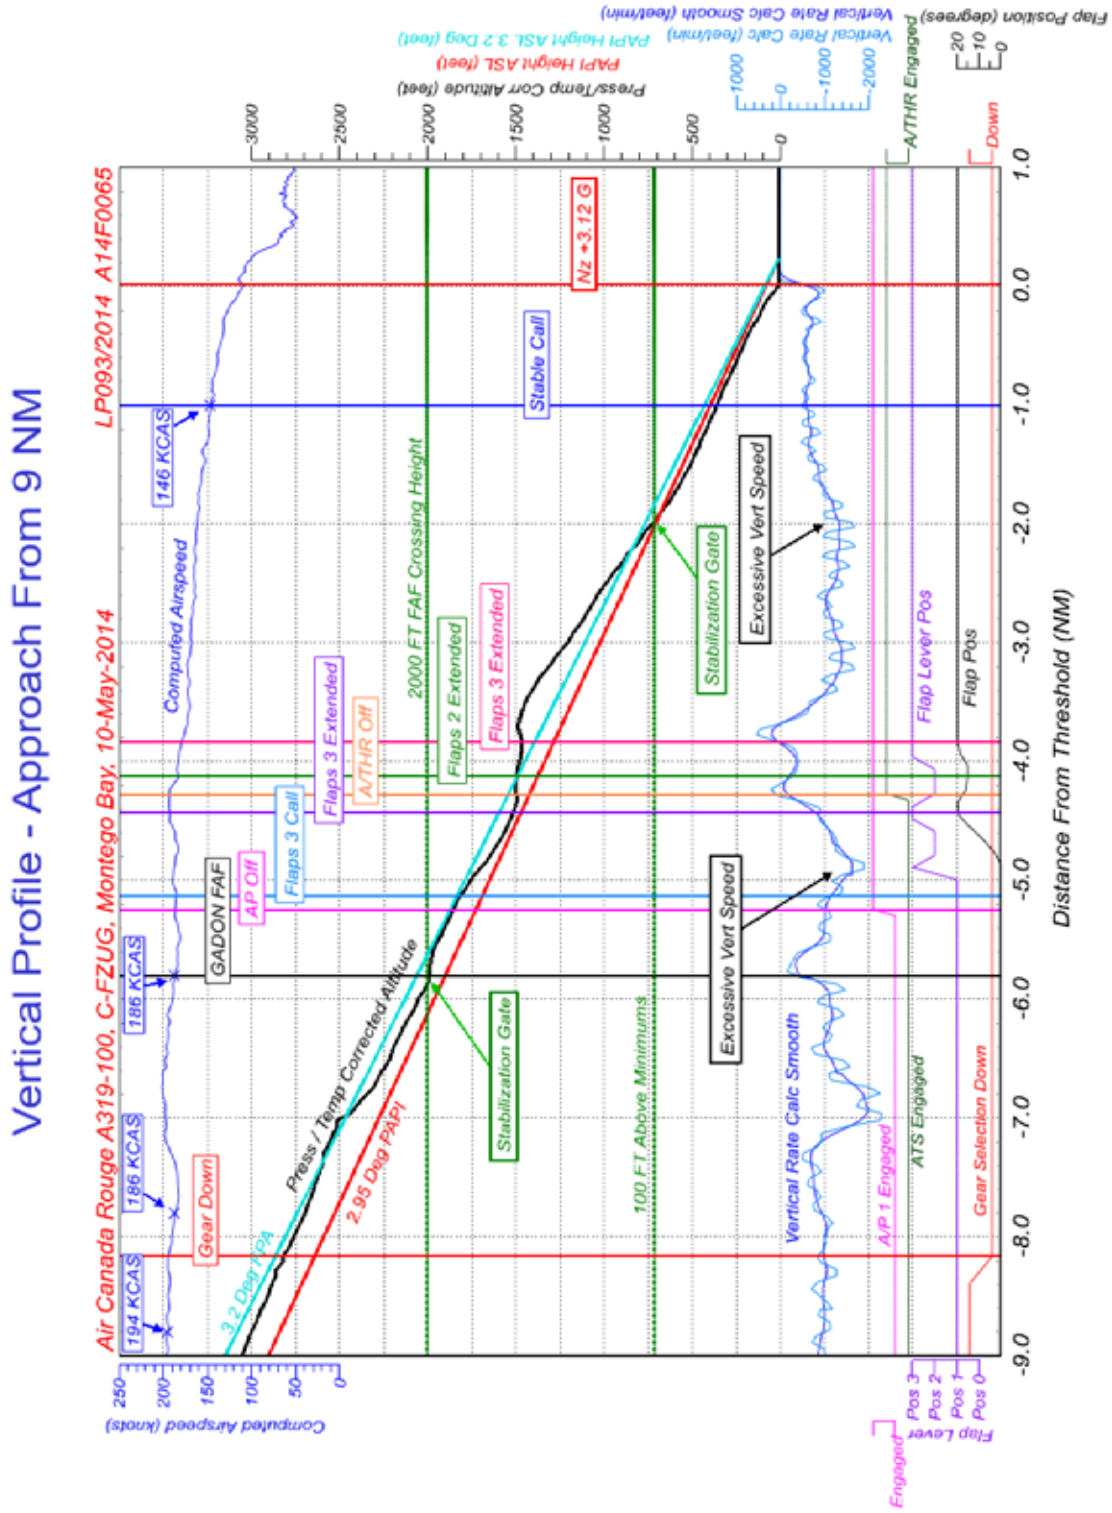
## Appendix A – Aircraft vertical profile

The flight crew did not recognize that the airspeed was decaying as the aircraft approached the runway, nor that the autothrust was off. While on short final approach, the airspeed decayed well below  $V_{APP}$ , placing the aircraft in an undesired aircraft state at a very low altitude. The PF applied full nose-up side-stick input, and the angle of attack (AOA) reached maximum levels. As a result, during the flare, the aircraft's AOA protection system engaged, reducing the pitch angle. The protection system functioned as designed, and as a result no significant nose-up elevator movement occurred, although full nose-up side-stick input had been applied before touchdown.

The crew were unaware of the low-energy state just before touchdown, as they believed that the autothrust was on. At 50 feet before touchdown, the flight crew suddenly realized that airspeed had been decaying and applied full manual thrust (i.e., maximum take-off thrust); however, in the time remaining before touchdown, the thrust increased by only 4%. When the flight crew recognized the undesired aircraft state, the late addition of engine power was insufficient to arrest the descent rate, resulting in a hard landing.
