**AVIATION INVESTIGATION REPORT
A14Q0060**

COLLISION WITH WIRES

**HÉLI-BORÉAL INC.
EUROCOPTER AS 350 BA (HELICOPTER), C-FHPC
SEPT-ÎLES, QUEBEC, 35 NM N
13 MAY 2014**

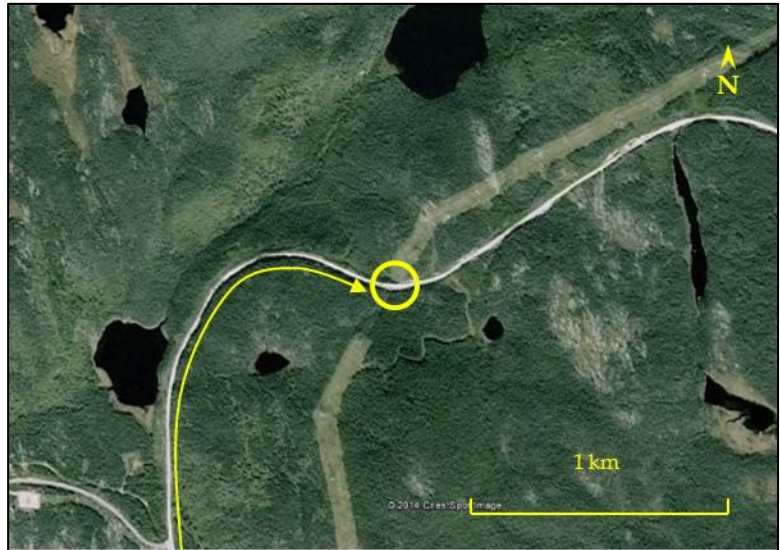
Figure 1. Survey route showing location of wire strike (Source: Google Earth, with TSB annotations)

along the right side of the road that was adjacent to the distribution line (Figure 1).

While following the distribution line around a hill (arrow, Figure 1), the observer noticed the 315 kV power transmission line² wires that crossed over and above the distribution line ahead. The observer indicated to the pilot that the survey was complete for that section. At that moment, the pilot noticed the transmission line straight ahead, running perpendicular to their flight path (Figure 2). The pilot immediately initiated a right turn to avoid a collision; but 1 main rotor blade hit one of the lower wires of the transmission line, was damaged, and this caused subsequent vibrations in the helicopter. The area under the transmission line was covered with mature trees, with a small cleared path approximately 6 metres wide directly below and parallel to the line. The pilot had limited control of the helicopter and attempted to slow the helicopter for a forced landing along the path. The helicopter's skid impacted the trees just short of the path, and the helicopter rolled to the left, descended into the trees, and came to rest on its left side. The cockpit was destroyed, and the pilot was suspended in the seat above the observer, who was in his seat against the snow-covered ground. The pilot quickly shut down the engine.

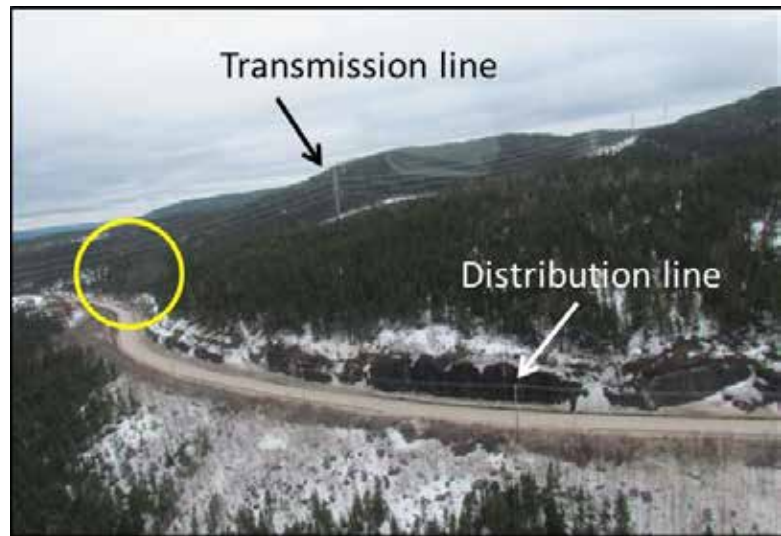
Figure 2. Intersection of distribution and transmission lines

The lower wire of the transmission line was severed by one of the main rotor blades and fell on the distribution line, which caused a power loss in the electrical distribution system.

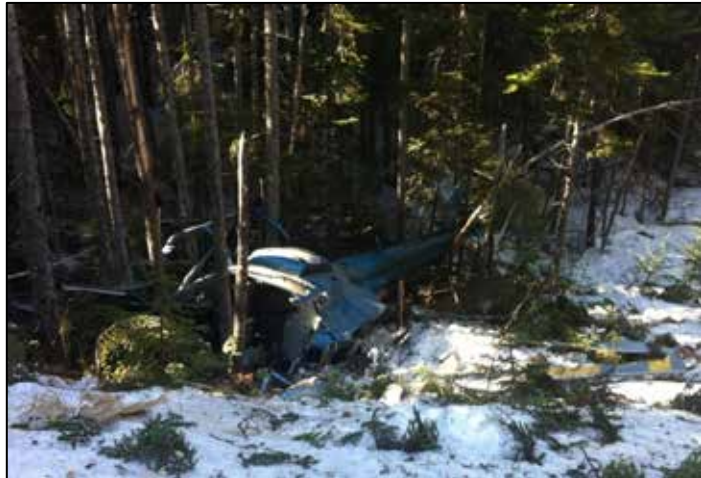
Photo 1. Impact site (Source: Héli-Boréal)

The cockpit, instrument panel, radio console, and cabin roof were destroyed during the helicopter's descent through the trees and impact with the ground. All of the rotor blades separated at the main rotor head during the impact with terrain.

The pilot seat back separated, but kept supporting the pilot by the seat belt. The passenger seat broke from the floor seat track attachments. The helicopter was destroyed in the sequence of impact (Photo 1).

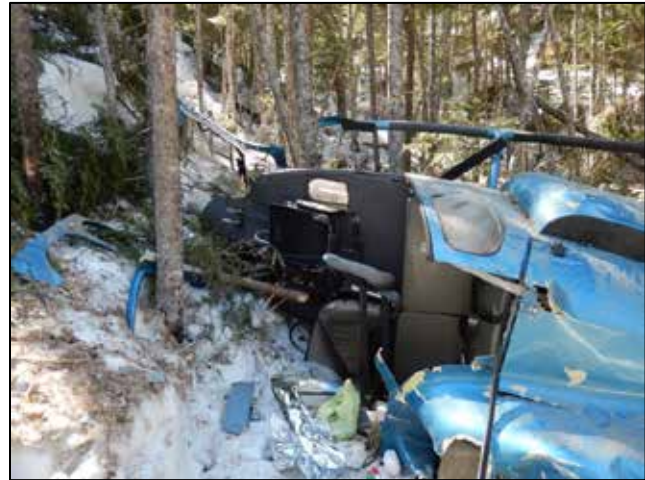
Photo 2. C-FHPC cabin floor (Source: Héli-Boréal)

The helicopter's cabin roof was ripped off the cabin aft wall and floor structures during the fall. The helicopter was on its left side on the snow-covered ground. Both the pilot and the passenger front seats failed by lateral loads at impact and held occupants in their position.

After falling about 50 feet, the helicopter impacted the frozen ground, with both the pilot and the observer held in their seats by the 4-point safety belt system. The pilot's seat back fractured and separated near the seat base. The observer's seat broke free of the cabin floor in a lateral direction to the left (Photo 2).

The injuries sustained by both occupants were caused by the breakup of the cockpit and cabin roof during the fall through the trees.

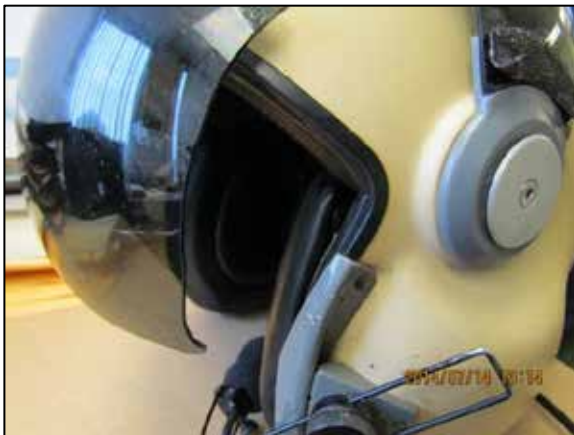
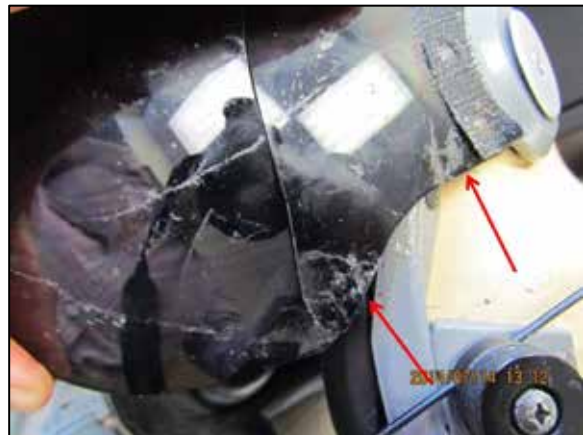
The pilot was wearing a flight helmet, but it came off the pilot's head during the impact.

Examination of the helmet revealed several impact marks visible on the left side and at the top of the helmet. The sun-visor part of the helmet showed 2 severe scratches starting from the left cheek and temple and going toward the left eye and the nose. Photo 3 and Photo 4 show the helmet condition after impact damage. The visor was cracked and scratched by impact loads on its surface. Examination of the helmet chin strap webbing material adjacent to the visor showed severe rubbing marks. However, it could not be determined how the helmet had come off the pilot's head.

Photo 3. Pilot's helmet impact damage to left side visor (Source: Héli-Boréal)

Photo 4. Pilot's helmet close-up view of the left side visor with impact damage (Source: Héli-Boréal)

The pilot's helmet came off during the impact sequence. The helicopter canopy was no longer protecting the occupants during the fall. The helmet provided sufficient protection to allow the pilot to remain conscious after the impact, to shut down the engine, and to provide help to the observer, who was seriously injured. Examination of the helmet revealed it had sustained a significant impact that would have caused severe injuries to the head and face had the pilot not been wearing it. Not wearing helmets and visors places pilots at greater risk of incapacitation due to head injuries following a ditching or crash. This type of injury jeopardizes a pilot's ability to assist in the safe evacuation and survival of the passengers.

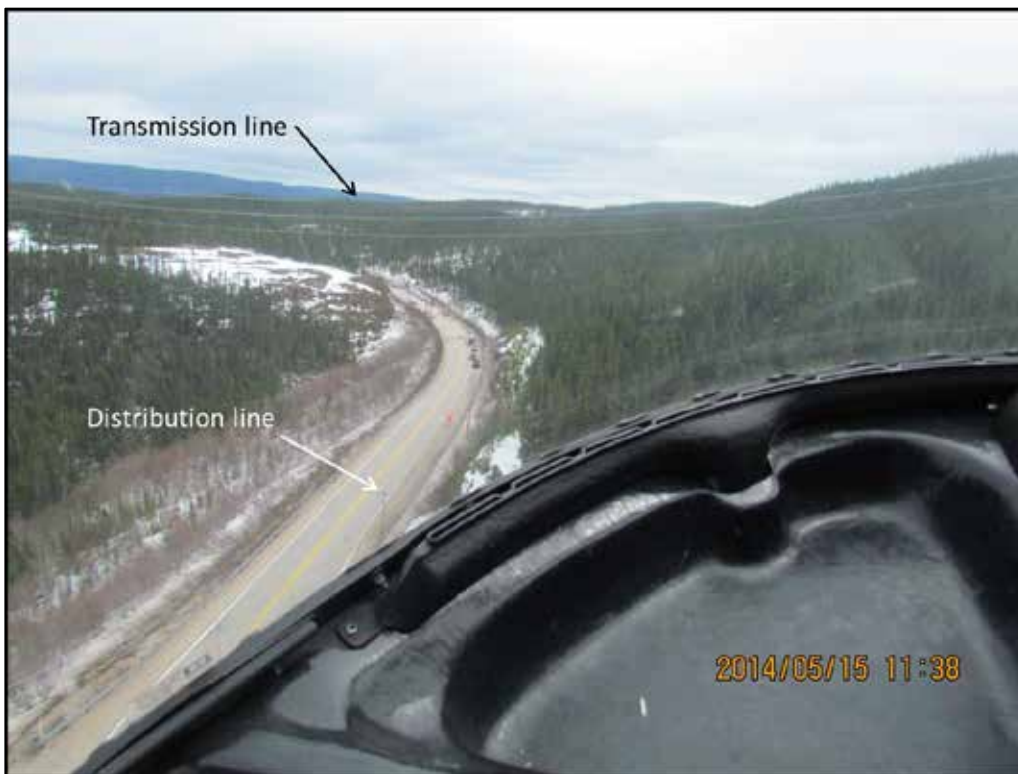
Figure 3. View from helicopter passenger seat approaching the transmission line (Source: Héli-Boréal, with TSB annotations)

During the occurrence flight, the helicopter was following a road to the right of the distribution line being surveyed, around a hill. The terrain was up-sloping to the right, with the right-hand tower of the crossing transmission line at a higher altitude than the helicopter (Figure 3).

The pilot was flying low, following a 25-kilovolt power distribution line at an altitude of approximately 50 feet above ground level, close to the tree tops and in valleys. This task required deep concentration. At the time of the occurrence, the flight was following the distribution line around a hill to the right. The crossing 315 kV transmission line came in sight at the end of the turn. In flight conditions such as these, the pilot has narrower peripheral cues than when flying at a higher altitude away from ground obstacles. At the time the observer indicated that the survey was completed for the area, the towers of the crossing power line were likely outside of the pilot's field of vision. There was not enough time to react prior to hitting the wires.

The cues from triangular markings allow pilots to be forewarned of impending hazards. The distribution line being surveyed did not have the standard markings to indicate the upcoming intersection with the transmission line located above it. The investigation revealed that other intersections of power lines throughout the Hydro-Québec network were also lacking the triangular markings. Furthermore, on some of the lines with markings, those markings did not meet Hydro-Québec TransÉnergie's standard as to size and colour. Also, when in place, the yellow and black markings reduce the chances of the markings being seen in a timely manner, compared to markings painted orange and white, which is the recognized paint colour standard in aviation. If power distribution companies do not enforce their power line marking standards, there is an increased risk of collision with wires from low-level flying aircraft.
