**AVIATION INVESTIGATION REPORT
A15C0005**

**COLLISION WITH TERRAIN
AIRSPAN HELICOPTERS LTD.
EUROCOPTER AS350 B2 (HELICOPTER)
C-GJPW
KEY LAKE, SASKATCHEWAN, 11 NM SE
21 JANUARY 2015**

Aviation Investigation Report A15C0005

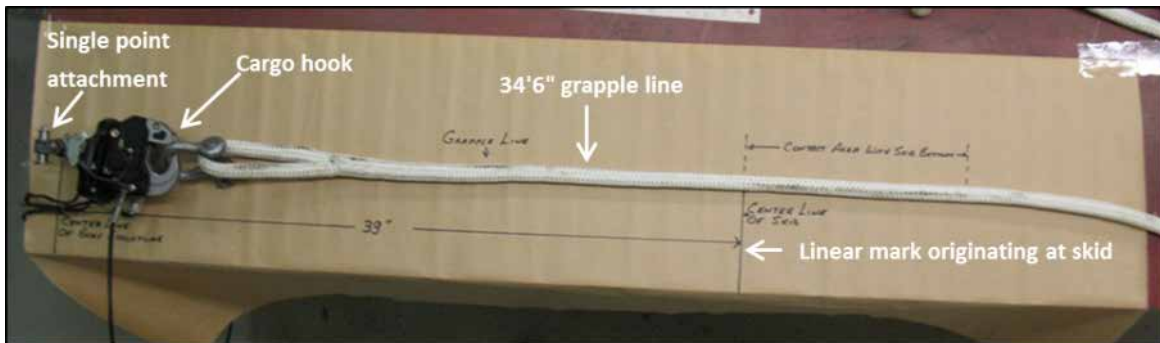
Figure 6. Cargo hook and grapple line

An inspection of the grapple line used during the occurrence flight revealed a linear mark originating at a distance that corresponded with the bottom of the landing gear skid (Figure 6). The mark suggested that contact had been made between the grapple line and the bottom of the landing gear skid and that the angle achieved to make contact with the skid was as high as 74°.
