AVIATION INVESTIGATION REPORT

A15F0165

Severe turbulence encounter

Boeing 777-333ER, C-FRAM

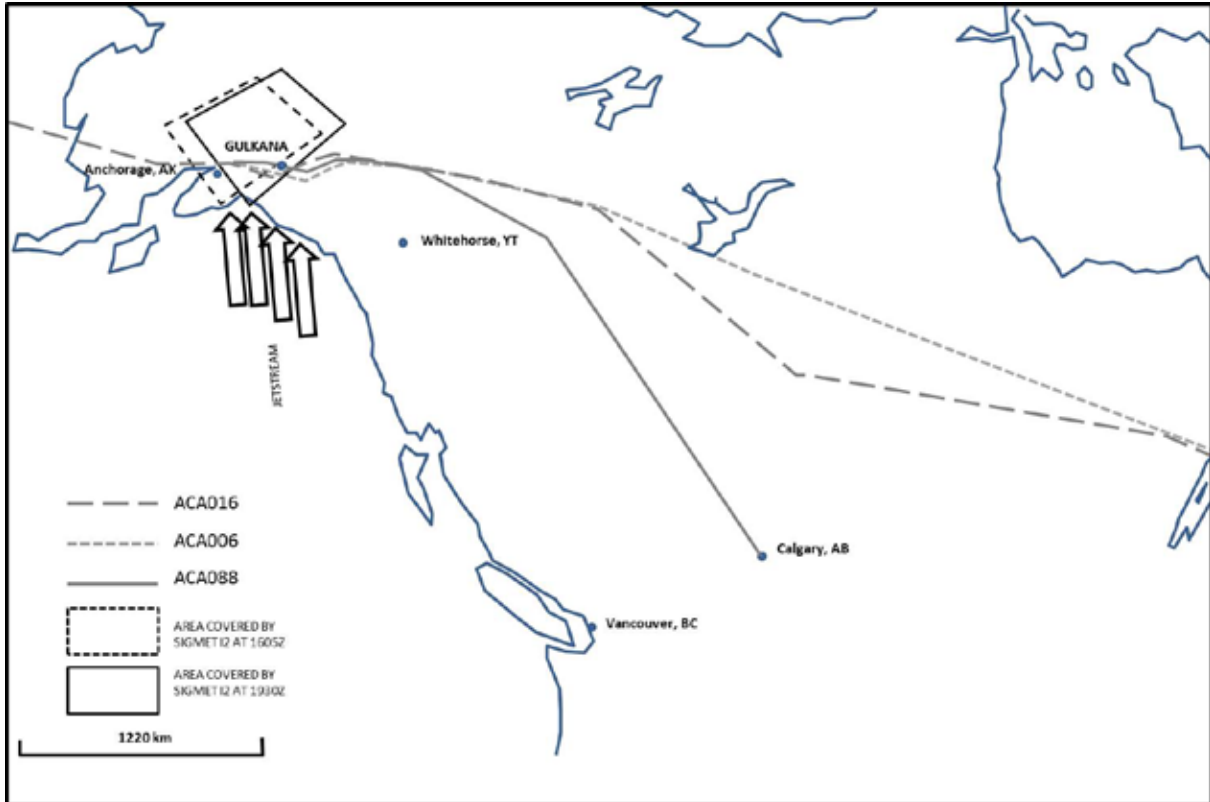
Figure 1. Routes of flight of ACA016, ACA006, and ACA088, showing area of turbulence forecast in SIGMET I2

At about 1755, ACA016 encountered moderate to severe turbulence at FL350 near the GULKANA waypoint, in the area covered by SIGMET I2. This information was relayed to the Anchorage ARTCC in a pilot weather report (PIREP). Air Canada dispatch retrieved the PIREP from its flight following software, but was not aware that it had come from ACA016. PIREPs indicate only the type of aircraft from which the report is made, not the air carrier. Air Canada dispatch then disseminated the PIREP via ACARS to ACA088. This PIREP was also communicated to ACA088 by the Anchorage ARTCC.

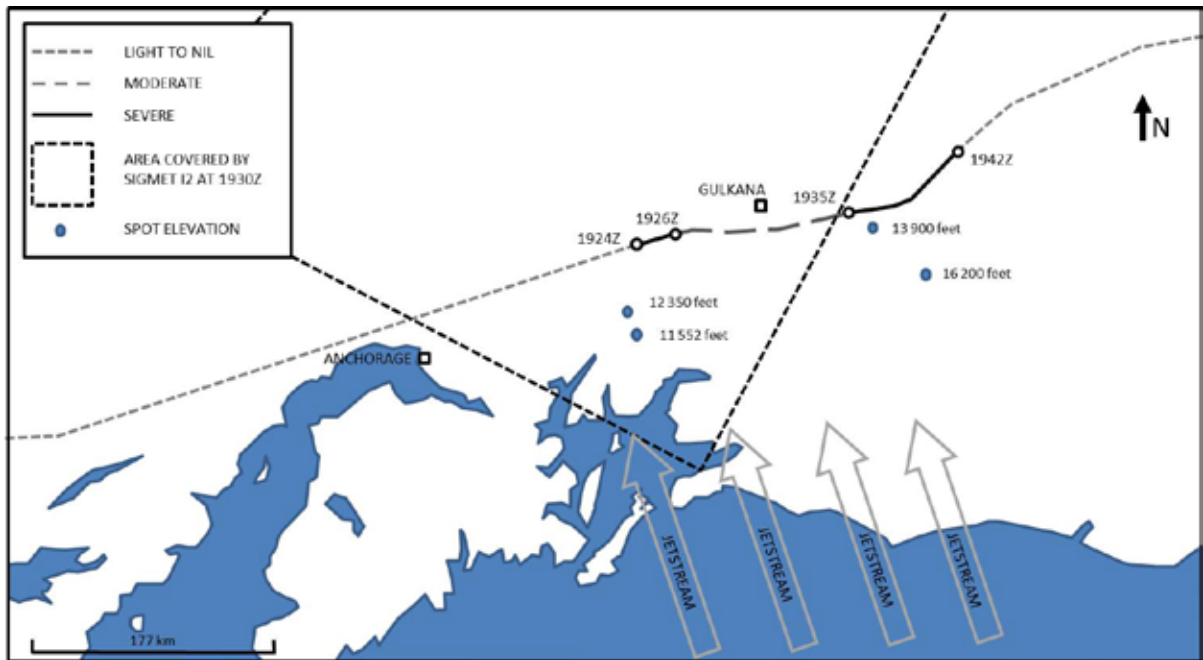
Figure 2. Location, time and severity of turbulence encountered by ACA088

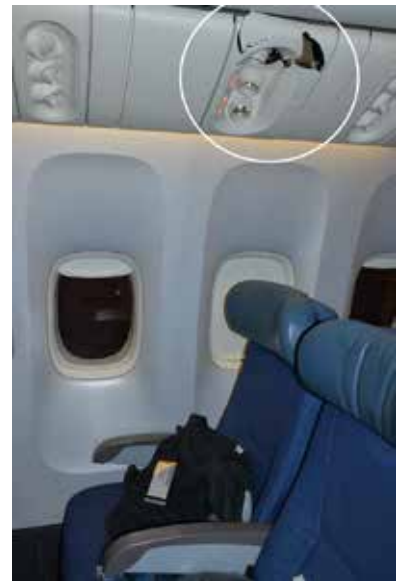
The moderate to severe turbulence events featured a significant negative *g* force, followed quickly by a positive *g* force. The height of the ceiling of the Boeing 777 is 2.4 metres in the aisles and 1.6 metres at the window seat. Several passenger service units were damaged when passengers were thrown upward into the ceiling during the negative *g* event (Photo 1). The passenger who was seriously injured was seated near the L4 door (Appendix A) and was thrown upward and then downward onto the floor area by the door.

Photo 1. Passenger service unit damage at seat 35K

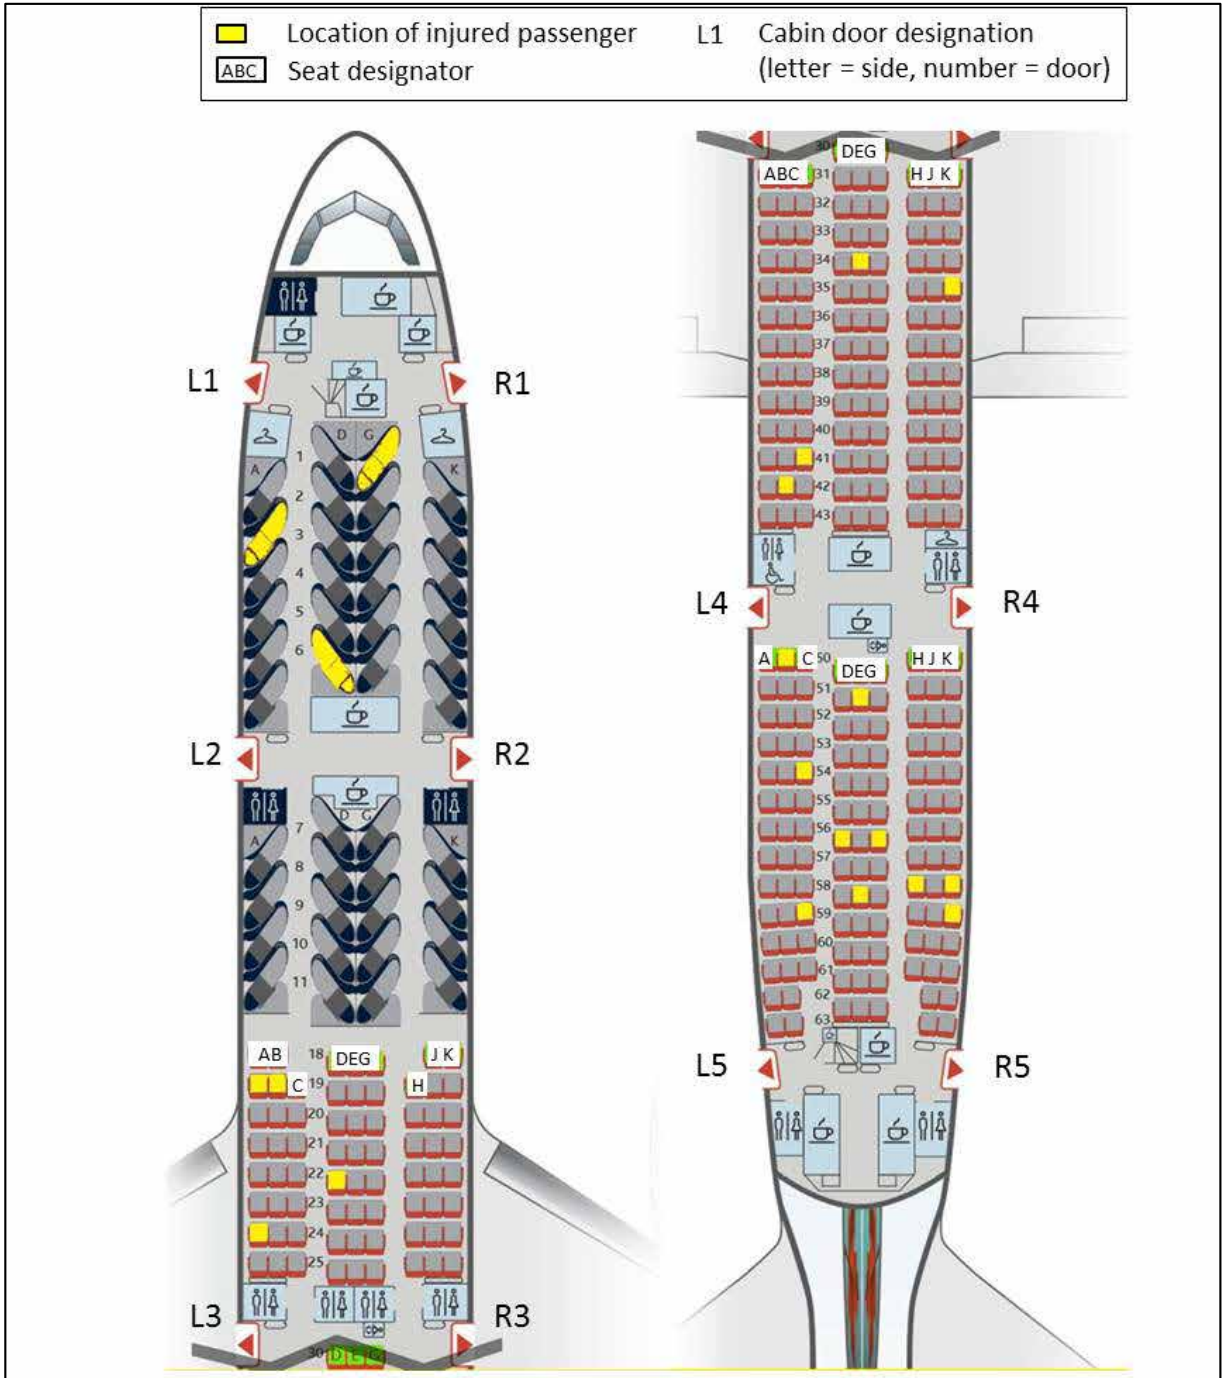
Appendix A – Cabin layout and door location

Most injuries were sprains, strains, bruising, and scrapes. Injured passengers were located throughout the cabin (Appendix A). One passenger in business class received cuts from broken glassware, and 1 seriously injured passenger required an extended stay in hospital. The injuries resulted from passengers coming into contact with aircraft furnishings, the ceiling, and the floor of the interior.
