# AVIATION INVESTIGATION REPORT

## A15P0217

### **Loss of control during night approach and near collision with terrain**

Sikorsky S-76C+ (helicopter), C-GHHJ

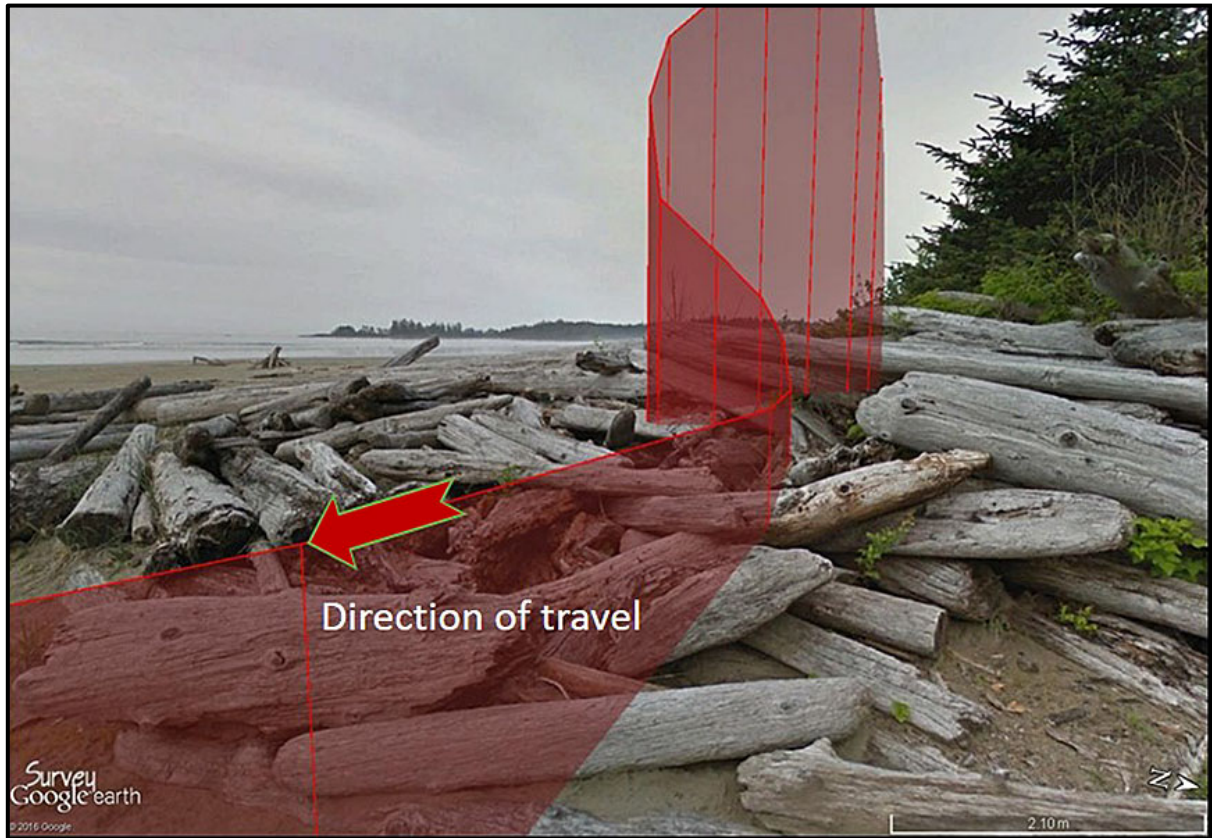
At 0239:39, with a pitch attitude of 11° nose-up, the EGPWS gave a voice alert of "TAIL TOO LOW."

The helicopter stopped descending at about 3 feet above the logs on the beach (Figure 4). The crew acknowledged that the flight parameters had returned to the normal operating range, with no caution or warning lights visible, and the captain confirmed that he had taken control as PF. The helicopter's airspeed increased, and the aircraft climbed away from the beach in a southerly direction.

Figure 4. Terrain in the area where the enhanced ground proximity warning system gave the “TAIL TOO LOW” alert. The approximate flight path is shown in red. The helicopter travelled from the top right to the bottom left. (Source: Google Earth, with TSB annotations)

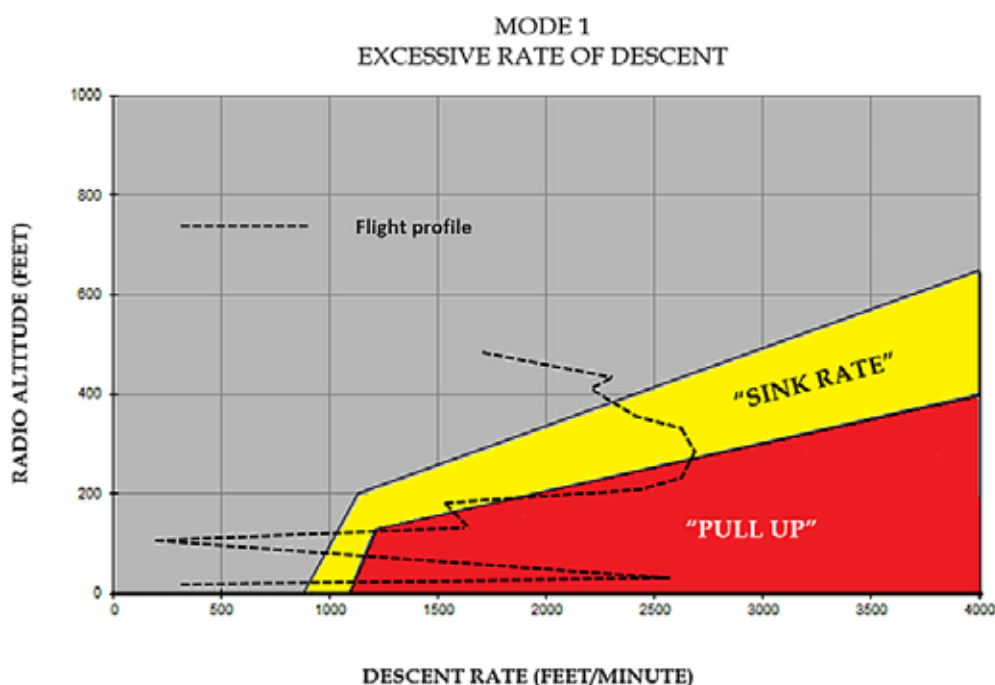
During the occurrence, no “SINK RATE” or “PULL UP” warnings were activated on the first approach to CYAZ due to the autorotation<sup>25</sup> inhibit function<sup>26</sup> that was configured when the EGPWS was initially set up. When engine torque values fall below 7.5% torque, Mode 1 of the EGPWS is inhibited until engine torque values increase above 7.5% and the helicopter is out of the autorotation. The EGPWS then takes 20 seconds to reset before additional “SINK RATE” and “PULL UP” alerts can be activated.

Figure 6. Enhanced ground proximity warning system mode 1: Alerting of excessive rate of descent (Source: Honeywell International Inc., 060-4314-200, *MKXXII Helicopter EGPWS Pilot Guide*, Rev. C [March 2004], with TSB annotations showing flight profile)

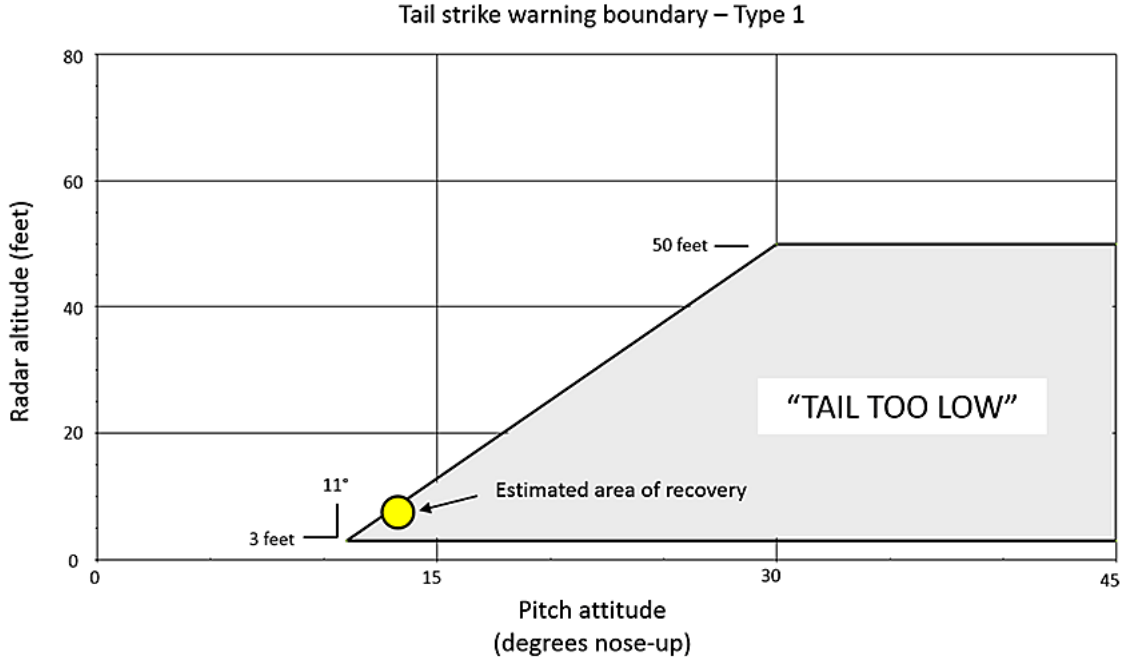
The boundary set for the occurrence helicopter is depicted in Figure 7.

Figure 7. Mode 6: Tail-strike warning boundary (Source: Honeywell International Inc., 060-4314-200, *MK XXII Helicopter EGPWS Pilot Guide*, Rev. C (March 2004), with TSB annotations indicating estimated area of recovery of this flight)
