**AVIATION INVESTIGATION REPORT  
A15W0087**

**MID-AIR COLLISION  
BETWEEN  
W.M.K. HOLDINGS LTD. (DBA MCMURRAY AVIATION),  
CESSNA 172P, C-GJSE  
AND  
CESSNA A185E, C-FAXO  
FORT MCMURRAY, ALBERTA, 21 NM NE  
21 JUNE 2015**

## Aviation Investigation Report A15W0087

### **Mid-air collision**

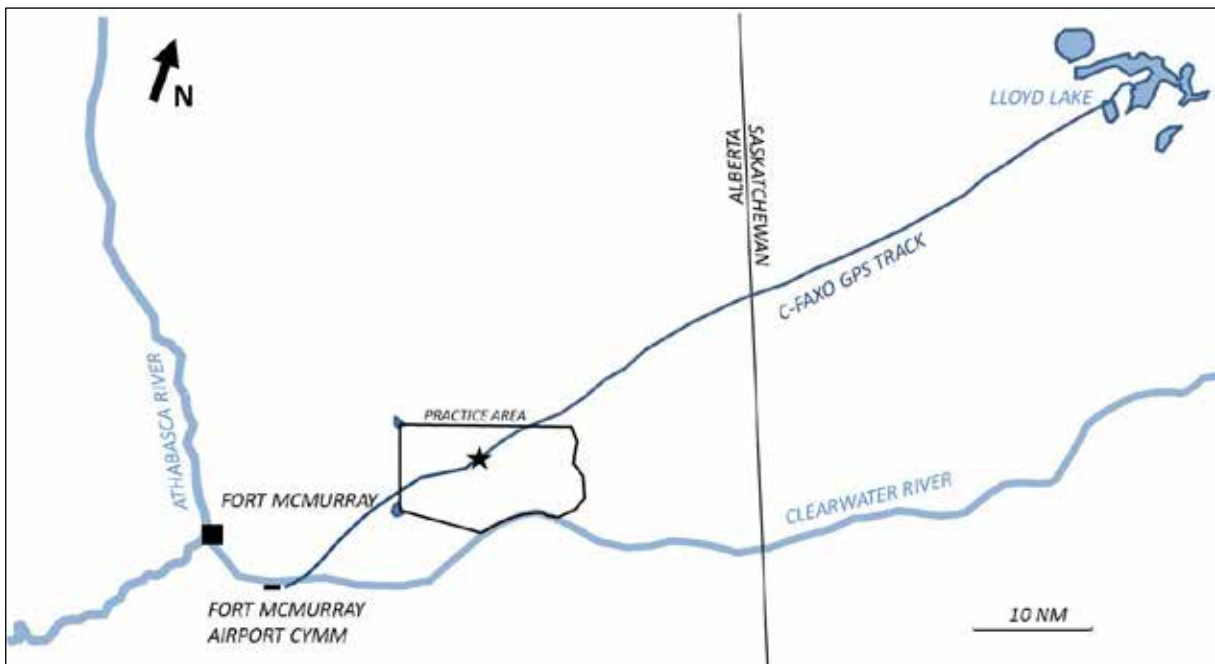
Figure 1. Location of northeast practice area and track of C-FAXO from Lloyd Lake to CYMM (Note: Star symbol denotes the location of the mid-air collision.)

C-FAXO (FAXO) departed Lloyd Lake, Saskatchewan, with only the pilot on board at 1843. Once airborne, FAXO proceeded direct to CYMM, climbing to an altitude of 4400 feet above sea level (asl). A direct route from Lloyd Lake to CYMM is approximately 82 nm. At 1849:11, FAXO appeared on radar 77 nm northeast (045°) from CYMM, climbing through 3600 feet asl with a ground speed of 130 knots. At 1915:21, FAXO entered the northeast corner of the practice area, descending out of 4000 feet asl (Figure 1).

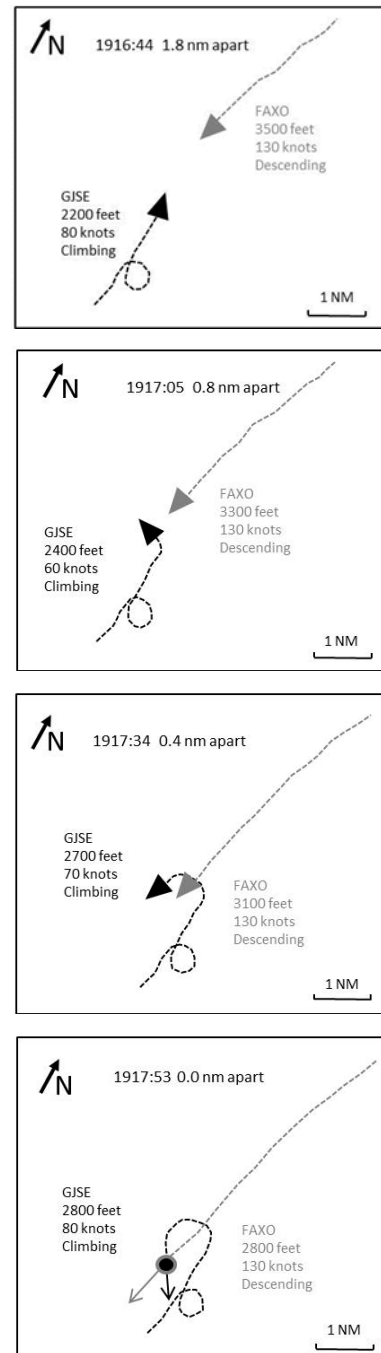
Figure 2. Radar data showing the positions of FAXO and GJSE in the practice area before the collision

At 1916:44, GJSE was 1.8 nm from FAXO, climbing through 2200 feet asl at 80 knots (Figure 2). At 1917:05, GJSE turned left and crossed in front of FAXO at a distance of 0.8 nm. At 1917:34, FAXO made contact with CYMM tower, and was assigned a transponder code. At the time of that communication, GJSE momentarily paralleled FAXO's track in a southwesterly direction, as the aircraft continued in a gradual left-hand turn. FAXO's ground speed was greater, and the aircraft was overtaking GJSE. At 1917:42, the CYMM tower controller advised the pilot of FAXO that there was a Cessna 172 in the area. At 1917:53, the 2 aircraft collided. GJSE broke up in flight due to collision forces and fell to the ground. Both of GJSE's occupants were fatally injured.

There were 3 opportunities during the occurrence flight when the instructor, who was sitting in the right seat, might have seen the approaching aircraft. The first was at 1916:44, when C-GJSE (GJSE) was travelling northeast on a reciprocal heading to C-FAXO (FAXO), offset 0.5 nautical miles (nm) to the right. At that time, FAXO was more than 1.8 nm away, below an overcast layer of cloud. Since GJSE was at a lower altitude, the instructor would have had to look up to see FAXO. FAXO, being predominantly white against a white and grey overcast sky, would have been difficult to see due to contour interaction. Also, at that approach angle, FAXO would have appeared as a relatively stationary and extremely small object in GJSE's windscreen. This would have made it difficult for the instructor to detect FAXO unless actively scanning for the traffic.

The second was at 1917:05, when GJSE turned left across the path of FAXO. Since the instructor likely had no idea that there was another aircraft in the general vicinity, it is likely that the instructor's attention was in the direction of the turn, not 90 degrees to the right.

The third was at 1917:34, while GJSE was heading southwest on a parallel track to FAXO, 0.37 nm to the right and 200 feet lower. FAXO was overtaking GJSE from behind by 60 knots. Given that GJSE is a high-wing aircraft, its left wing likely blocked the instructor's view of the approaching aircraft. This blockage of the instructor's vision would have likely continued during the left climbing turn in front of FAXO until the collision at 1917:53.

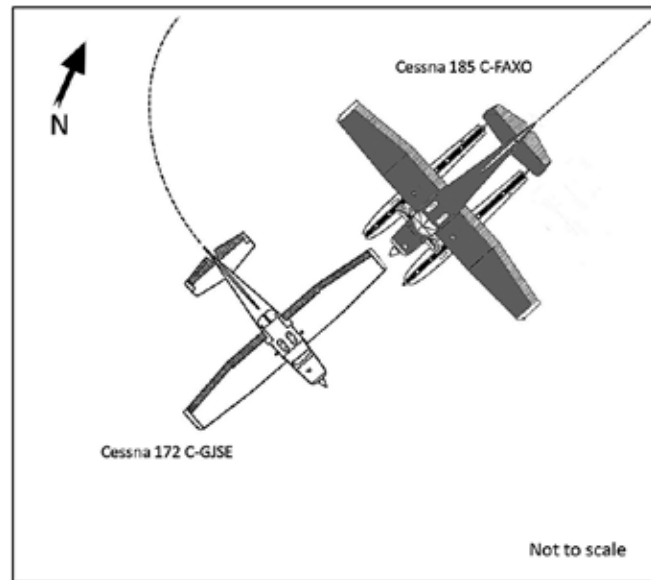
**Figure 3. Collision angle between C-FAXO and C-GJSE**  
(Note: Aircraft images are close approximations of the actual aircraft.)

Scratch marks, impact damage, and paint transfers observed on the wreckage are consistent with the floats of FAXO coming into contact with and separating the left wing of GJSE, followed by the cabin, empennage, and right wing. During the collision sequence, the left wingtip fuel tank extension and left float of FAXO separated; they were found in the debris field of GJSE. There were no other indications of collision on the fuselage, empennage, or wings of FAXO.

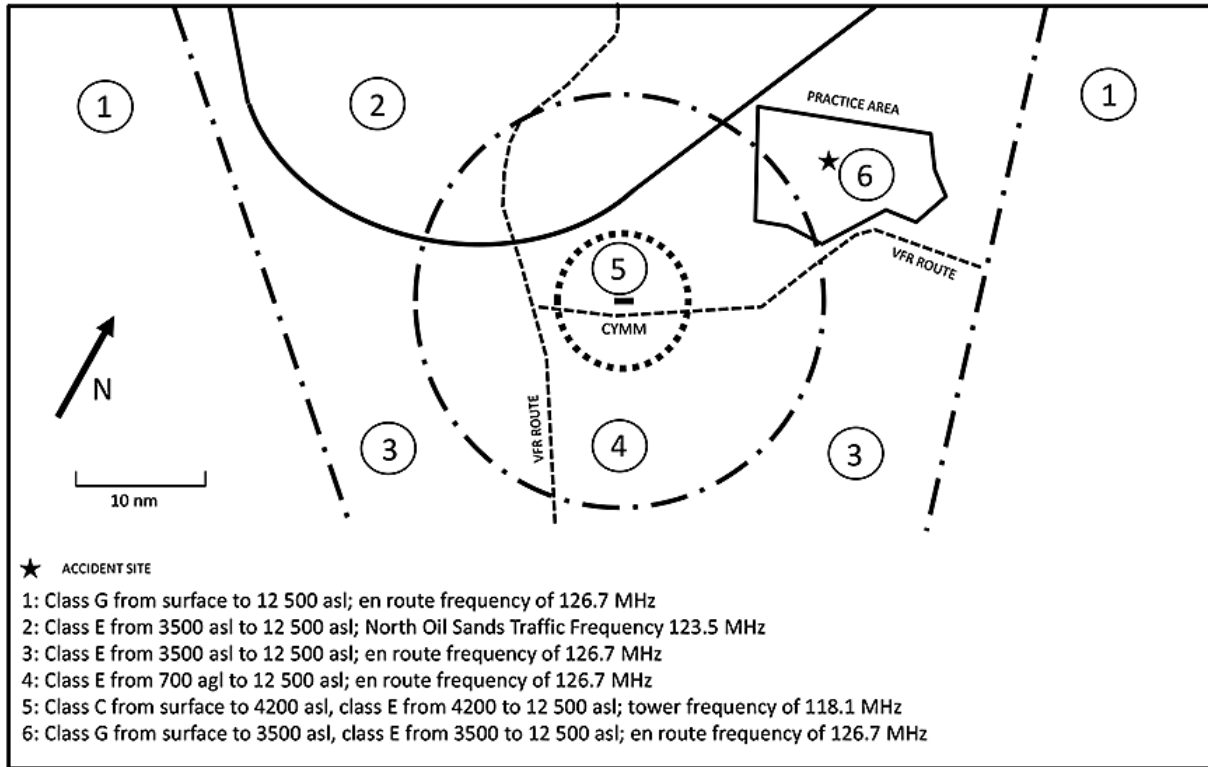
Figure 4. Map depicting airspace classification, altitude blocks, and radio frequencies around CYMM (Note: The star is the approximate location of the mid-air collision.)

The collision happened in Class G uncontrolled airspace at 2800 feet asl. This uncontrolled airspace lies underneath a Class E control area extension based at 3500 feet asl. A Class E terminal area (controlled airspace) surrounds CYMM from 700 feet agl up to 12 500 feet asl (Figure 4). The *Aeronautical Information Manual* (AIM) states:
