Air Transportation Safety Investigation Brief A16P0230

TEMPORARY DIFFICULTY WITH AIRCRAFT CONTROL

Blackcomb Helicopters LP
Aérospatiale AS355N, C-FELE
Squamish, British Columbia
30 December 2016

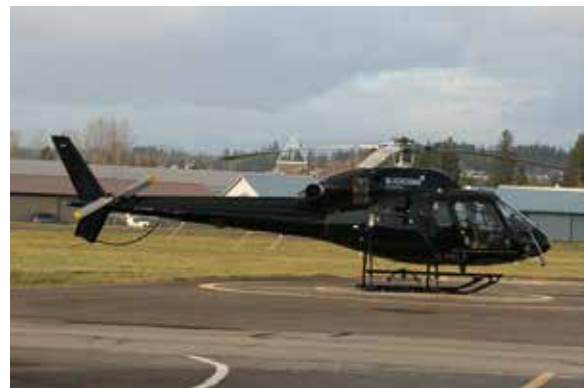
Figure 1. C-FELE (Source: Vernon Harvey)

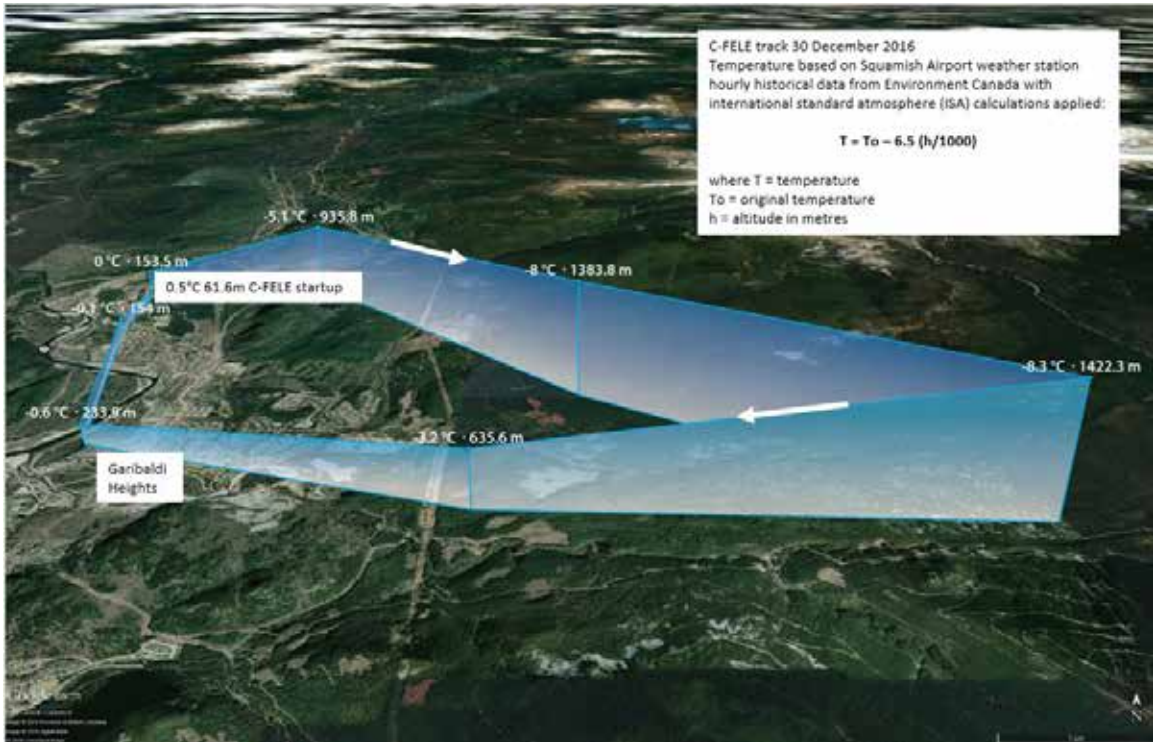
Figure 2 shows the flight path of the occurrence flight and the changes in elevation and temperature during the flight.

Figure 2. Depiction of C-FELE's flight path based on satellite tracking data, showing changes in elevation and temperature during the flight
