AIR TRANSPORTATION SAFETY INVESTIGATION REPORT A17O0264

COLLISION WITH TERRAIN

Hydro One Networks Inc.
Airbus Helicopters AS 350 B2 (helicopter), C-GOHS
Tweed, Ontario, 8 NM NNE
14 December 2017

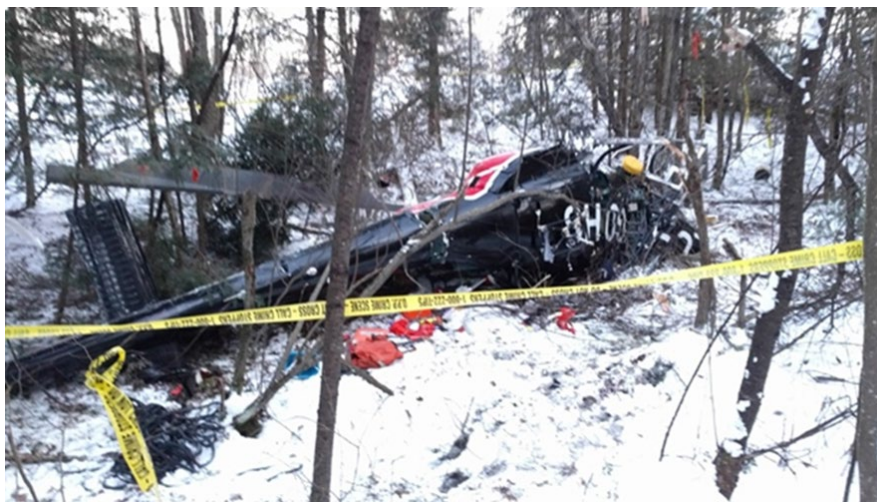
Figure 2. Main wreckage site (Source: TSB)

The loss of the tail rotor and vertical fin resulted in the helicopter becoming uncontrollable, and during its uncontrolled rapid descent it struck nearby trees and then the ground. The helicopter was destroyed during the accident sequence (Figure 2).

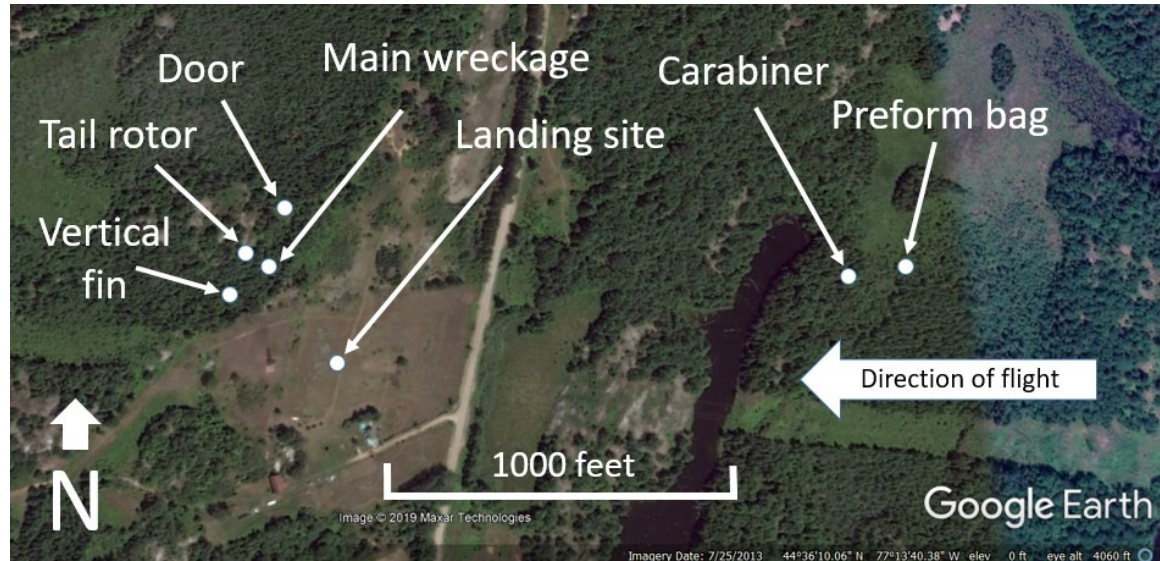
Figure 4. Wreckage area (Source: Google Earth, with TSB annotations)

The helicopter crashed in a forested area approximately 400 feet northwest of the intended landing site (Figure 4). The tail rotor gearbox was found 67 feet north-northwest of the main wreckage site with the tail rotor blades attached, and the vertical fin was found 144 feet southwest of the main accident site with the end of the tail boom still attached.

A broken carabiner with part of a preform bag attached was found about 1900 feet east of the accident site. The rest of the preform bag was found about 310 feet further to the east.

One tail rotor blade was missing approximately 10.75 inches of the outer portion, including the blade balance weights. Although most of the outer portion of the blade was recovered, the tip and balance weights were not. There were signs of damage, likely caused by the carabiner striking it, on the leading edge of the tail rotor blade where the outer portion of the blade had fractured.

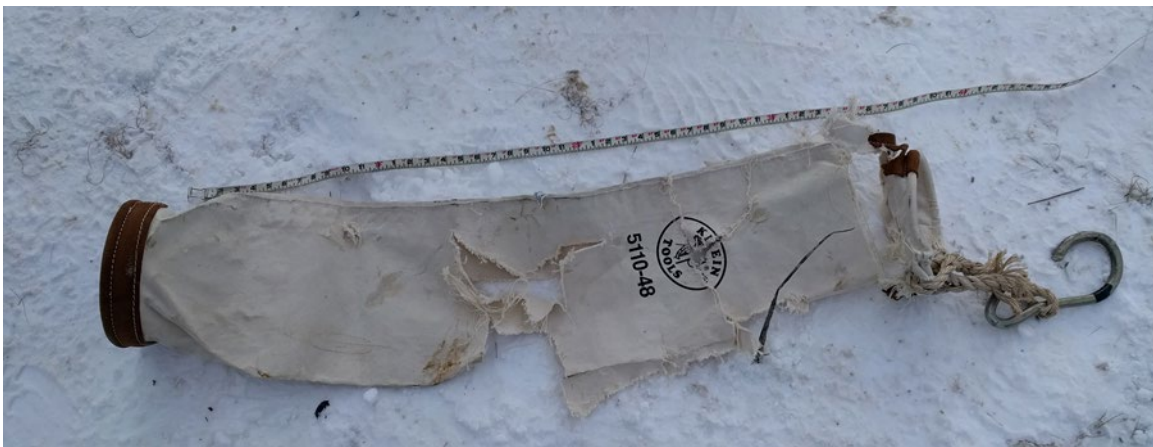
Figure 5. Preform bag at the accident site (Source: TSB)

The preform bag, which was used to carry line maintenance supplies, was approximately 43 inches long, tube-shaped and made of a light canvas-type material. The bottom of the bag was made of black plastic, and the top and bottom edges of the bag were reinforced with leather (Figure 5). The top of the bag had 2 loops made of a polypropylene-type rope attached to each side of the bag as handles. One of the loops had detached from the bag and was missing.

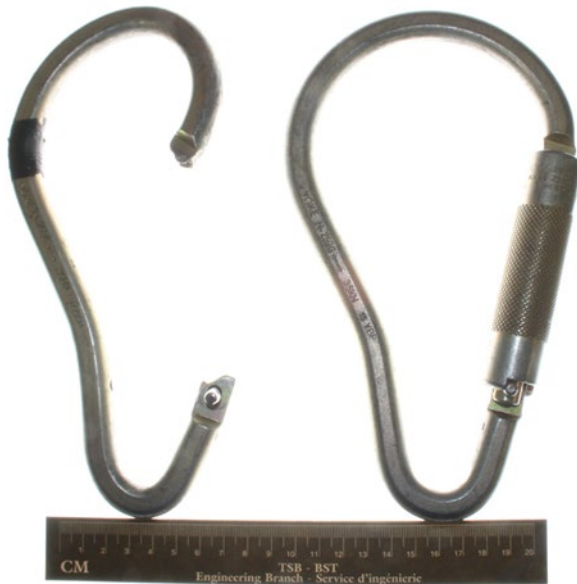
Figure 6. View of the accident carabiner (left) and an exemplar unit (right) (Source: TSB)

Attached to the rope handles of the preform bag was a large carabiner, approximately 8.5 inches long, that was designed to have a large load-carrying capability. All that remained

of the carabiner was the frame; the top portion was bent, and the gate, which had a twist-lock-type locking sleeve, was fractured and missing (Figure 6).

During the flight, a preform bag with an attached carabiner that had been on the Air Stair struck the helicopter's tail rotor, causing significant damage, severe imbalance, and intense vibration. There was no damage to the Air Stair that would have allowed an attached carabiner to become loose and, given the post-impact condition and load-carrying capability of the carabiner, it is unlikely that the carabiner had failed.

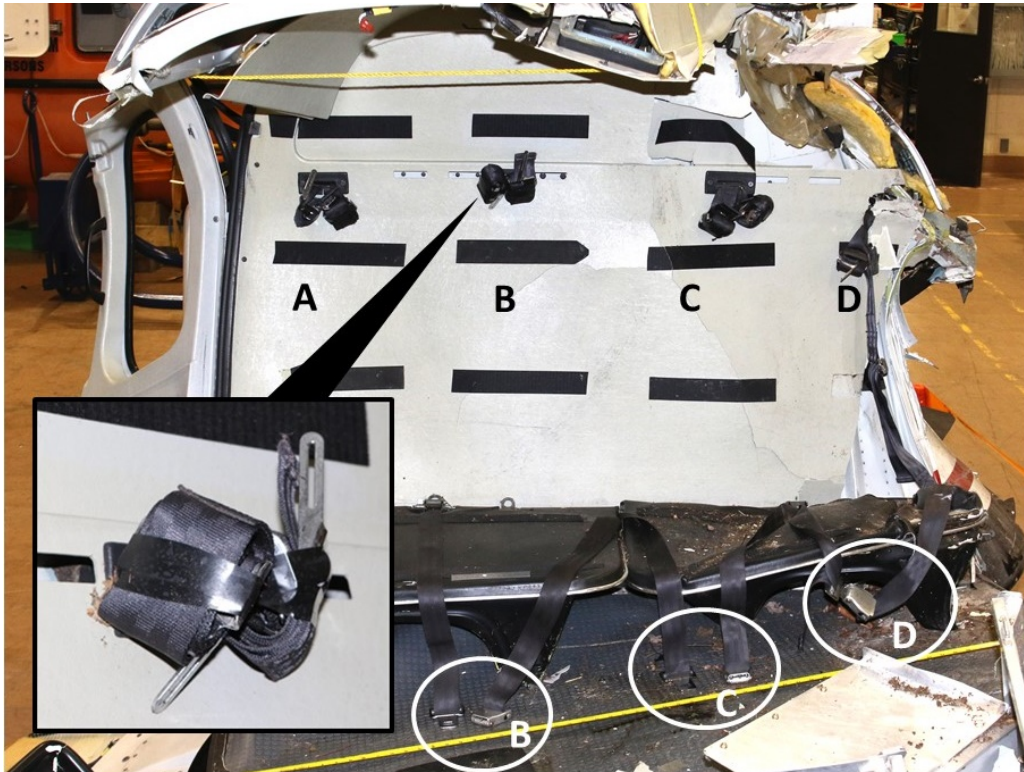
Figure 10. The rear bench safety belt system of the occurrence helicopter, with inset image showing how the shoulder harnesses were rolled up and taped (Source: TSB)

- The lap strap at seat A had been removed by Hydro One for operational reasons.
- The straps, buckles, and latches of the other 3 lap straps (seats B, C, and D) were in good condition.
- The lap straps at seats B and C were unlatched and adjusted to full length.

- The buckle of the lap strap at seat D was fastened and adjusted to approximately 80% of its full length.
- There were no signs that the lap strap buckle assemblies at seats B and C had been forced apart.
- The shoulder harnesses at all seats were rolled up and taped with black electrical tape in their retracted positions, which rendered them inaccessible.
