AVIATION INVESTIGATION REPORT

A17W0172

Loss of control and collision with terrain

Piper PA-34-200T Seneca II, C-GCCM

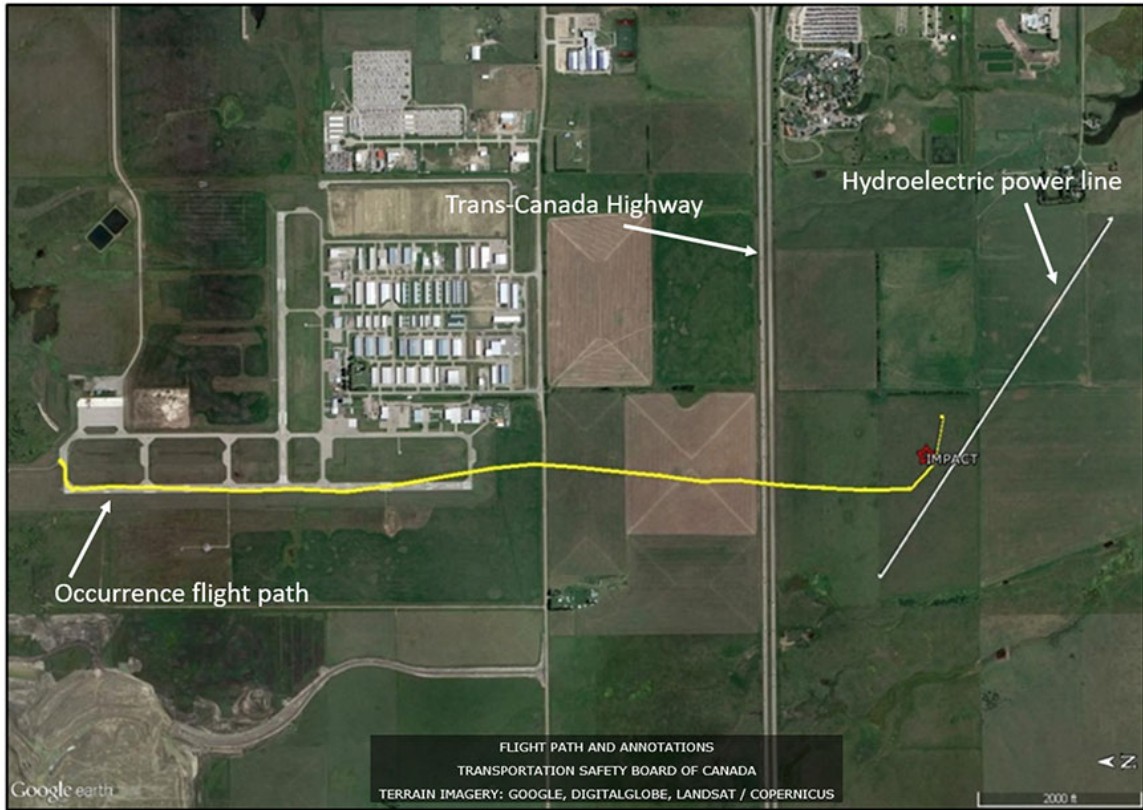
The aircraft then entered a tight descending and rolling left turn approximately 300 feet north of hydroelectric power lines that were running in an east-west direction. The estimated airspeed dropped to about 65 KCAS when the aircraft was at an altitude of about 100 feet AGL (Figure 1 and Figure 2).

Figure 1. Overhead depiction of the occurrence aircraft's flight path based on NAV CANADA wide-area multilateration data (Terrain imagery sources: Google Earth, DigitalGlobe, and Landsat/Copernicus, with TSB annotations)

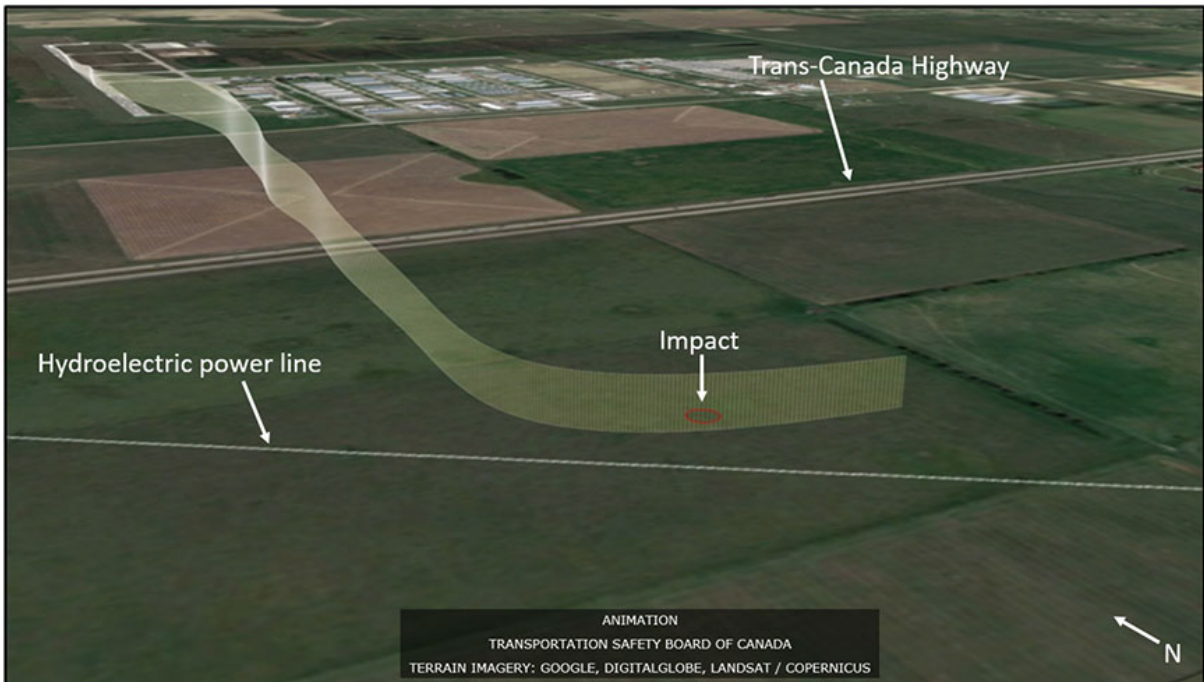
Figure 2. Screen capture of the occurrence aircraft's flight path based on a TSB Engineering Laboratory animation of smoothed wide-area multilateration data—view to the northeast (Terrain imagery sources: Google, DigitalGlobe, and Landsat / Copernicus, with TSB annotations)

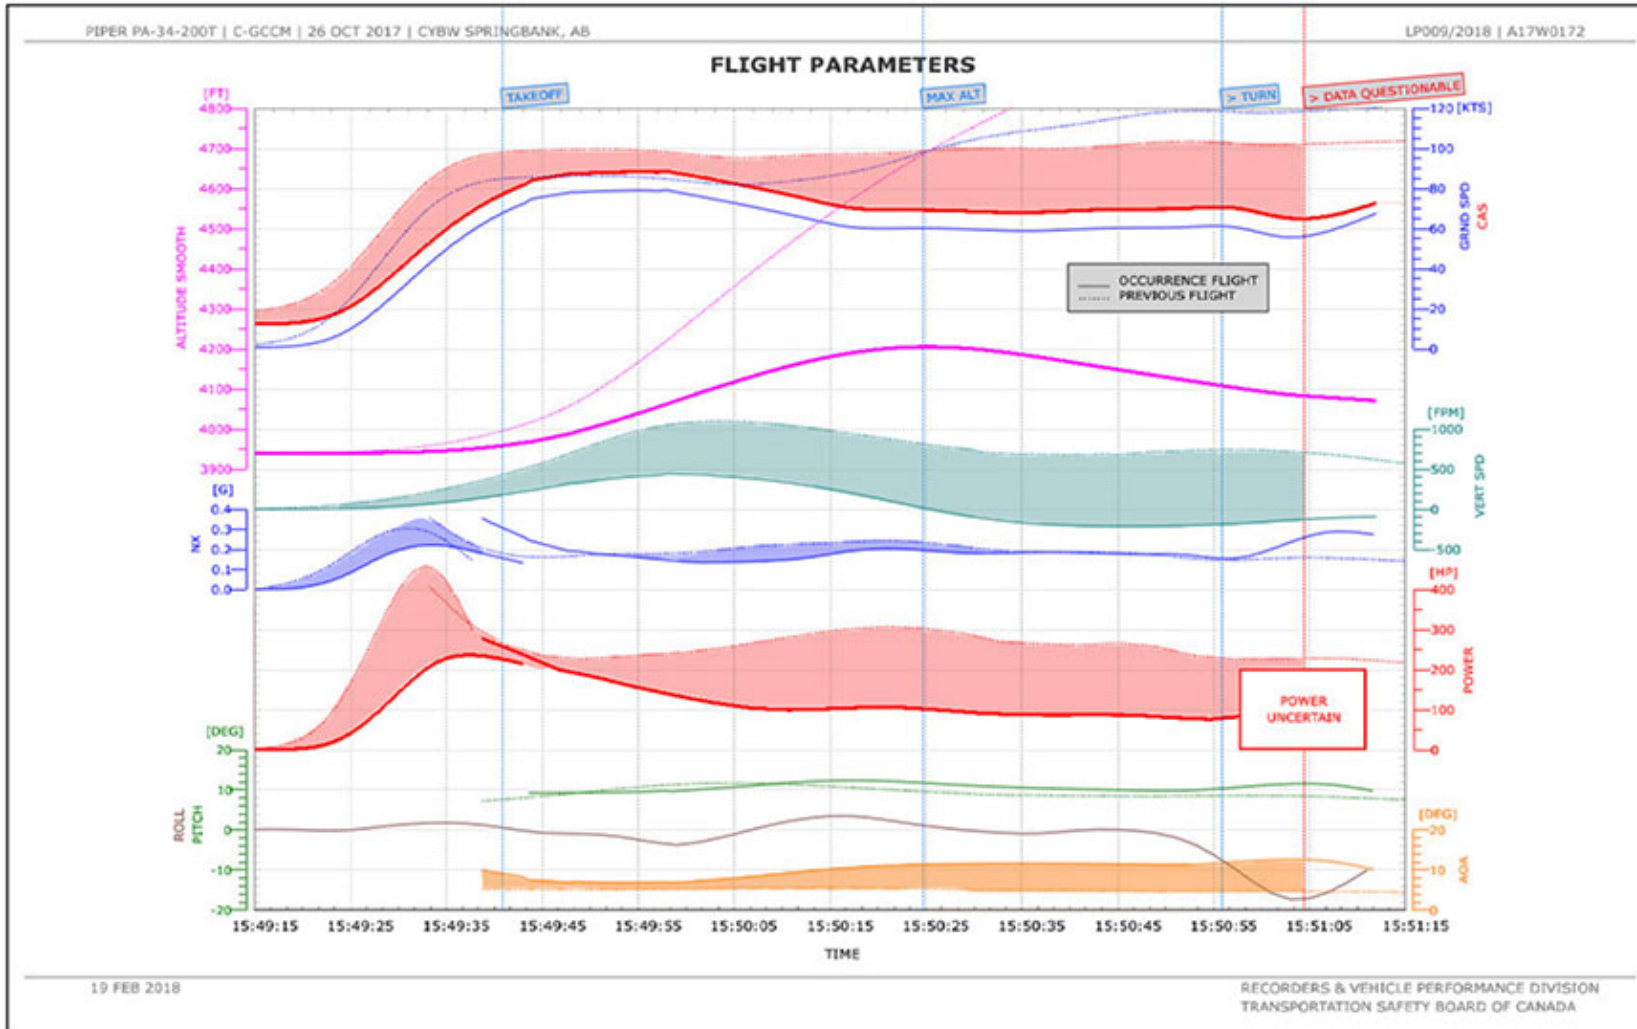
Appendix A – Comparison of flight data

The lack of climb performance and reduction in airspeed are consistent with maximum continuous power not being set on the operating engine. Springbank Air Training College's normal take-off procedure uses a reduced power setting of 35 inches of manifold pressure, and, shortly after landing gear is selected up and a climb is established, power is further reduced to 31.5 inches of manifold pressure. If an engine failure occurs or is simulated at this time, power would have to be increased on the operating engine to 40 inches of manifold pressure to obtain a positive rate of climb and to maintain V_{YSE} .

Comparison of estimated flight parameters for the occurrence aircraft based on wide-area multilateration data. The occurrence flight is depicted by a solid line and the previous flight by a dotted line; the difference between the 2 is the tinted area.
