# Air Transportation Safety Investigation Report A18W0111

## COLLISION WITH OBSTACLE ON TAKEOFF

Piper PA-28-161 Warrior II, C-GVZJ  
Black Diamond, Alberta  
29 July 2018

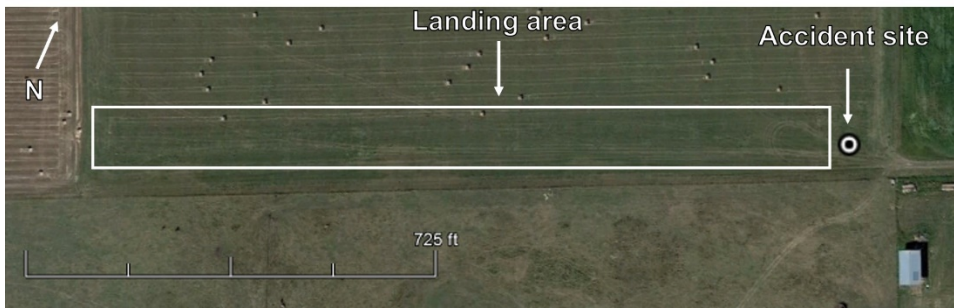
**Figure 1. View of hay field and landing area (Source: Google Earth, with TSB annotations)**

At approximately 1300<sup>1</sup> on 29 July 2018, the Piper PA-28-161 Warrior II aircraft (registration C-GVZJ, serial number 28-8316092) departed from Claresholm Industrial Airport (CEJ4), Alberta, on a visual flight rules flight with 2 people on board, both of whom were licensed pilots. The aircraft was bound for a mixed-hay field approximately 2 nautical miles (nm) east of Black Diamond, Alberta. At approximately 1330, the aircraft landed along the southern edge of the hay field, which was normally used as the landing area.<sup>2</sup> The aircraft occupants proceeded to work in the field for the rest of the afternoon. At 1900, they prepared to depart for the return trip to Claresholm. At approximately 1915, the take-off run was conducted heading east, beginning from the southwest corner of the field (Figure 1).

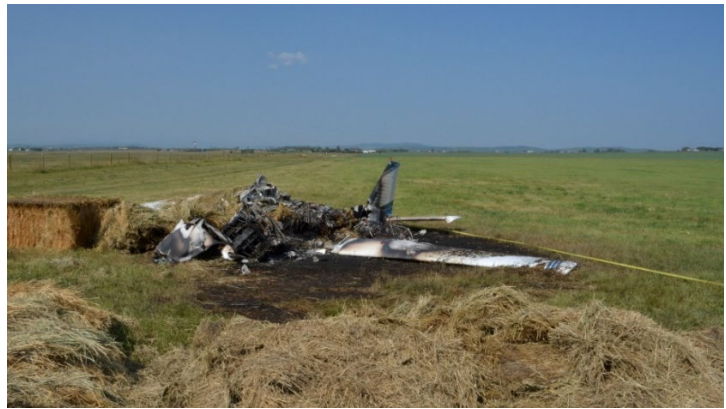
**Figure 2. Accident site, looking west**

The aircraft failed to climb sufficiently to clear some hay bales that had been stacked in the southeast corner of the field, and struck them. The left-wing fuel tank ruptured on impact, and the resulting post-impact fire destroyed the aircraft (Figure 2).

The aircraft was examined at the accident site. The left-wing fuel tank was found ruptured. The right-wing fuel tank was found intact and still containing approximately 10 U.S. gallons of avgas. The flap handle was found in the flaps-retracted position. Because the aircraft had been almost completely destroyed by the crash and post-impact fire, it could not be determined whether any pre-impact failure or system malfunction contributed to this accident. The aircraft systems were examined to the degree possible, and no indication of a malfunction was found.

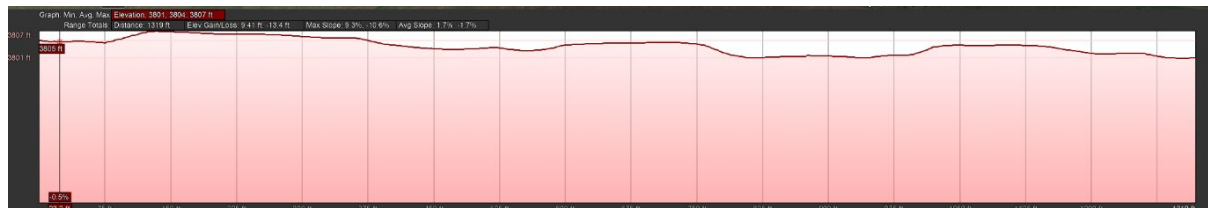
Figure 3. Elevation variations on the landing area (Source: Google Earth)

The accident occurred in the southeast corner of a mixed-hay field located approximately 2 nm east of the town of Black Diamond. The rectangular field—approximately 2350 feet long and 1440 feet wide—is at an elevation of approximately 3820 feet ASL. The long side of the field is oriented in a north-south direction. The southern edge of the field was used as the landing area, and the elevation there varied between 3801 feet ASL and 3807 feet ASL (Figure 3).
