AIR TRANSPORTATION SAFETY INVESTIGATION REPORT A19C0038

Fuel exhaustion

Keewatin Air LP
Beechcraft B200, C-FRMV
Gillam, Manitoba
24 April 2019

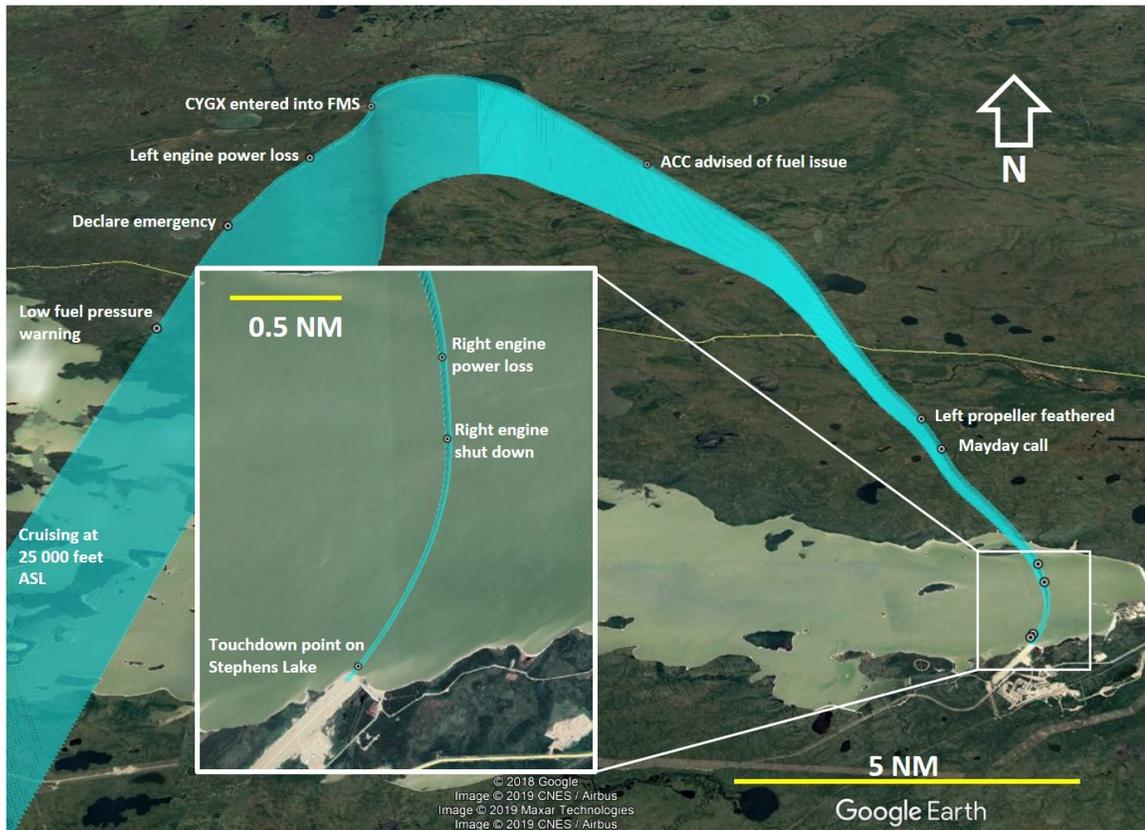
At 1813, when the aircraft was about 14 NM west-northwest of CYGX and still level at FL 250, the left fuel pressure (L FUEL PRESS) warning light illuminated, indicating low fuel. The warning was followed almost immediately by power surging in the left engine. The captain turned the boost pump ON, and noticed that the fuel quantity indicators were showing 0 pounds. The captain asked the FO about the fuel quantity, at which point the FO realized that he had forgotten to order fuel. The flight crew declared an emergency with the Winnipeg Area Control Centre (ACC) at 1814 and began an emergency descent. The weather conditions at CYYQ were marginal, so the decision was made to divert to the alternate aerodrome, CYGX; however, the aircraft continued on the same heading toward CYYQ for another 2 minutes (Figure 1).

Figure 1. Overlay of global positioning system data showing the aircraft's descent profile and key events (Source: Google Earth, with TSB annotations)

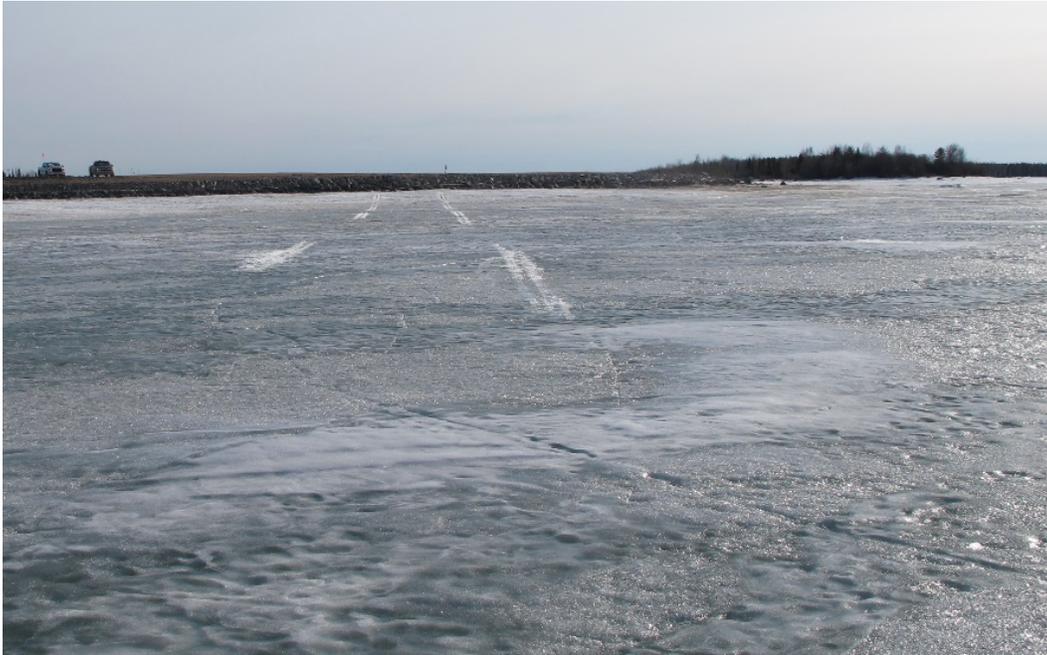
The flaps remained up throughout the approach and subsequent landing. The crew selected the landing gear DOWN when the aircraft was at about 50 feet AGL and the aircraft touched down on the frozen surface of Stephens Lake with the landing gear fully extended (Figure 2).

Figure 2. Marks made by the main landing gear on initial touchdown (Source: TSB)

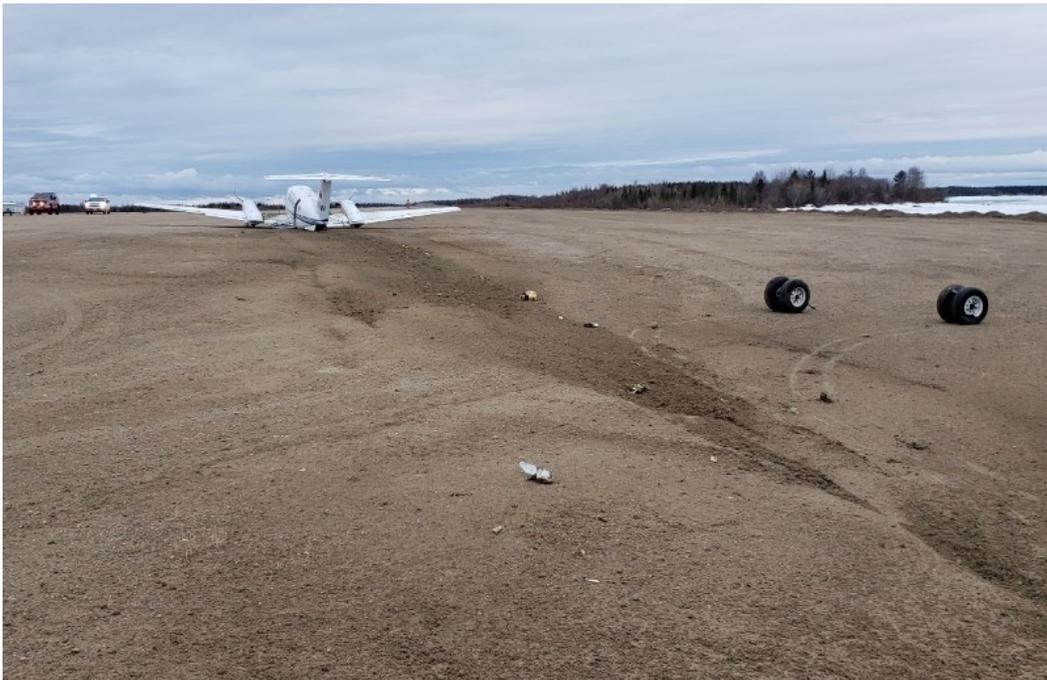
Sufficient airspeed remained to enable the FO to raise the nose as the aircraft approached the rocky shoreline at the approach end of Runway 23. The aircraft struck the rocky shoreline in a nose-high attitude and skidded up onto the right edge of the runway area, coming to rest approximately 190 feet before the threshold (Figure 3).

Figure 3. The occurrence aircraft near the threshold of Runway 23 (Source: Royal Canadian Mounted Police)

The aircraft struck the frozen surface of Stephens Lake with the landing gear fully extended and the flaps retracted. On contact with a rocky berm, the lower portions of both main landing gear legs were torn away, damaging both nacelles and the lower surfaces of both wings. The main fuel-feed pipes in both nacelles were severed when the main landing gear trunnion attachments failed. However, there was no fuel spillage.

The nose landing gear remained attached and extended. The fuselage was creased aft of the main cabin door. The underside of the fuselage was damaged due to contact with the rocky berm. The main wing spar exhibited permanent deflection in the centre section. One propeller was damaged due to contact with the ground.
