AIR TRANSPORTATION SAFETY INVESTIGATION REPORT A19C0138

IN-FLIGHT BREAKUP

Blue Water Aviation
de Havilland DHC-3, C-GBTU
Little Grand Rapids, Manitoba
26 October 2019

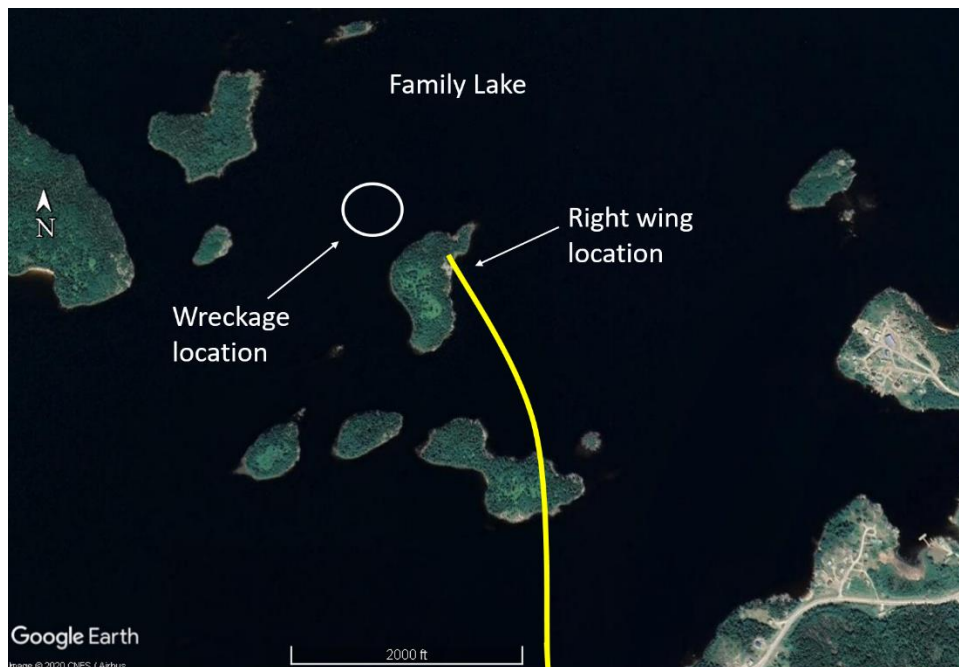
Figure 3. Wreckage site and final flight path (Source: Google Earth, with TSB annotations)

The debris field indicated that the aircraft had struck the water at a steep flight path angle with very little horizontal speed, and that it sank almost immediately after impact with the surface of the water. The right wing was transported to a secure location. There was noticeable damage to the wing lift strut upper attachment.

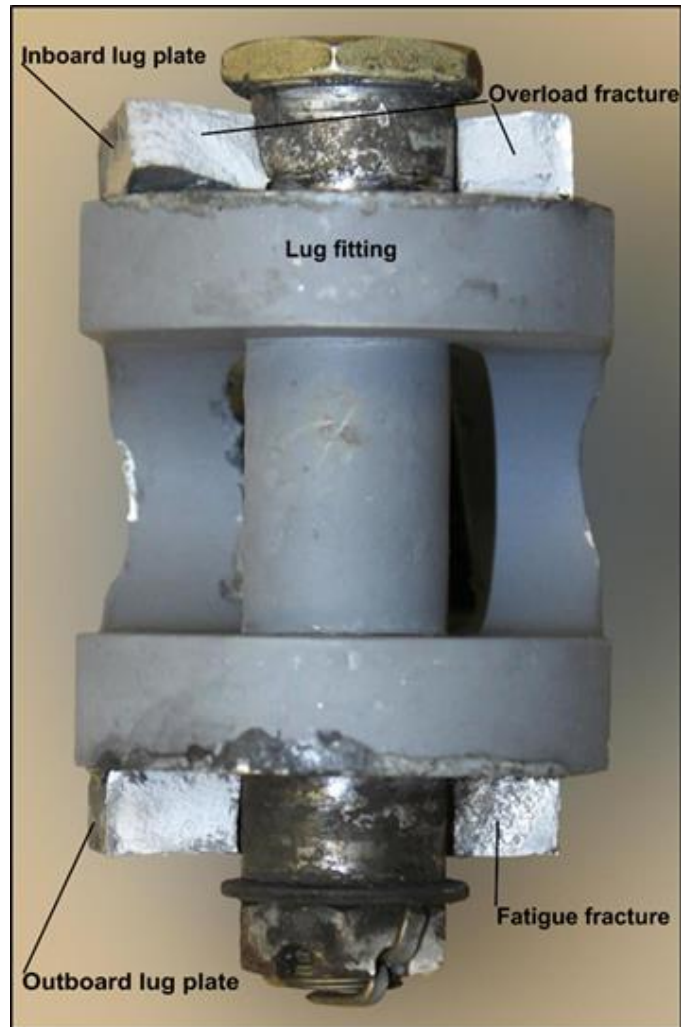
Figure 4. Broken wing lift strut showing fractures (Source: TSB)

inside the bolt hole bore of the right-hand wing lift strut's upper outboard lug plate, at the strut-to-wing attachment end (Figure 4). A slight fatigue crack was also noted on the opposite (inboard) side of the bolt hole bore (Figure 5). The TSB Engineering Laboratory's examination indicated that the bore surface was rather rough with circumferential and some longitudinal scoring, though nothing particular was observed on the bore near the fatigue origin.

The fatigue fracture originated in the bolt hole bore of the right-hand wing lift strut's upper outboard lug plate, and eventually led to an overstress fracture of the right-hand wing lift strut's upper outboard and inboard lug plates during the left turn prior to the final approach.

In response to this occurrence, Blue Water Aviation has removed the complete wing lift strut assemblies on 2 of the aircraft that it operates, and on 4 for which it provides contract maintenance. All have been replaced with new or overhauled wing lift strut assemblies.

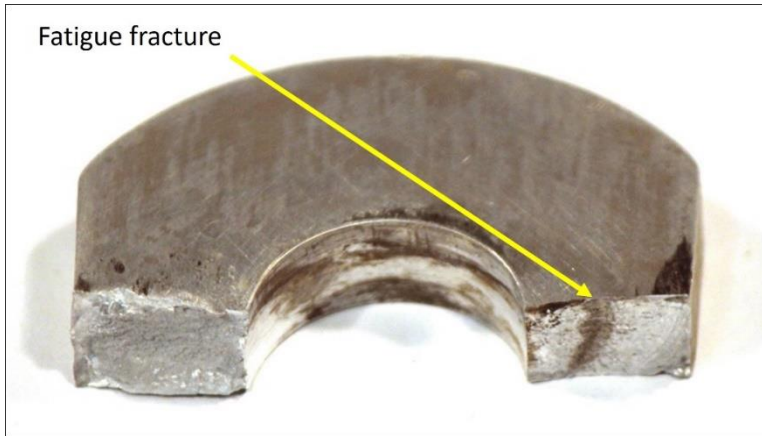
Figure 5. Fatigue fracture on the inboard side of the bolt hole bore of the right-hand wing lift strut's upper outboard lug plate (Source: TSB)

Surface imperfections, such as scratches, nicks, or corrosion, are known to act as a stress riser for fatigue initiation. It could not be determined what had initiated the fatigue fracture.

Laboratory analysis revealed that a fatigue fracture in the right-hand wing lift strut's upper outboard lug plate initiated the failure of the wing lift strut assembly, which, at the time of the occurrence, had 8747 hours remaining in its service life. The exact cause of fatigue initiation could not be determined; however, the most likely fatigue origin location would have been a surface imperfection, such as a scratch or nick.
