Air Transportation Safety Investigation Report A1900103

WHEELS-DOWN WATER LANDING

Privately registered
Cessna A185E (on amphibious floats), C-GBUI
Upper Raft Lake, Ontario
04 August 2019

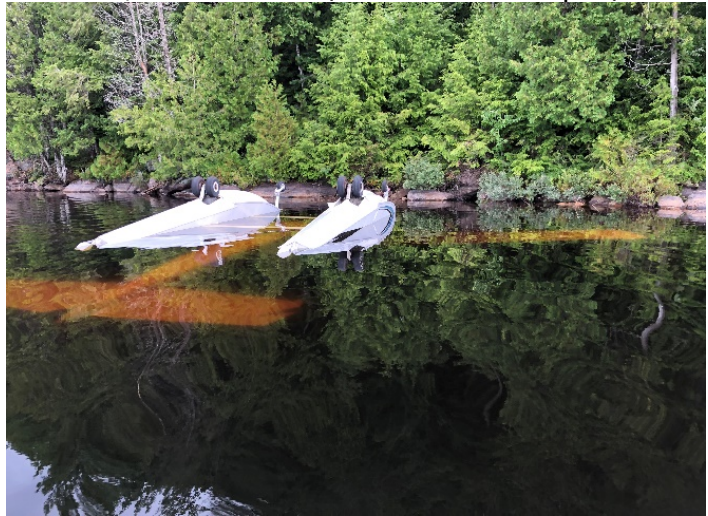
The aircraft touched down on the surface of the water with the wheels down, causing it to flip over; the aircraft came to rest inverted, the floats above the water keeping it afloat (Figure 1).

The aircraft was recovered from Upper Raft Lake 5 days after the occurrence. It had sustained substantial damage. All damage to the airframe was attributable to impact forces when the aircraft flipped over.

Figure 1. The occurrence aircraft found the day after the occurrence, tied to the shore (Source: friend of the pilot)

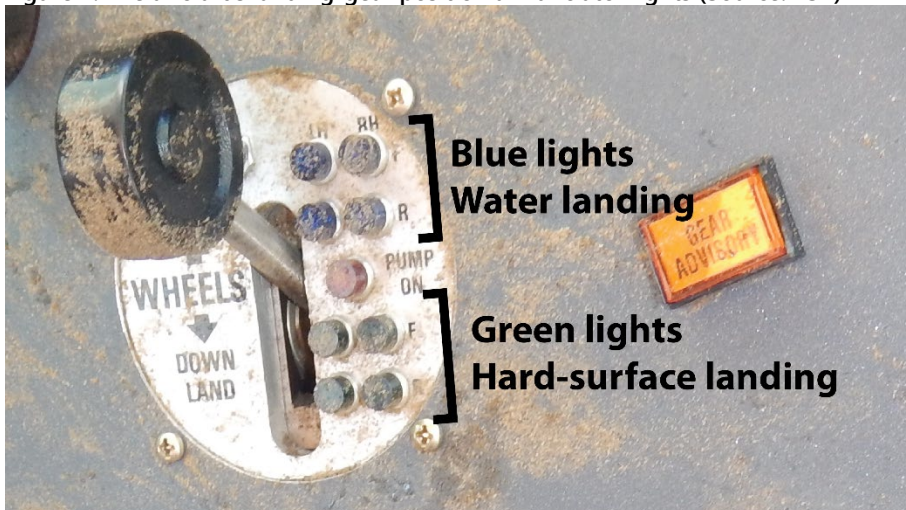
The aircraft was equipped with 8 independent landing-gear position annunciator lights (Figure 2). These lights are split into 2 groups: 4 blue lights for water landing, and 4 green lights for hard-surface landing. Normally, each light, in each colour grouping, is associated with each of the 4 wheels of the landing gear: 2 lights for the nose gear at the top and 2 lights for the main gear below. When the landing gear is up, the blue lights illuminate; when the landing gear is down, the green lights illuminate.

Figure 2. The aircraft's landing-gear position annunciator lights (Source: TSB)
