Air Transportation Safety Investigation Report A19W0052

ENGINE POWER LOSS AND FORCED LANDING

Buffalo Airways Ltd.
Douglas DC3C-S1C3G, C-GJKM
Hay River/Merlyn Carter Airport, Northwest Territories
03 May 2019

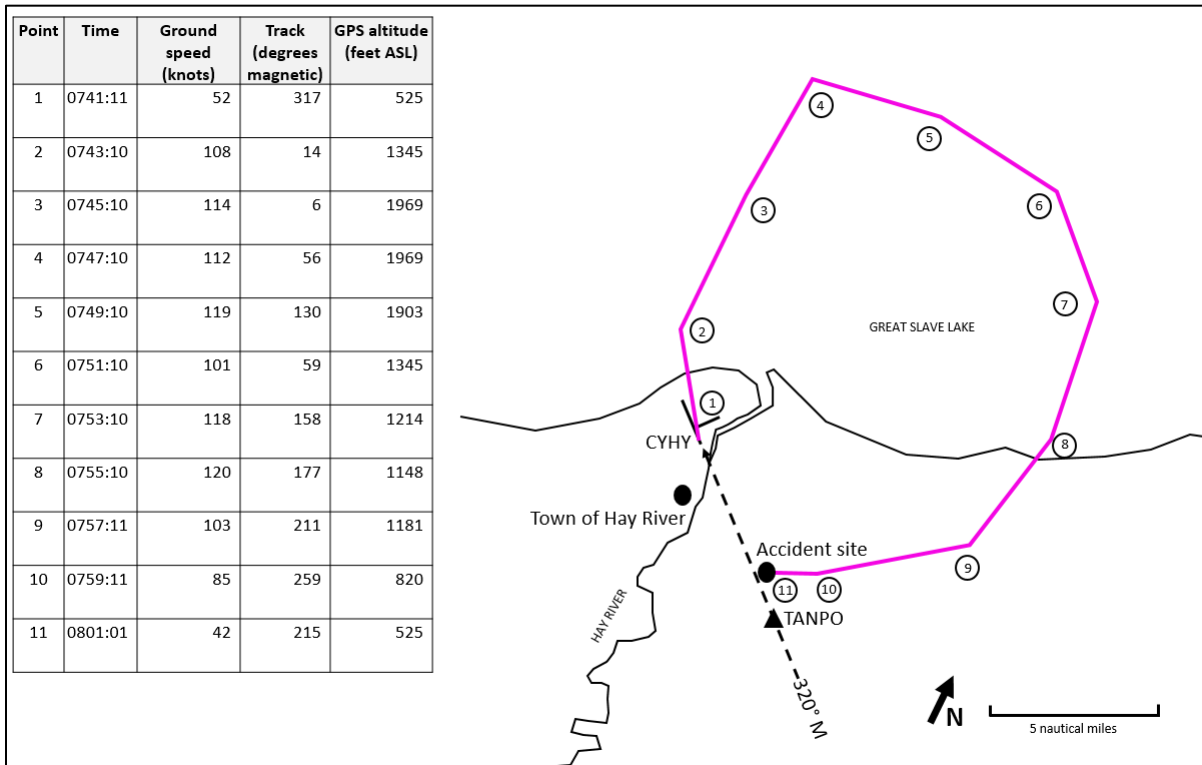
Figure 1. Satellite tracking information retrieved from the occurrence flight. The magenta line is the aircraft's track. (Source: TSB, based on data received from Latitude Technologies Corporation)

As the aircraft reached an altitude of 1969 feet ASL (Figure 1, point 3), the captain set the left engine to a reduced power setting and increased the power on the right engine to maximum except takeoff (METO)⁵ power. The flight crew began to set up for an instrument landing system approach to CYHY via TANPO.⁶

At 0747 (Figure 1, point 4), while the aircraft was in a right turn proceeding towards TANPO, smoke and oil were observed, and abnormal sounds were heard coming from the left engine. Using the engine failure checklist, the flight crew then shut down the left engine and feathered the propeller.

At 0753 (Figure 1, point 7), the aircraft levelled off at 1214 feet ASL. The FO observed zero hydraulic pressure on the landing gear DOWN gauge.⁸ Thinking this zero pressure was an issue, he mentioned it to the captain, who then directed the FO to “prep the gear.” The FO extended the landing gear, which the captain did not expect because the aircraft had not started its final approach and the airport had not been visually acquired.

At 0755 (Figure 1, point 8), as the aircraft continued towards TANPO, the altitude was between 1200 and 1300 feet ASL, and the airspeed was maintained at approximately 100 knots indicated airspeed (KIAS). When the aircraft was abeam TANPO, the captain began a right turn to intercept the localizer for the final approach. The aircraft’s airspeed decreased from 100 KIAS to 80 KIAS, while its altitude decreased to 1100 feet ASL. With the reduced airspeed, the aircraft’s flight control response became sluggish and the captain directed the landing gear to be raised (Figure 1, point 9).

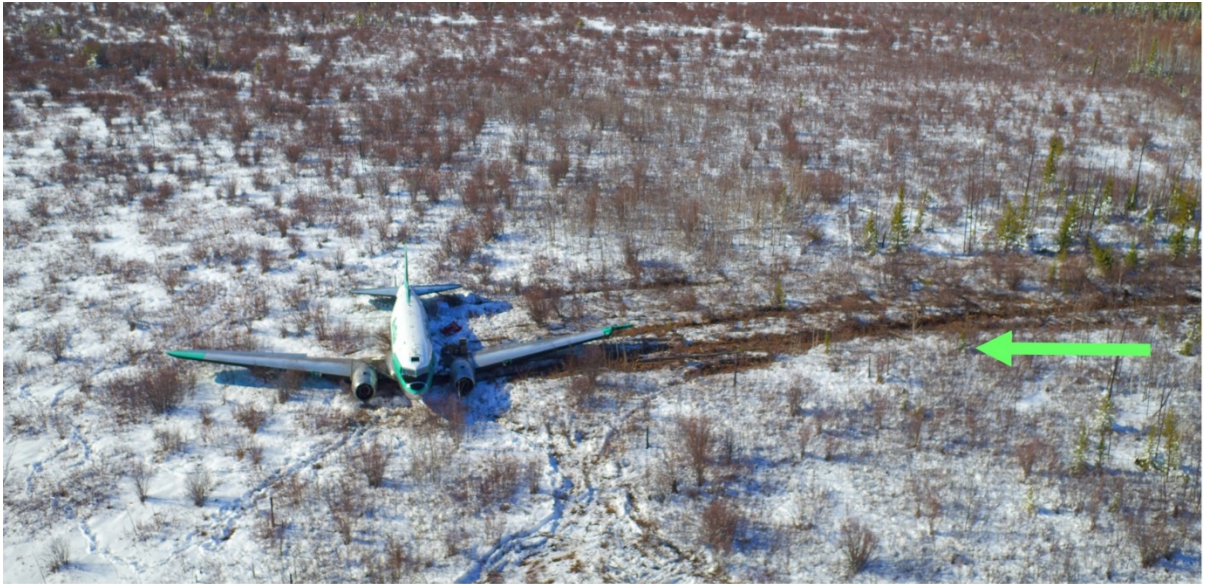
At 0801, the aircraft landed in muskeg on K’at’Odeèche First Nation land, approximately 3.5 nautical miles southeast of CYHY. After the aircraft came to a stop, the FO exited the aircraft through the right-hand crew window, while the captain remained in the cockpit to secure the right engine and aircraft systems before evacuating via the forward door. The FO contacted the flight information centre to notify them of the crew’s status and aircraft location. The emergency locator transmitter had not activated during the forced landing, so the FO activated it manually to assist search and rescue in locating the aircraft. The flight crew was uninjured. The aircraft received substantial damage (Figure 2). There was no post-impact fire. First responders arrived at the accident site at 1114.

Figure 2. Aerial photo of the accident site looking northwest. The green arrow indicates the aircraft's path on touchdown. (Source: K'atl'Odeeché First Nation, with TSB annotation)
