## **AIR TRANSPORTATION SAFETY INVESTIGATION REPORT A19W0105**

### **CONTROLLED FLIGHT INTO TERRAIN**

Alkan Air Ltd.  
Cessna 208B Grand Caravan, C-FSKF  
Mayo, Yukon, 25 NM ENE  
06 August 2019

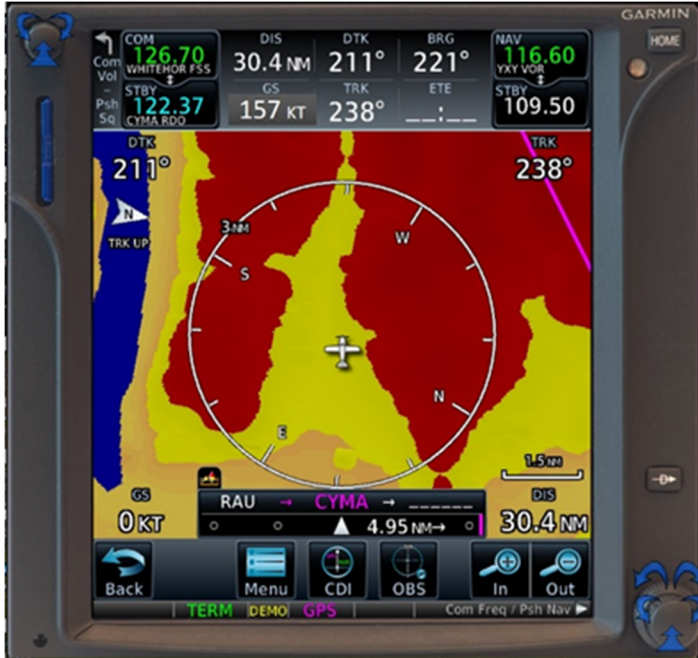
Figure 1. GTN 750 simulator display of terrain depiction based on GPS data entering Granite Creek at 4000 feet ASL. Magenta line is direct track between Rau Strip and CYMA (Source: Garmin, with TSB annotations)

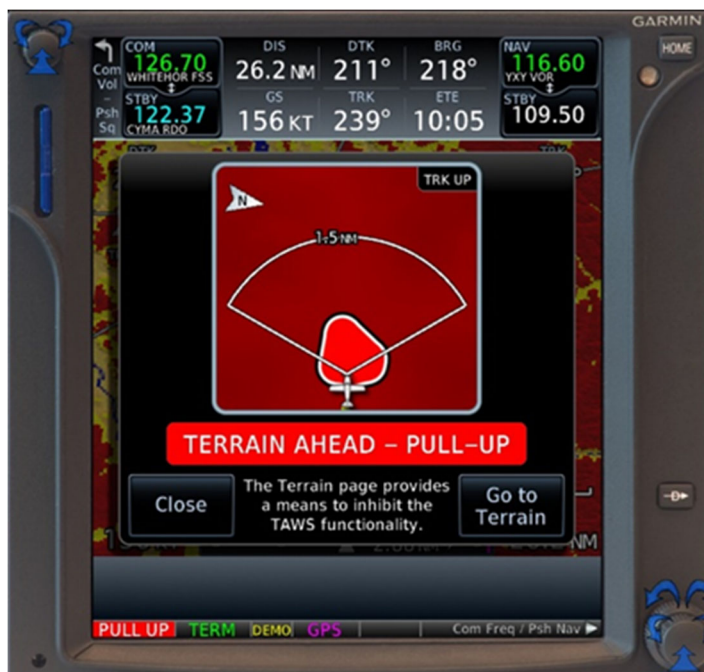
the aircraft or less than 100 feet below the aircraft's GPS altitude. This is accompanied by a visual annunciation of PULL-UP and an aural message of "terrain ahead, pull up; terrain ahead, pull up" (Figure 2).

Figure 2. GTN 750 simulator display of terrain warning based on GPS data about 90 seconds before impact at 4000 feet ASL  
(Source: Garmin, with TSB annotations)

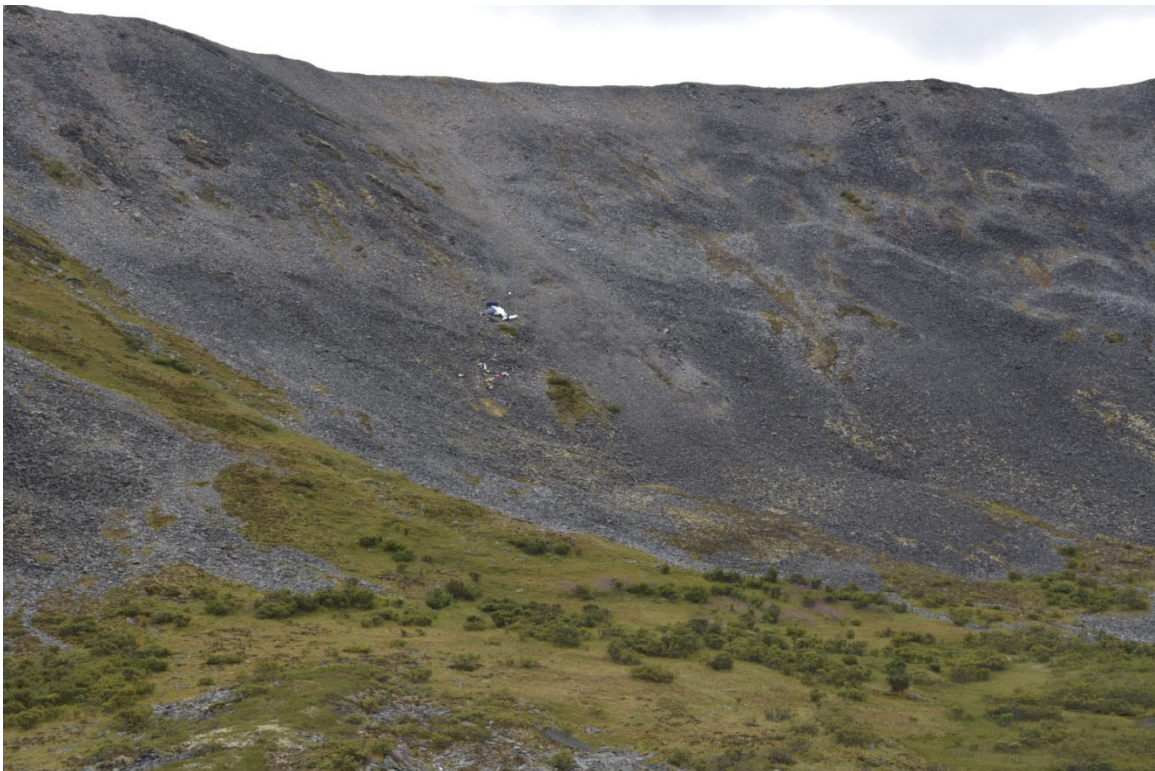
Both wings partially detached from the fuselage and the left elevator separated from the horizontal stabilizer. The engine separated from the firewall and all 4 propeller blades were broken free from the propeller hub. There were signs of a small post-impact fire on the outboard portion of the left wing.

The wreckage was located on a rocky mountain slope on a bearing of 340° true (T), 25 NM from CYMA. The aircraft had impacted a 30–40° rocky slope in a slightly nose-up, wings-level attitude at moderate speed, causing the wings to detach and destroying the aircraft. The wreckage trail was approximately 300 feet long, oriented on a heading of 180° magnetic (M) (Figure 3).

Figure 3. Aircraft wreckage, looking south (Source: TSB)

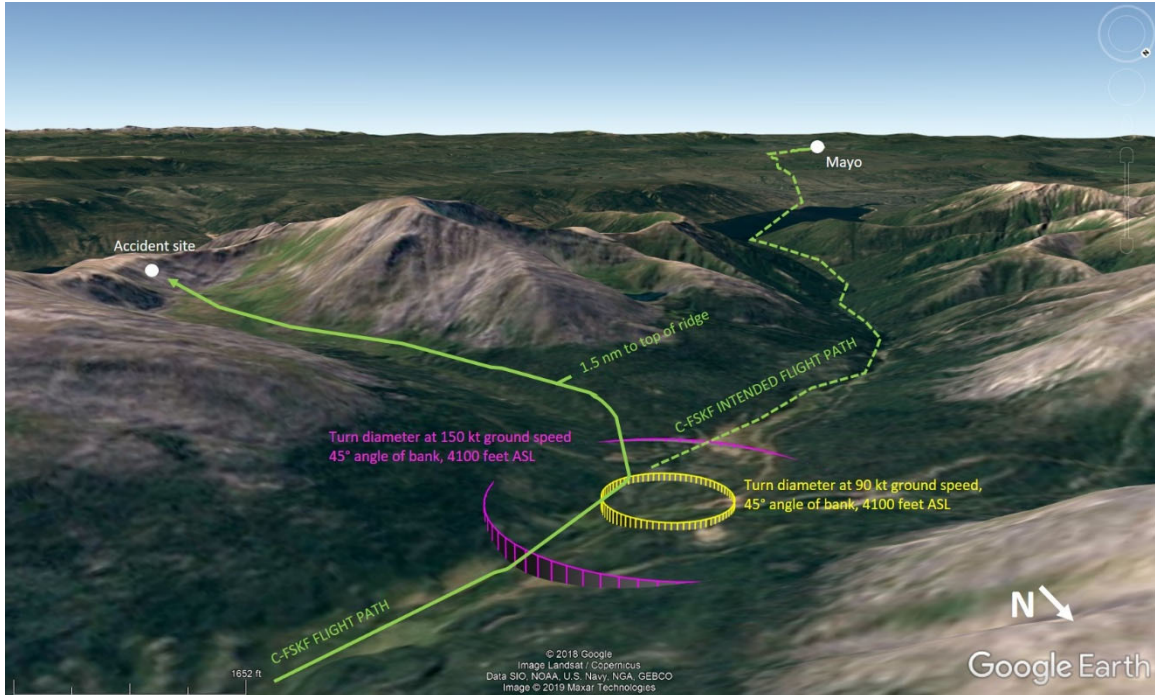
At a constant ground speed of 90 knots, an aircraft would need a turn diameter of 1441 feet at 45° angle of bank and 15 seconds to complete the course reversal (Figure 4).

Figure 4. Comparison of turn diameters at various ground speeds in Granite Creek (Source: Google Earth, with TSB annotations)

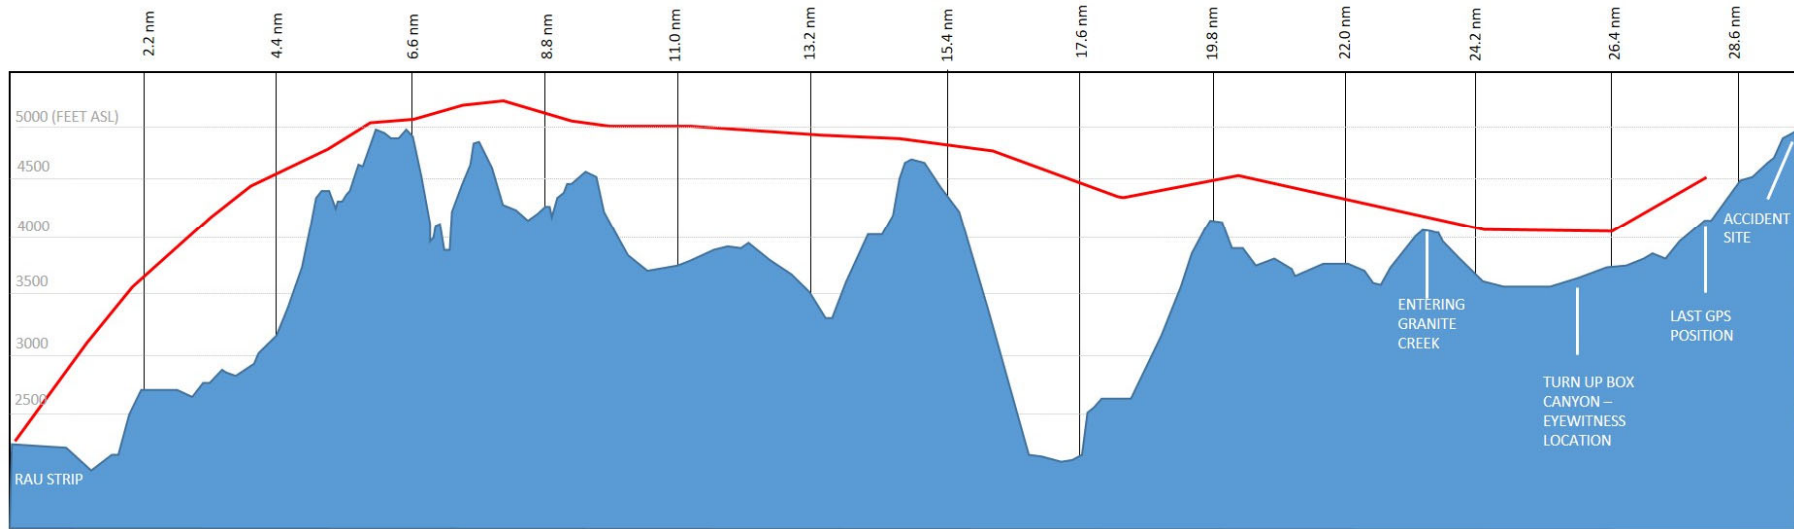
The route of the 4th flight from Rau Strip to CYMA was the reverse of the previous flight. The aircraft entered Granite Creek at 4300 feet ASL and was flying at a ground speed of 156 knots (Appendix B).

### Appendix B – Profile view of accident flight showing GPS altitude (red line) compared to Google Earth terrain elevation
