## **AIR TRANSPORTATION SAFETY INVESTIGATION REPORT A20P0013**

### **RUNWAY EXCURSION**

De Havilland Aircraft of Canada Ltd. DHC-8-402, C-FKWE

Terrace Airport, British Columbia

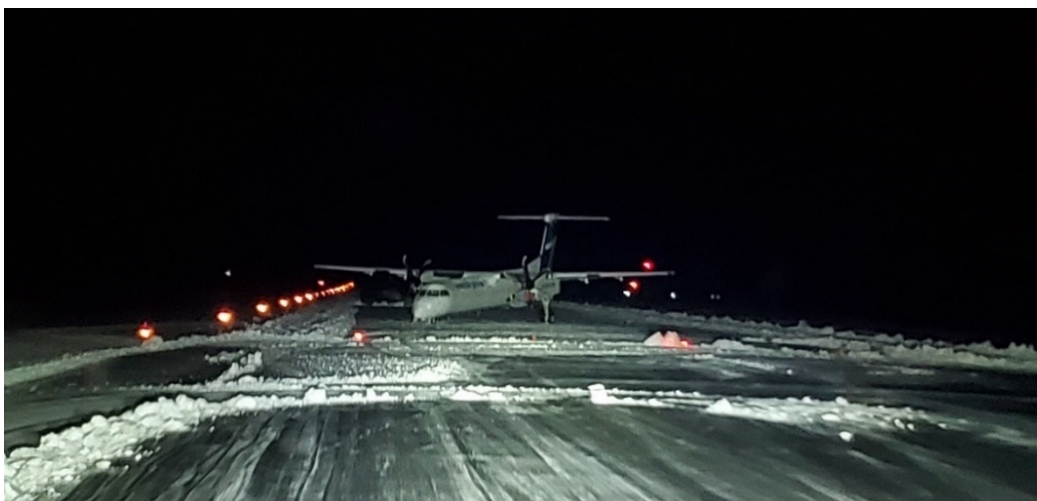
The impact and drag created by the left main landing gear contacting the windrow pulled the aircraft to the left, resulting in the nose and right main landing gear also coming into contact with the windrow. The left main landing wheels proceeded off the runway surface, travelling to the outside of the runway edge lights, while the nose and right main landing wheels remained on the uncleared portion on the runway. The aircraft travelled with the left main landing gear off the runway surface for approximately 400 feet. The captain then manoeuvred the aircraft to the right, and the aircraft travelled back through the windrow and onto the cleared portion of the runway. During the runway excursion, the nose landing gear collapsed rearward. The aircraft came to a stop in the centre of the runway, approximately 3600 feet from the threshold, with the nose facing approximately 30° to the right (Figure 1).

Figure 1. The occurrence aircraft on Runway 33 at Terrace Airport. Image taken approximately 9 hours after the occurrence (Source: Terrace Airport)

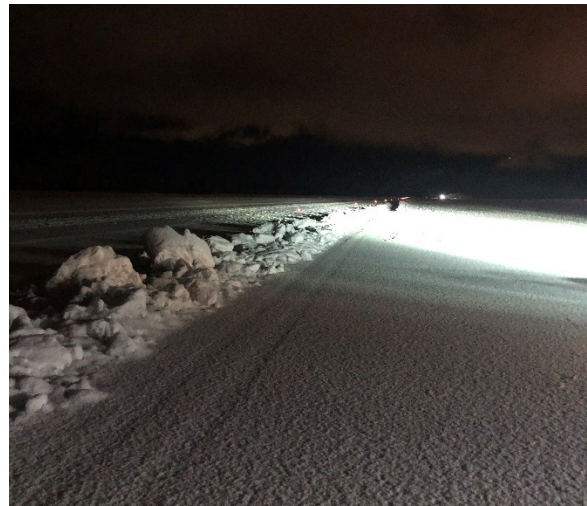
On the day of the occurrence, the airport had been conducting ongoing snow clearing operations involving 3 snow plow trucks with tow-behind sweepers. The priority was to clear an area 130 feet wide, along the centreline for the entire length of Runway 15/33; however, due to the continuous snowfall, only a 100-foot wide area was cleared of snow. The remaining width of the runway was last reported as 11 inches of wet snow. Separating the cleared portion from the remaining width was a windrow approximately 18 inches high. These runway snow clearing operations continued until approximately 10 minutes before the occurrence aircraft landed.

Figure 2. Windrow and occurrence aircraft left main landing gear track along Runway 33. Image taken approximately 5 hours after the occurrence (Source: Terrace Airport)

Airports can report windrows including location and height as part of the RSC (for example, “along cleared width”); however, it is not part of the minimum information to be provided in an RSC report.<sup>28</sup> The airport did not include the windrow in the RSCs in the 3 hours preceding the occurrence and, as a result, the crew was likely unaware of their existence or location.

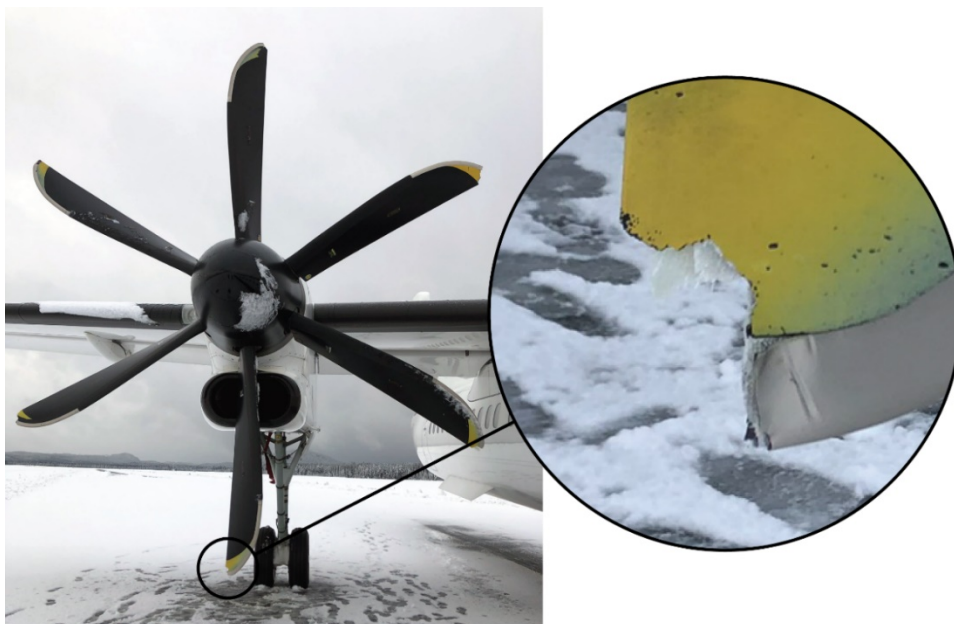
During the excursion through the snow and ice windrows, all 6 blades of the right-hand propeller made contact with a foreign object—likely snow or ice—and the tips of the propeller blades were damaged to varying degrees (Figure 3). The propeller blade debris damaged the right-hand ice shield and underlying fuselage skins in 2 locations on the right side of the fuselage. No piece of the blades penetrated the aircraft cabin.

Figure 3. Right-hand propeller (Source: De Havilland Aircraft of Canada Ltd.)
