Air Transportation Safety Investigation Report A20P0105

PILOT FATALLY INJURED DURING GROUND OPERATIONS

Wilderness Seaplanes Ltd.
de Havilland DHC-2 Mk. I, C-FDSG
Port Hardy Water Aerodrome, British Columbia
07 December 2020

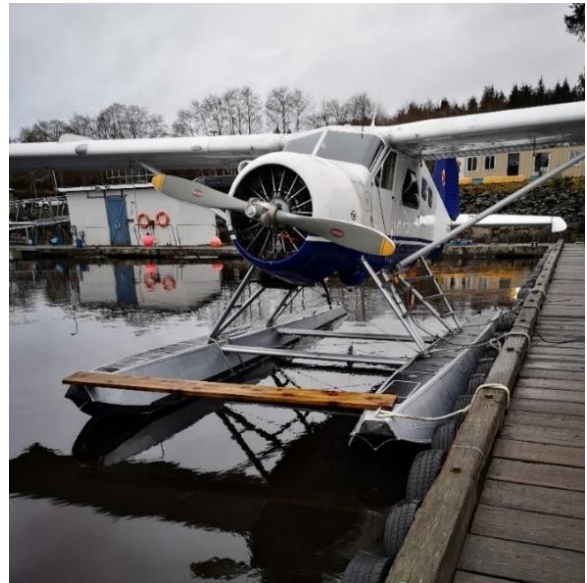
The aircraft was moored on the right side of the dock with a plank spanning the front of the floats (Figure 1).

Figure 1. Photo of the occurrence aircraft at the Port Hardy Water Aerodrome, taken 56 minutes after the occurrence, showing the position of the plank (Source: Royal Canadian Mounted Police)

In this occurrence, the pilot was standing on a plank in front of the aircraft when the propeller was manually rotated with the engine controls configured for start, but the video resolution from the closed-circuit television camera was insufficient to enable the investigation to determine whether the

propeller rotation was intentional (oil scavenging, inspection, or hand propping) or unintentional (pilot bracing due to a loss of footing or falling).

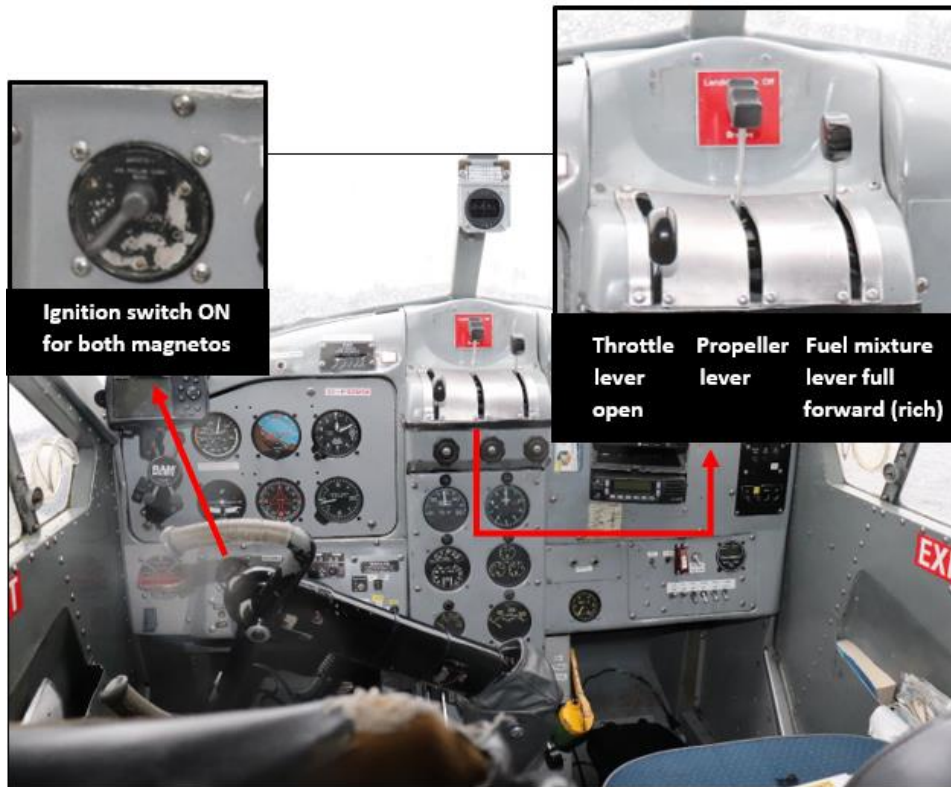
Approximately 45 minutes after the occurrence, the PRM examined the aircraft and found the battery master switch in the OFF position and the aircraft engine controls configured for a normal engine start, as outlined by the airplane flight manual (AFM):⁵ the throttle lever was slightly open, the fuel mixture lever was in the full forward (rich) position,⁶ and the ignition switch was in the ON position for both magnetos (Figure 2). The investigation could not determine the exact time at which the pilot configured the engine controls for start.

Figure 2. Photo, taken 5 hours after the occurrence, showing the aircraft engine control positions as found by the person responsible for maintenance 45 minutes after the occurrence (Source: Royal Canadian Mounted Police, with TSB annotations)

In both cases, the AFM indicates that all switches must be off and the mixture lever must be set to idle cut-off to prevent an unintentional start during propeller rotation. TC's *Flight Training Manual*¹² and *From the Ground Up*¹³ also identify that the aircraft ignition (magneto) switches must be off during any inspection or hand movement of the propeller before starting the engine.
