AIR TRANSPORTATION SAFETY INVESTIGATION REPORT A22C0093

AFT FUSELAGE STRIKE ON LANDING

Perimeter Aviation LP
de Havilland DHC-8-314, C-GJYZ
Sandy Lake Airport, Ontario
19 October 2022

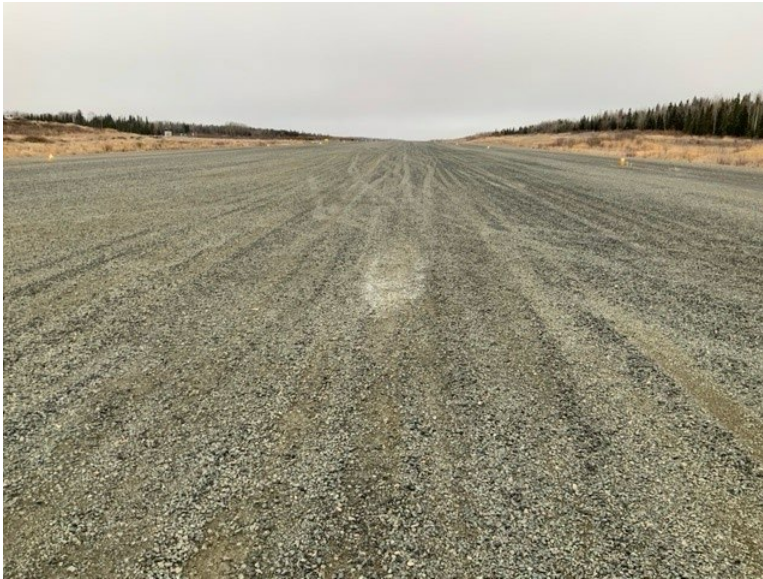
The first marks made by the occurrence aircraft’s main landing gear when it touched down on Runway 29 at CZSJ were approximately 350 feet from the runway threshold. The aft fuselage struck the runway immediately afterward (Figure 2).

Figure 2. Impact mark made by aircraft's fuselage showing the touchdown point on Runway 29 (Source: Sandy Lake Airport)

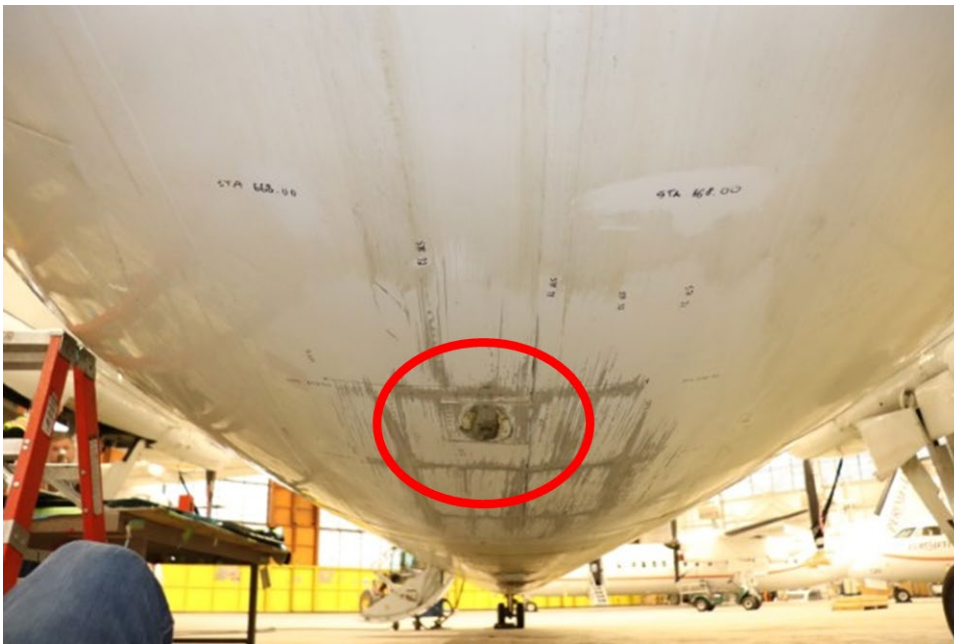
The aircraft sustained substantial damage to the lower aft fuselage structure, which consisted of the deformation of bulkheads and scarred belly skins (Figure 3). In addition, the tail strike switch broke off during the impact.

Figure 3. Exterior view of the occurrence aircraft's rear fuselage, showing the missing tail strike switch (Source: TSB)

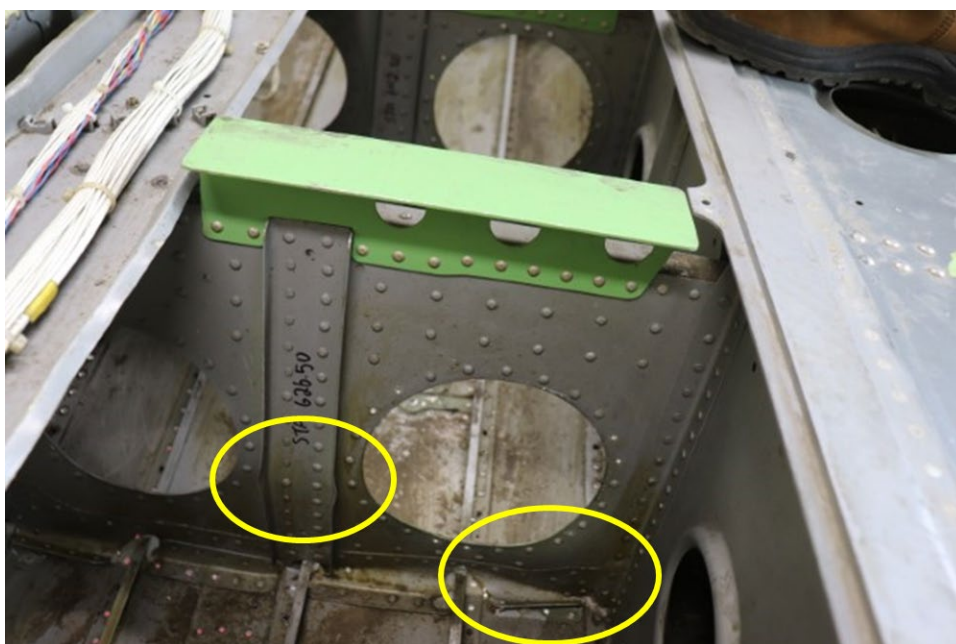
The aircraft underwent a hard landing inspection (level 1 and level 2), resulting in the replacement of all main landing gear load-absorbing components. An inspection of the engines, engine mounts, and nacelles did not reveal any anomalies. The aircraft also sustained interior structural damage. There was buckling of the structural members in the area that impacted the runway (Figure 4).

Figure 4. Interior structural damage (buckling of structural members) beneath the floorboards and above the missing tail strike switch (Source: TSB)

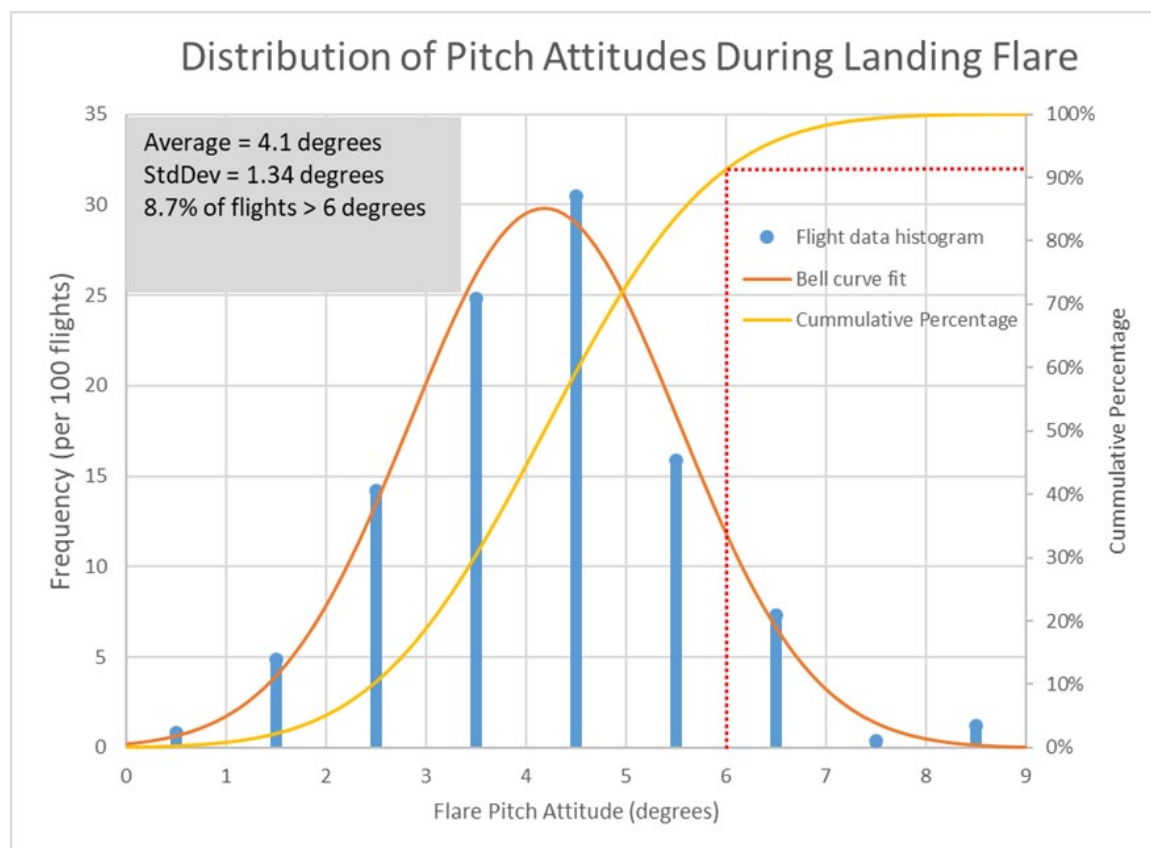
Of particular interest was the peak pitch attitude of the aircraft during landing. Custom algorithms were created by the TSB to scan the flight data to detect the peak pitch attitude during the final moments of the flare and touchdown (Figure 6).

Figure 6. Graph showing pitch attitudes during the landing flare (Source: TSB)

The pitch attitude at which the DHC-8-314 aircraft's aft fuselage contacts the ground ranges from 6.8° to 11.9°, depending on the extent to which the main landing gear is compressed.

The air operator's SOPs state that pitch should not exceed 6° during the landing flare. However, the results from the statistical analysis show that 8.7% of the recorded landings had pitch attitudes exceeding this threshold.
