AVIATION OCCURRENCE REPORT

**LOSS OF TAIL ROTOR AUTHORITY -
TAIL ROTOR DRIVE TRAIN FAILURE**

**CAMPBELL HELICOPTERS LTD.
BELL B205A-1 (HELICOPTER) C-FJTF
EDSON, ALBERTA 48 nm S
24 SEPTEMBER 1993**

REPORT NUMBER A93W0159

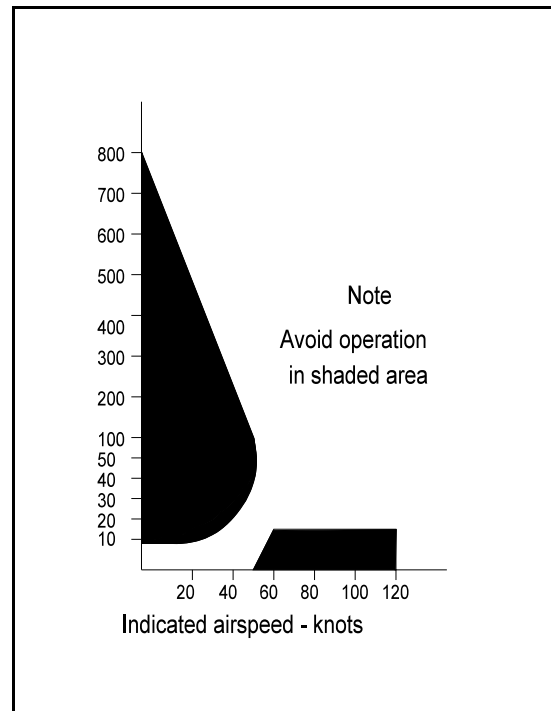
Figure 1
Height/Velocity Curve

The H-V curve is included in the operating limitations section of the approved BHT 205A-1 basic *Flight Manual* (see Figure 1)¹, which directs pilots to avoid operation in the shaded area of the H-V curve. Operating the helicopter at a combination of low height and low speed corresponding to the shaded area of the H-V curve will preclude performing a safe autorotative landing.

Although the helicopter was operated at a low height and low speed combination within the shaded area of the H-V curve, the external load operation was conducted in accordance with the approved *External Load Operation Supplement* to the basic flight manual.
