AVIATION OCCURRENCE REPORT

MISSING AIRCRAFT

**PIPER PA-28-140 C-GXGB
LAKE ONTARIO
24 FEBRUARY 1994**

REPORT NUMBER A94O0056

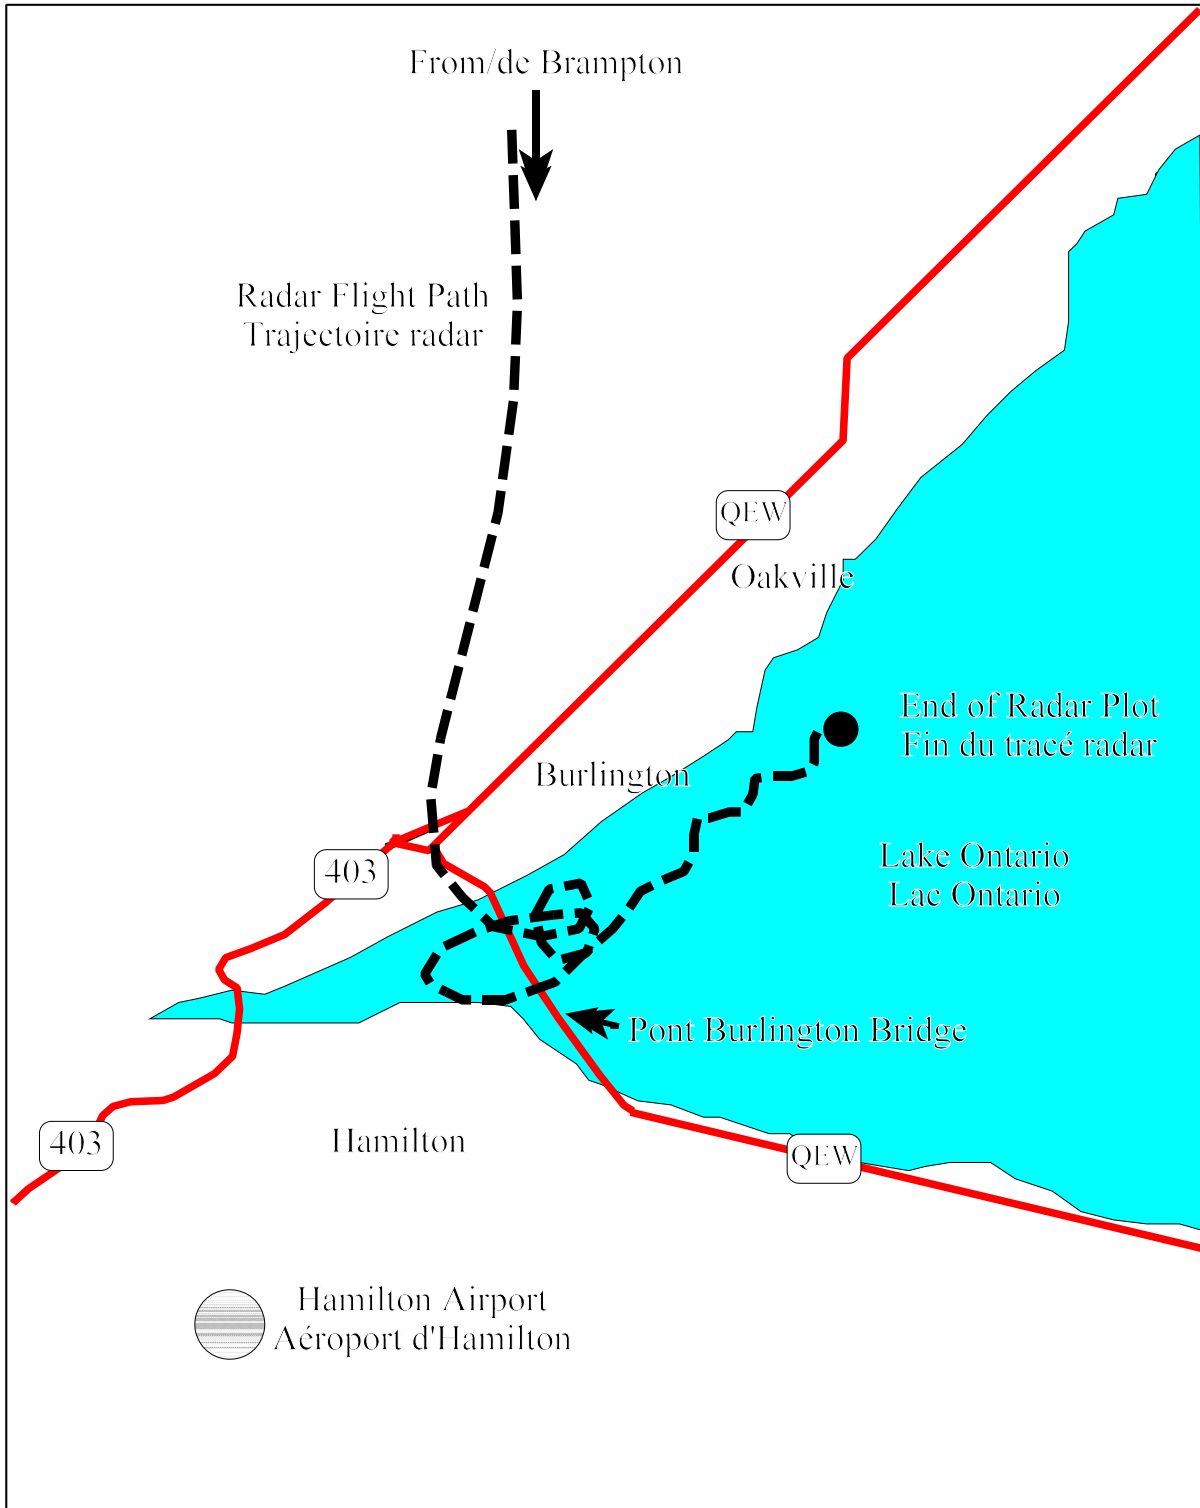
Appendix A - Radar Plot of Flight Path

could not see, and that he could not see the instruments. At one point he stated that he was disoriented. At 1340 the pilot made his last radio transmission, and further attempts to contact the pilot were unsuccessful; at about 1345 the aircraft disappeared from the radar screen. The aircraft was observed on radar to fly an S-pattern eastbound over Lake Ontario before it disappeared from the radar,

approximately 14 miles northeast of Hamilton Airport. The pilot and aircraft are still missing.
