STALL AT LOW ALTITUDE

**EDMONTON FLYING CLUB
BELLANCA 8KCAB DECATHLON C-GWZE
VILLENEUVE, ALBERTA
15 MARCH 1994**

REPORT NUMBER A94W0032

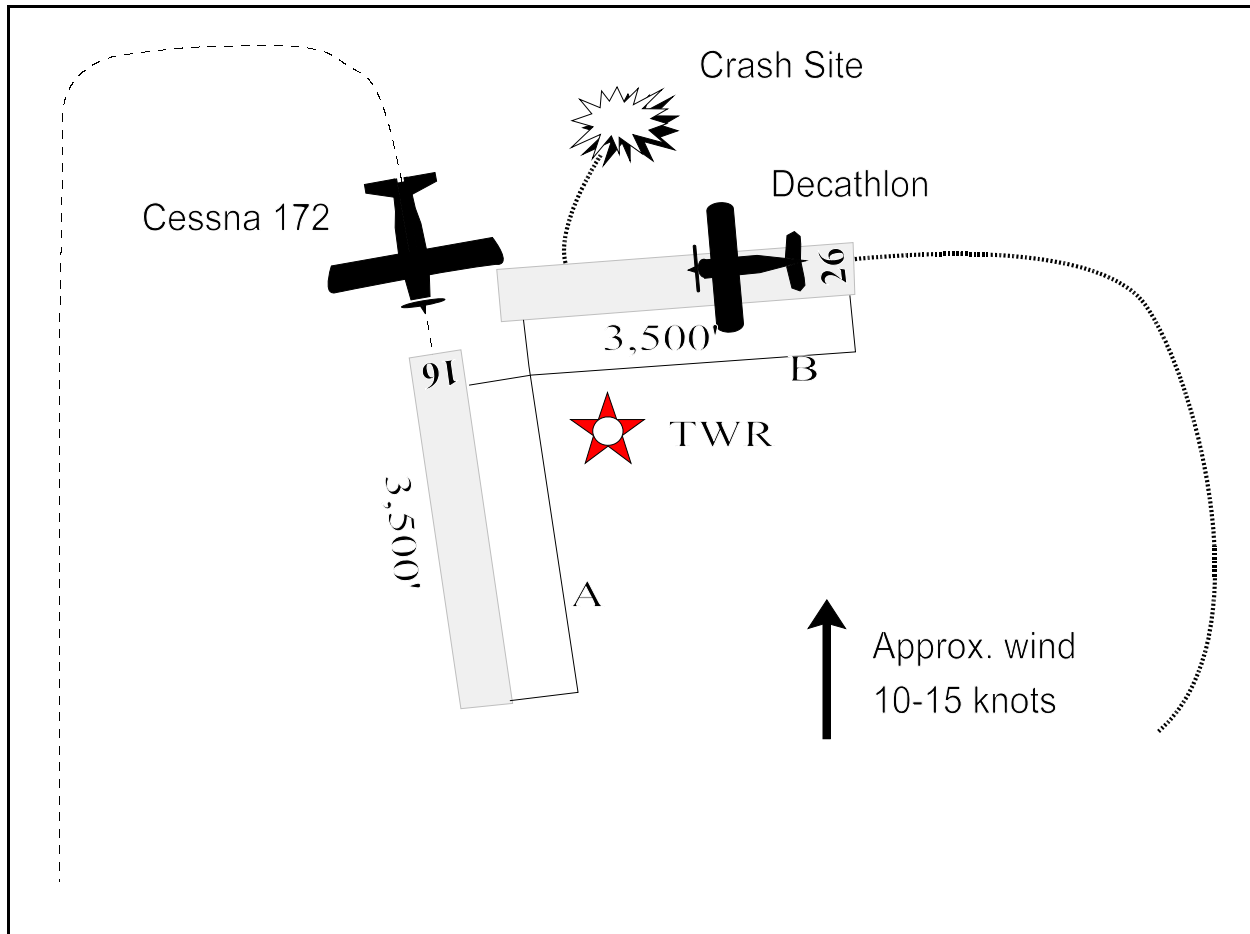
Appendix A - Representative Flight Paths

Also at the Villeneuve Airport was a Cessna 172, from the same company, cleared for a right-hand downwind circuit to runway 16. (See Appendix A.) While on final to runway 26, the Decathlon pilots were re-cleared for a touch-and-go landing. Following the Decathlon's touch-and-go, the Villeneuve Tower issued an instruction to the Decathlon to sequence behind the Cessna 172 that was on final for runway 16. At this point, the Decathlon instructor spotted the traffic, and, believing there was a risk of collision with the Cessna, assumed control of the aircraft from the student, and commenced a steep climbing turn to the right³.

Review of the Edmonton North Terminal Control Unit taped radar tracings and statements from airborne and ground witnesses indicated that the Cessna 172 was through the departure path of runway 26 when the Decathlon commenced its take-off roll. It was also determined from the radar tracings and witness reports that, had the Decathlon continued in a straight-out departure off runway 26, it would likely have passed above and behind the Cessna on final for runway 16.

The instructor took control of the Decathlon from the student because he perceived there was a risk of collision with the Cessna 172. Although the control tower instructed the pilot to move slightly right of the centre line, the instructor took evasive action by performing a steep climbing turn to the right. The radar tracings and witness reports indicated that, had the Decathlon continued in a straight-out departure off runway 26 or even moved slightly to the right of the centre line, it would likely have passed above and behind the Cessna on final for runway 16.
