AVIATION OCCURRENCE REPORT

RUNWAY OVERRUN

**ROYAL AVIATION INC.
BOEING COMPANY 727-217 C-GRYR
ST. JOHN'S, NEWFOUNDLAND
11 MAY 1995**

REPORT NUMBER A95A0093

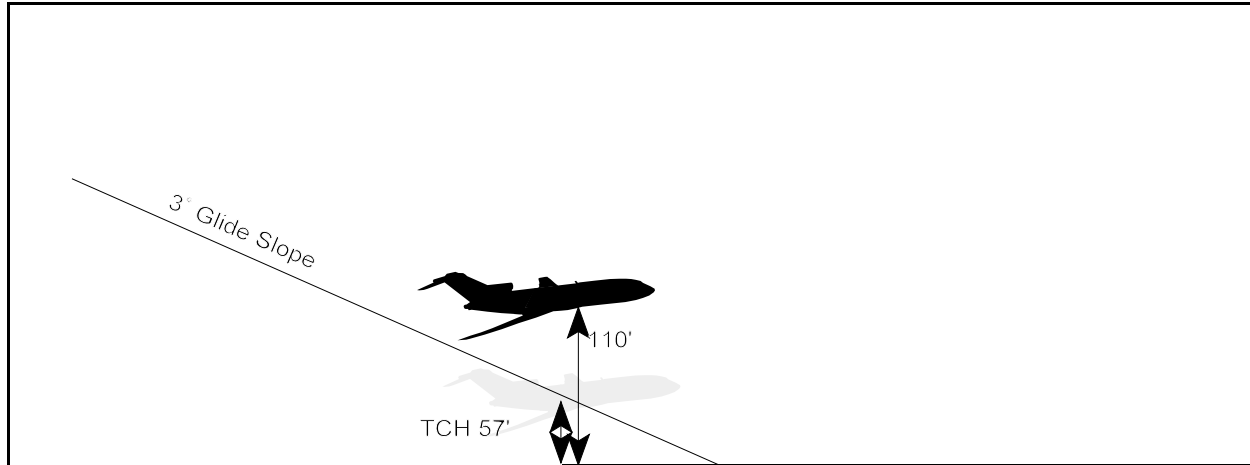
Figure 1 - Actual Height Over Threshold

Analysis of the FDR data indicated that the aircraft crossed the threshold 110 feet above ground level (agl). The published threshold crossing height (TCH) for the approach to runway 11 is 57 feet agl.

Although the failure of the No. 1 main tire resulted in decreased aircraft braking effectiveness and a slight increase in the landing distance required, it was primarily the delayed touchdown that resulted in insufficient runway remaining to stop the aircraft. Therefore, the analysis will concentrate on the approach profile and the captain's decision to continue with the landing.
